CK-2472  
CK-2472

MAISAL 6km

2020 Inspection

Crossing Name Upper Maisal

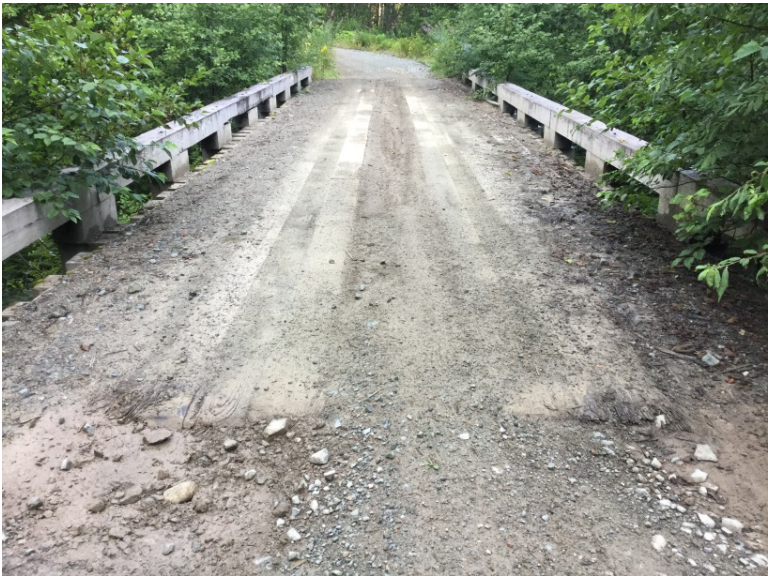
Deck

Wearing at ends and in random locations throughout

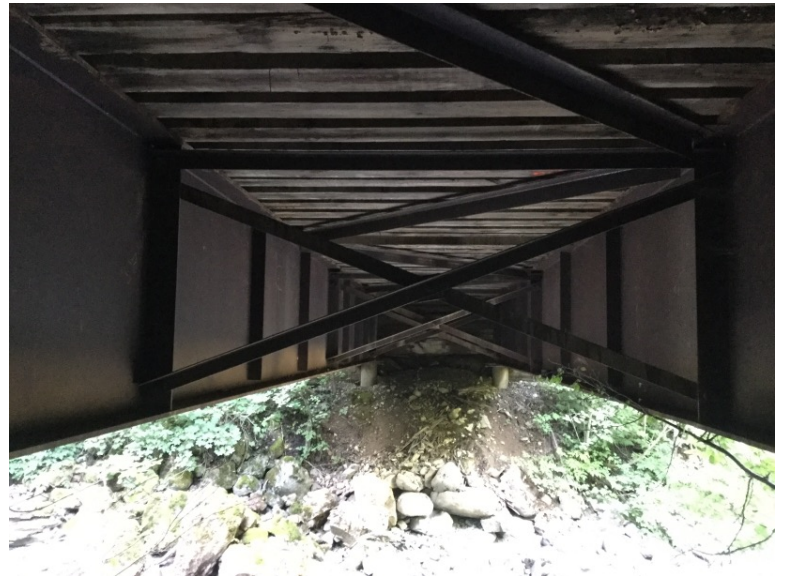
Superstructure

Girders Good

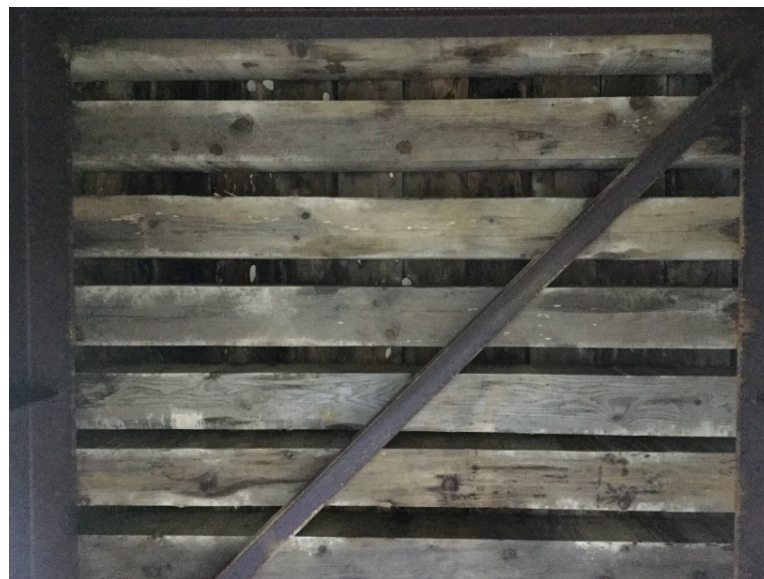
Deck from underneath

Fair to poor - small fruiting bodies at various locations on underside

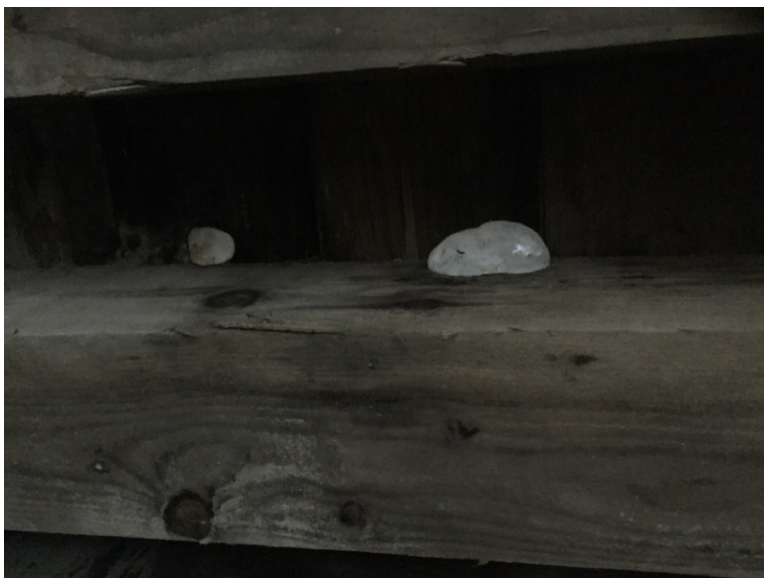
The timber deck is now 8 years old and nearing the end of its industrial life. Fruiting bodies are showing up at various locations on the underside of the subdeck. Only 1 fruiting body present on a single cross tie.

A single fruiting body present on 1 tie

Small fruiting body present on single tie and at various locations of subdeck -  
typical size shown

Brush approaches and replace missing delineators. Limit the loading to L100 or 91 tonnes - post load rating signs. Replace the cross ties, subdeck, wear planks and guardrail system for design vehicle loading.
