CK-2477  
CK-2477

Nahatlatch FSR 40.0km

2020 Inspection

| Crossing Name | Nahatlatch River |

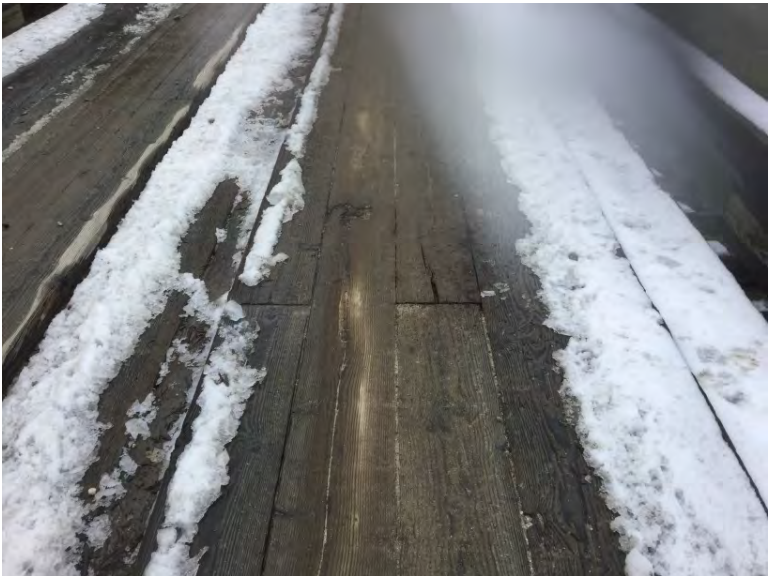
Running Planks      Fair      Some wear

Minor wear on wheel path planks

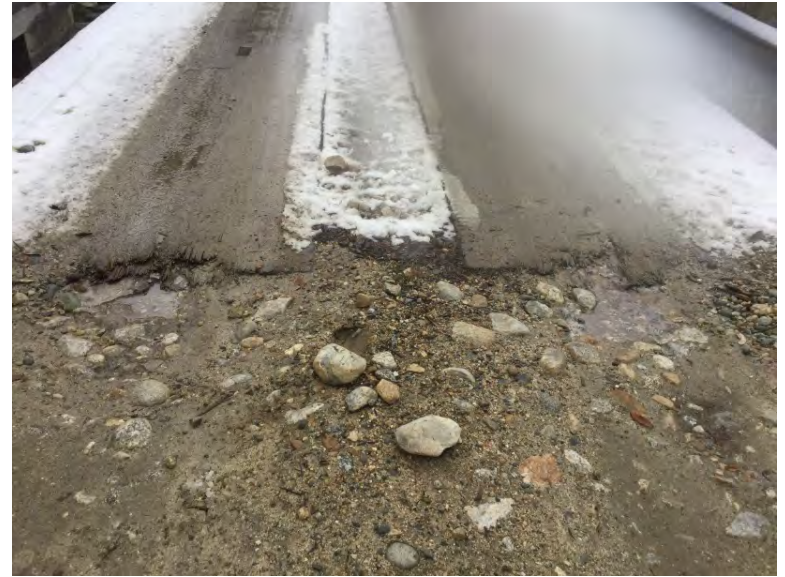
Minor wearing of planks at each approach

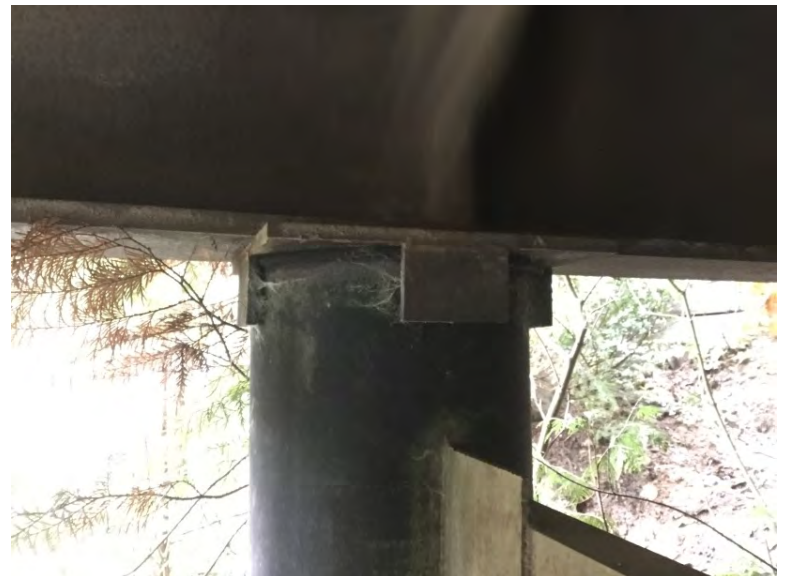
Bearing

Bearings Fair Thin rubber pads

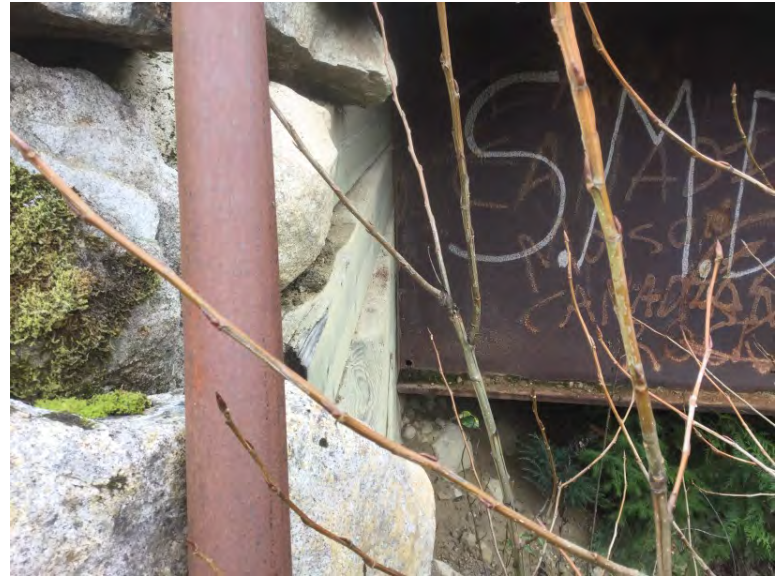
Left bank ballast wall

Ballast wall appears to have been reinforced between the girders but is misaligned, especially noted at downstream ends.

Ballast Wall Fair Treated timbers, reinforced between girders, and misaligned at downstream ends

Brush approaches and update load rating signs. Continue to monitor the condition of the ballast walls. The current load rating of L90 or 80 tonnes to continue.

| Item | Monitor Description | Frequency |
|---|---|---|
| 1 | Ballast wall condition | Routine Inspection |
