CK-2479  
CK-2479

## Grizzly Creek 2.0km

2020 Inspection

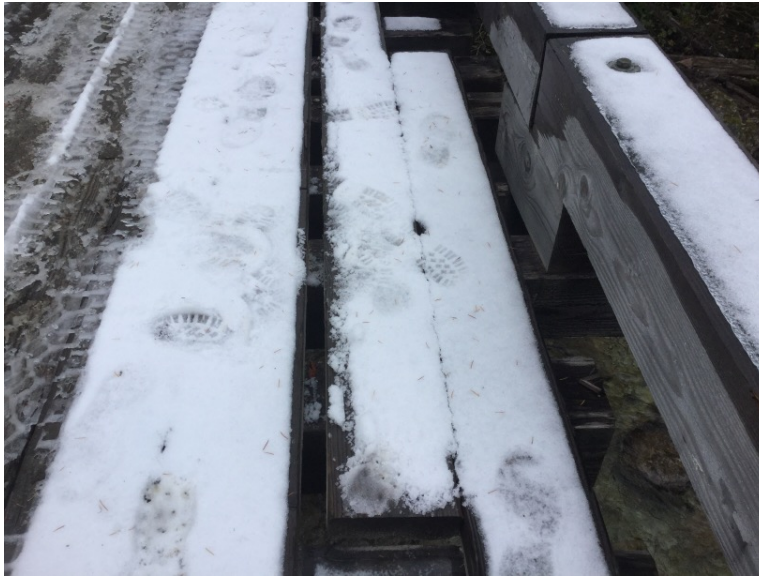
Not placed tight together and outside strips not fastened

Outside strip of planks on downstream not tight to each other or fastened to cross ties

| Repair Item | Repair Description |
|---|---|
| 2 Medium | Fasten all planks to ties |

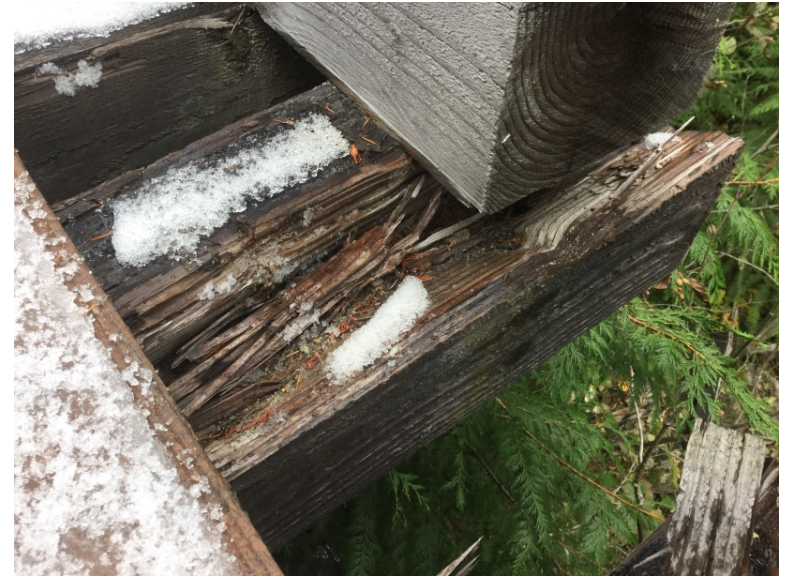
Damage noted to random ties, likely done when removing old subdeck materials

Damage to downstream cross tie

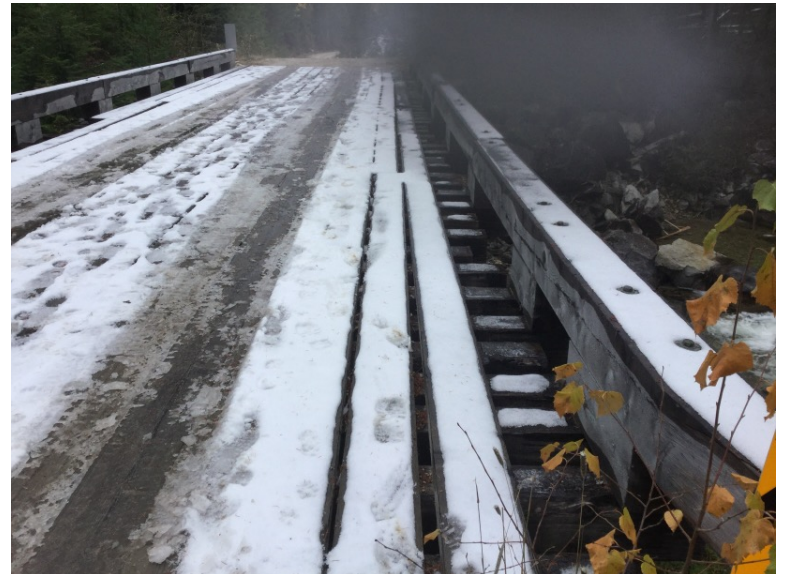
Upstream planks not tight to each other and not fastened to the cross ties
