CK-2488

STS'AILES (WEST) 10.1km

2020 Inspection

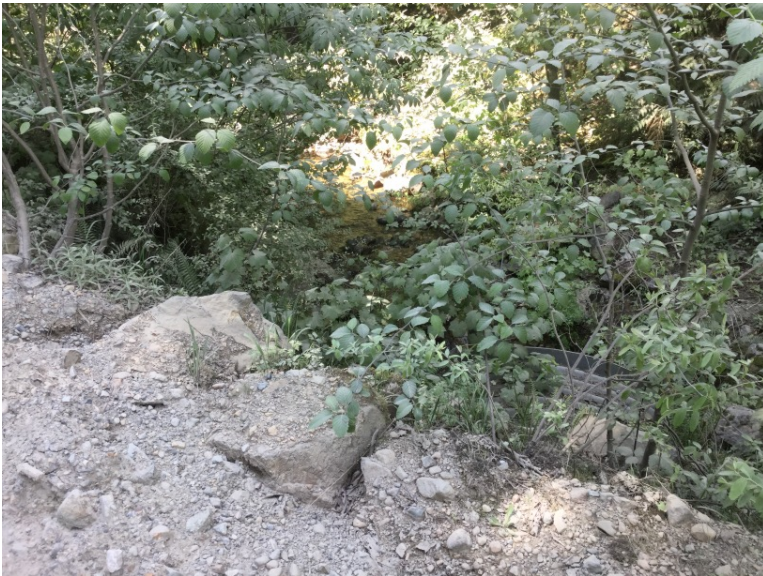
Upstream from Crossing

Stream aggrading reducing hydraulic capacity - monitor

| 1 | Stream aggradation | Routine Inspection |

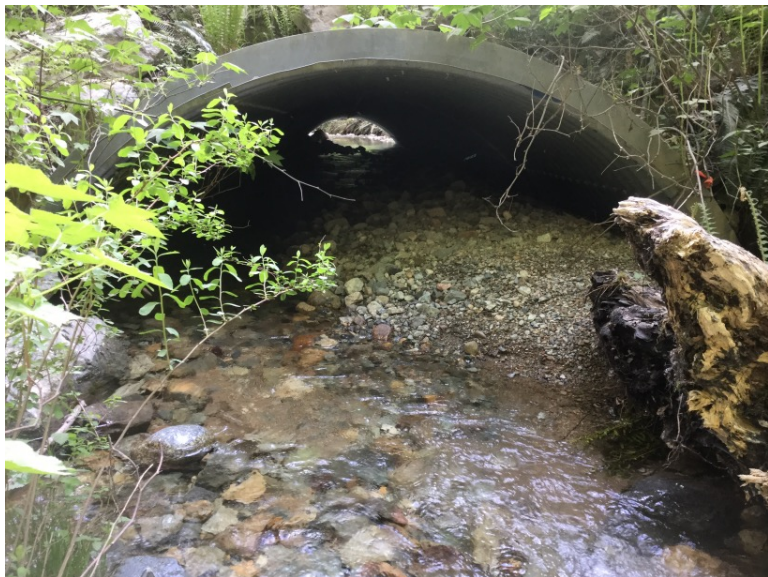
Comments    Inlet aggrading and debris collecting at both inlet and outlet

| 2 | Medium | Remove debris from inlet and outlet |
