CK-2489

BENCH 7.2km

2020 Inspection

| Crossing Name | Side Creek |

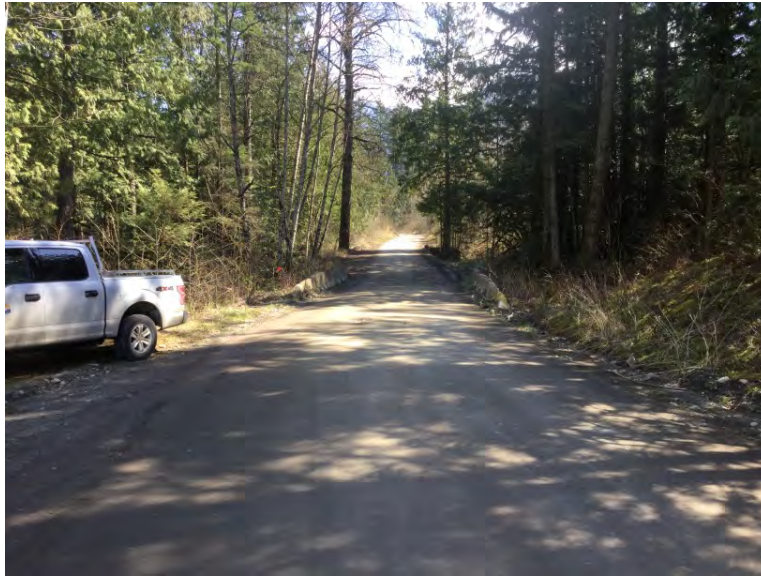
Approach from Right Bank when facing downstream

Brushing Required **Y**

| Repair Item | Priority | Repair Description |
|---|---|---|
| 1 | Low | Brush approaches |

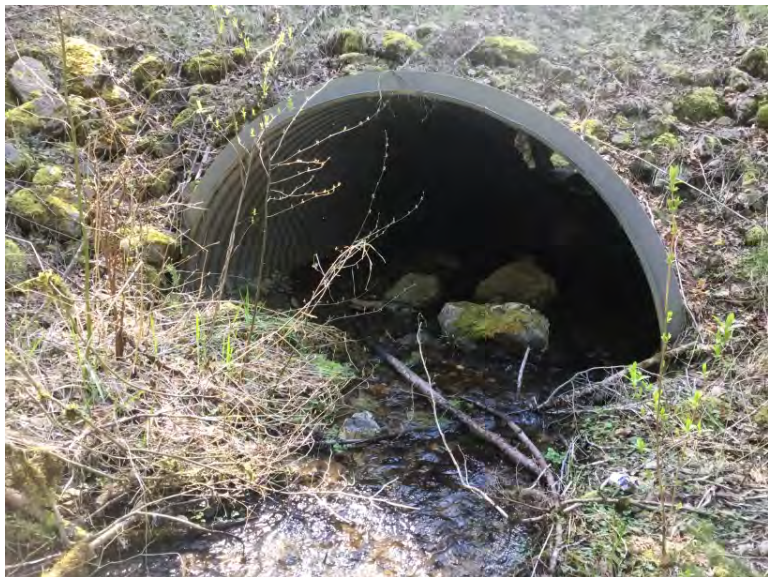
Inlet      Good

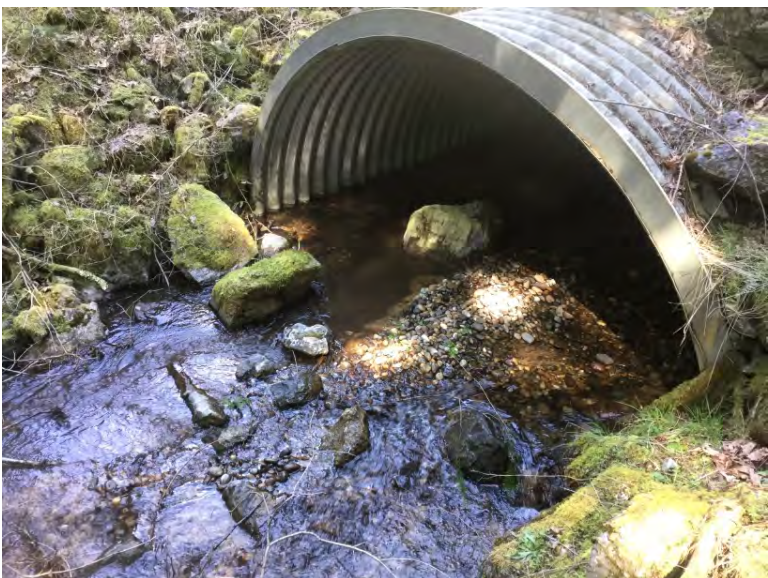
Outlet      Good
