CK-2493  
CK-2493

RUBY 5200A 0.15km

2020 Inspection

Crossing Name Mahood Creek

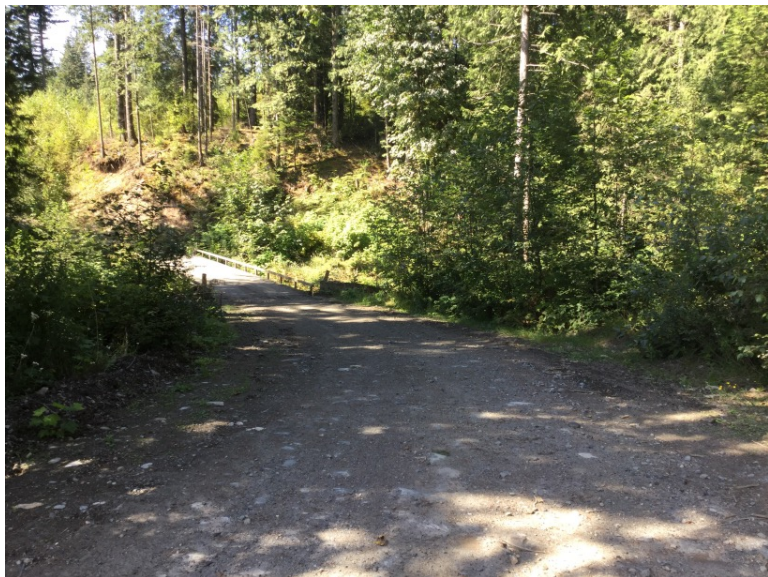
Approach from Left Bank when facing downstream

Alignment Fair

Brushing Required Y

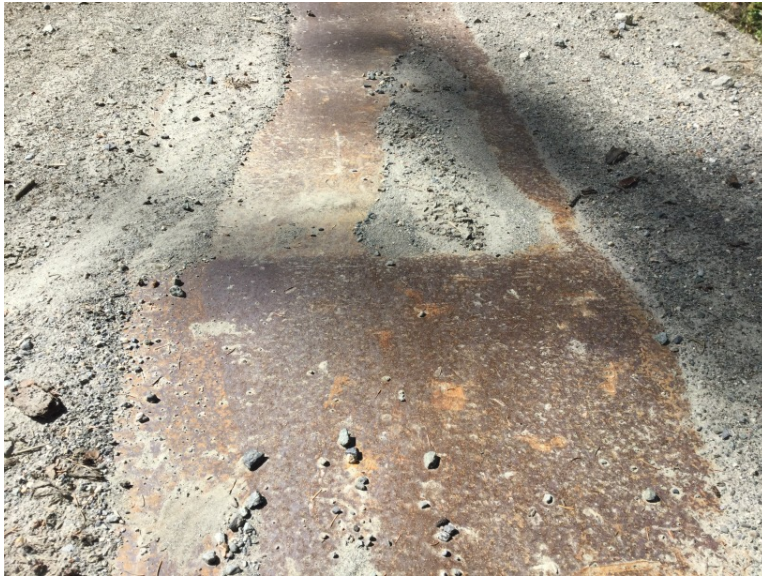
Steel Deck Plate Fair Minor deformations along wheel path and mainly all anti skid worn off

Minor deck deformation noted on wheel path

Brush approaches and monitor steel deck deformations. The current load rating of L75 or 68 tonnes to continue.

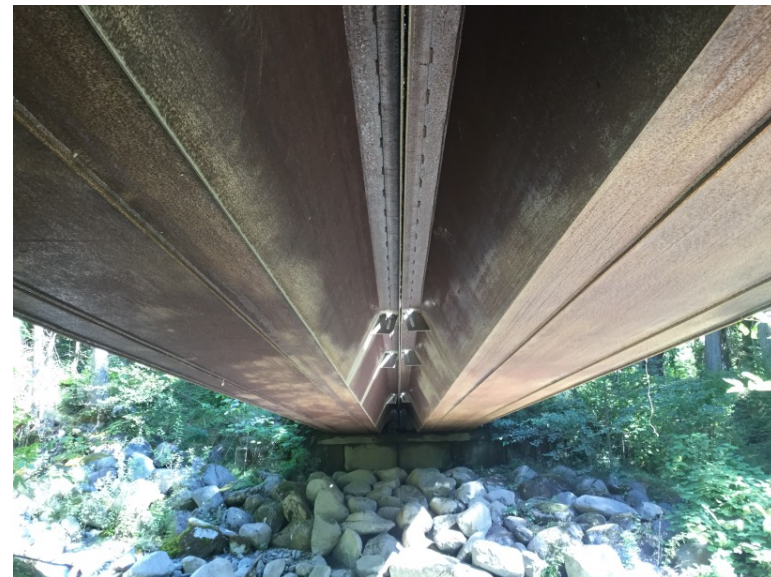
Superstructure

Girders Good Very minor corrosion throughout

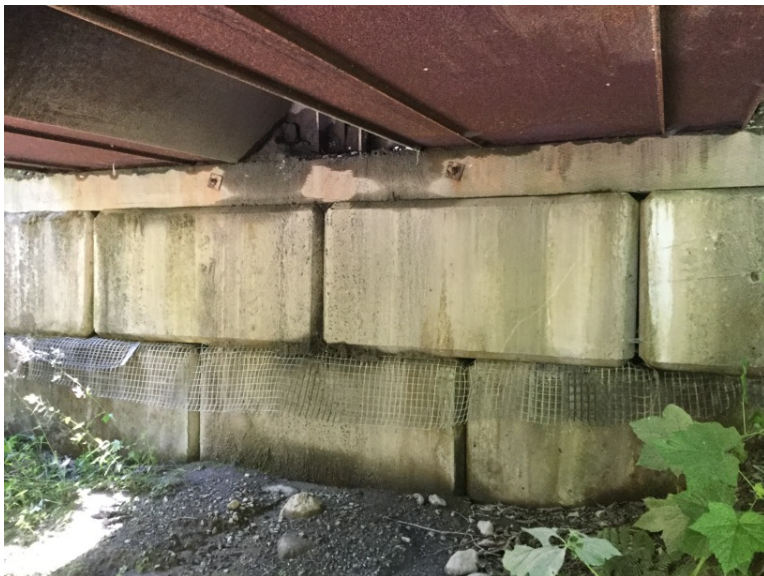
Right Bank Abutment when facing downstream

Bracing Good Geogrid between lock blocks on right bank
