CK-2496  
CK-2496A

## ENGLISH 2km

2020 Inspection

| Crossing Name | Side Creek |

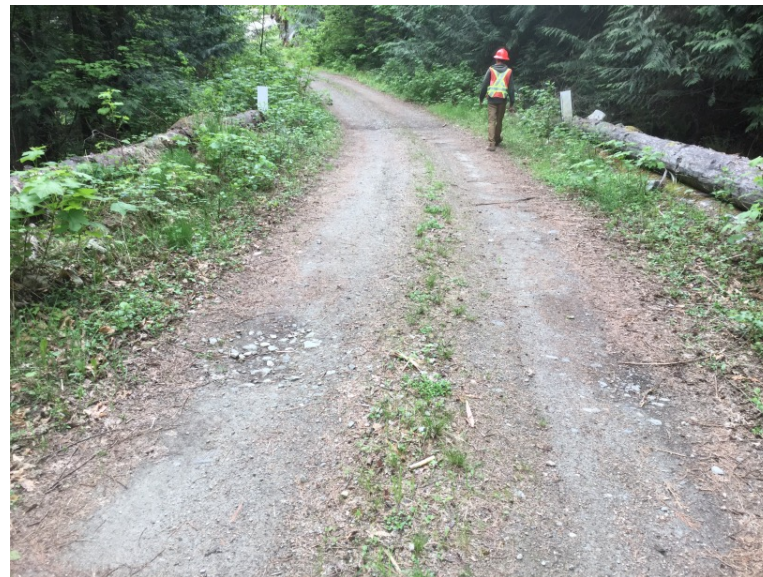
Deck

Curb Rail/Blocks/Posts      **Fair**      **Not fastened**

Ensure curb logs are fastened to stringers. Brush approaches and post bridge ahead signs. The current load rating of L100 or 91 tonnes to continue, post load rating sign. To increase the load rating to the design vehicle add 200mm well compacted gravel fill to deck and blend into grade.

| Repair Item | Repair Description |
|---|---|
| 3 Structure. Hardware (re-torque or tighten). # of items. Priority:Low | Fasten curb log |

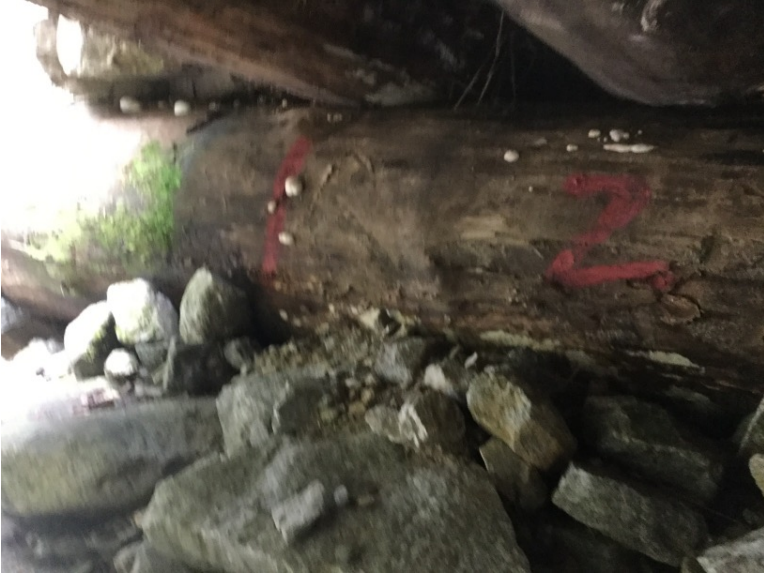
Caps or Sills Fair Fruiting bodies starting to form

Fruiting bodies stating to show on sills
