CK-2497  
CK-2497

ENGLISH 2.6km

2020 Inspection

Date of Inspection 2020-05-15 12:16 PM

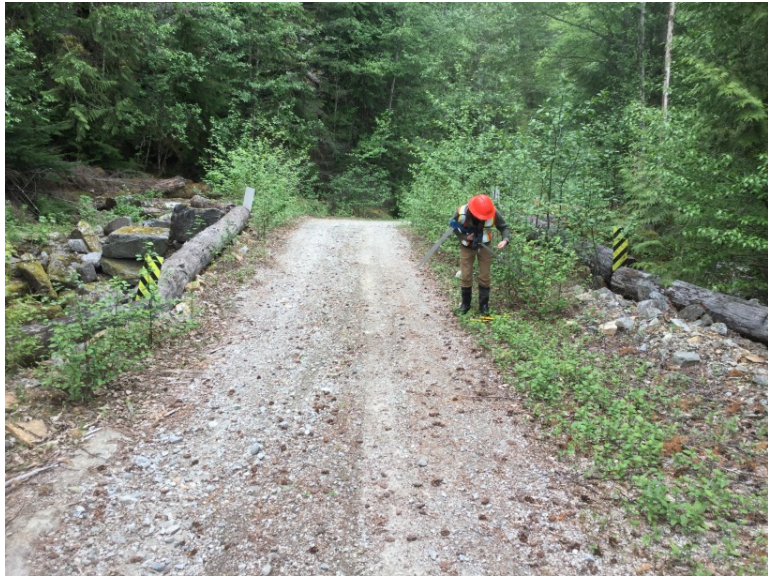
Approach from Right Bank when facing downstream

HC and sharp VC left approach, steep approach right bank

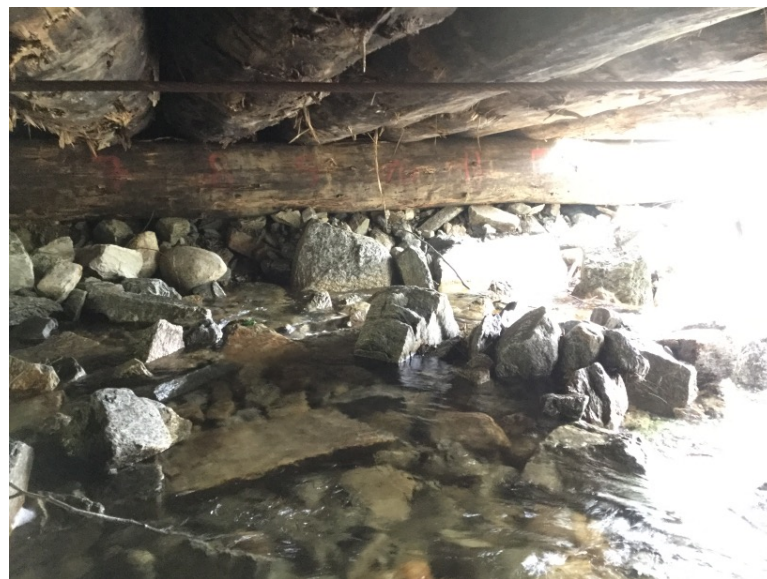
Downstream left bank sill has been scoured  
6.5m span

Scoured downstream left bank

Downstream left bank starting to scour below sill

Repair scour under the downstream left bank log sill to prevent further migration of foundation materials. Ensure the log sill is completely bearing on its foundation materials prior to covering with scour protection. Any further scour will likely result in a reduction of capacity. Brush approaches and post bridge ahead signs. Monitor scour under left bank sill. The current load rating of L100 or 91 tonnes can continue.

| Repair Item | Repair Description |
|---|---|
| 1 Substructure. Log sill maintenance. Priority:High | Repair scour under left bank log sill |

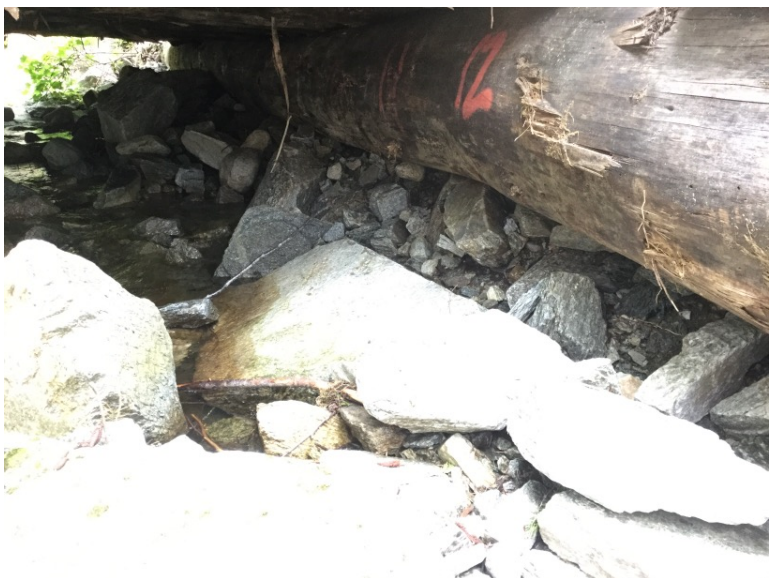
Downstream left bank sill scour

| Item | Monitor Description | Frequency |
|---|---|---|
| 1 | Scour noted under left bank sill | Annually |
