CK-2498

FOLEY 0.1km

2020 Inspection

| Structure Class | Major Culvert |

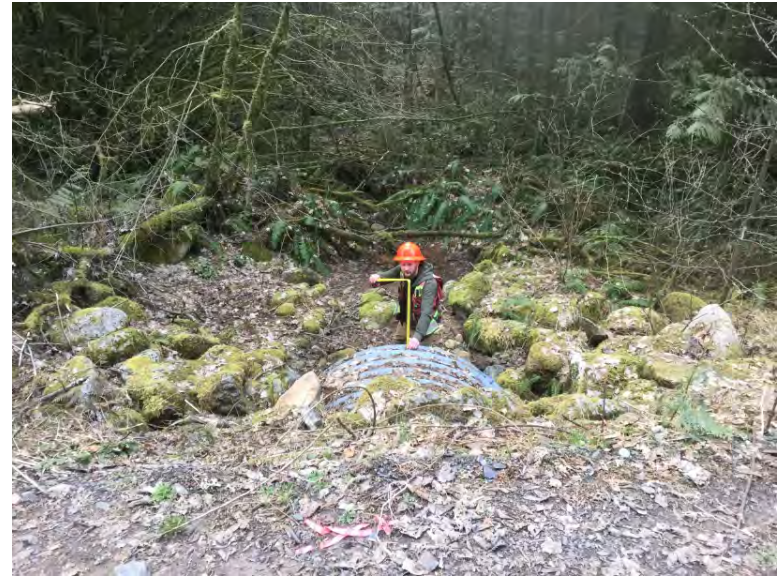
Upstream from Crossing

Comments    **Dry stream**

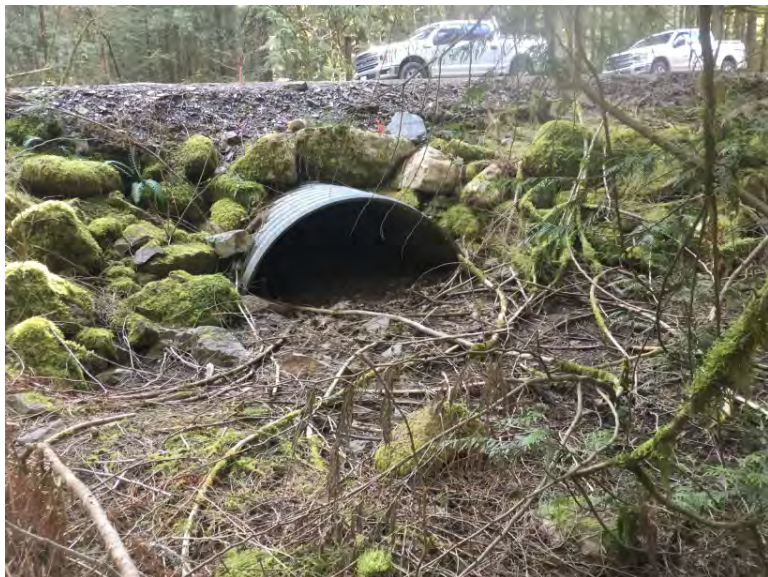
Outlet      Good

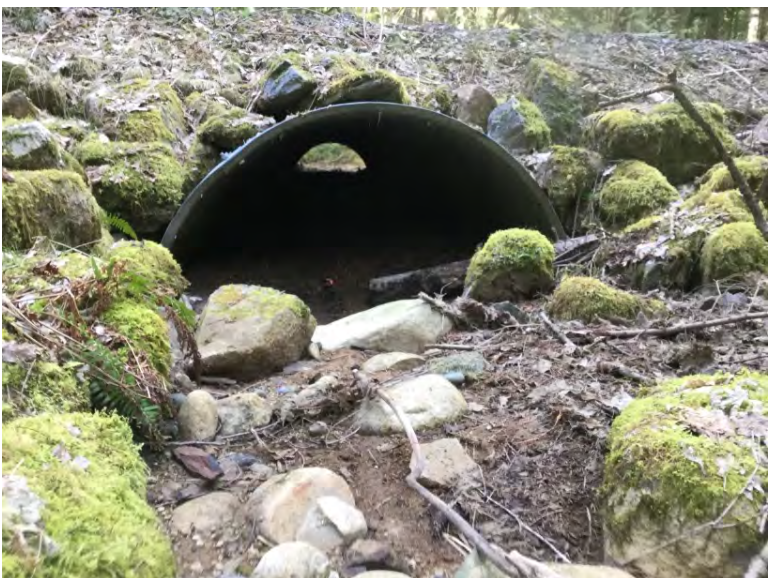
Inlet      Good
