CK-2499

BENCH 2.7km

2020 Inspection

| Structure Class | Major Culvert |

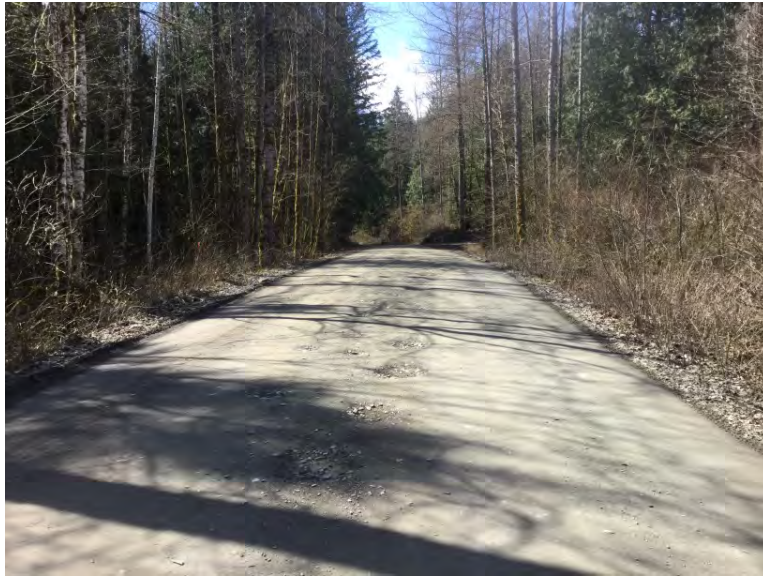
Approach from Left Bank when facing downstream

Brushing Required Y

| Repair Item | Priority | Repair Description |
|---|---|---|
| 1 | Low | Brush approaches |

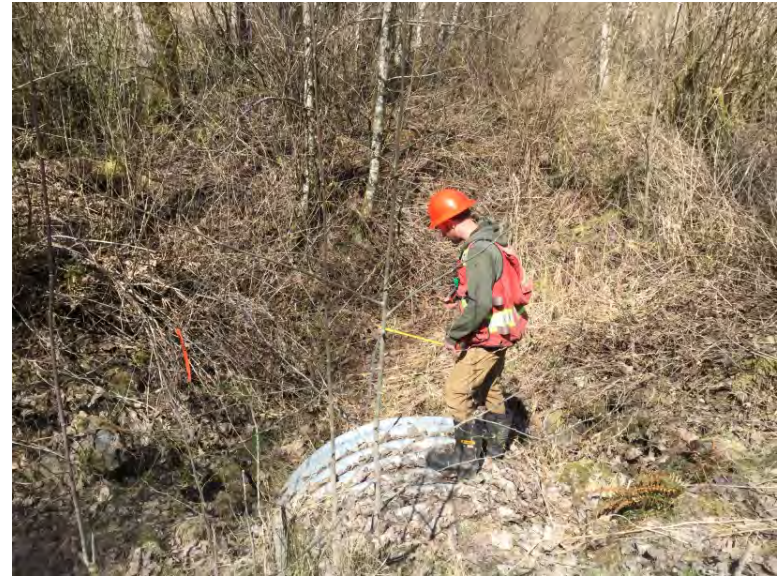
Upstream from Crossing

dry stream

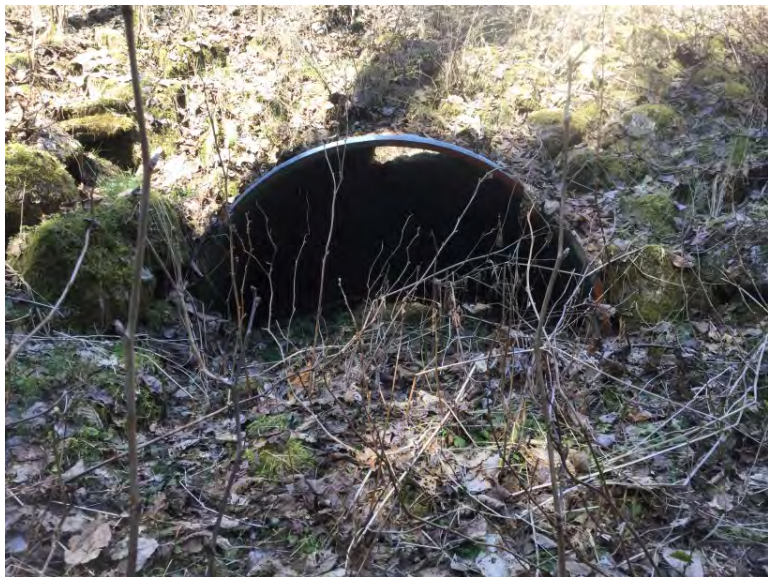
Outlet      Good

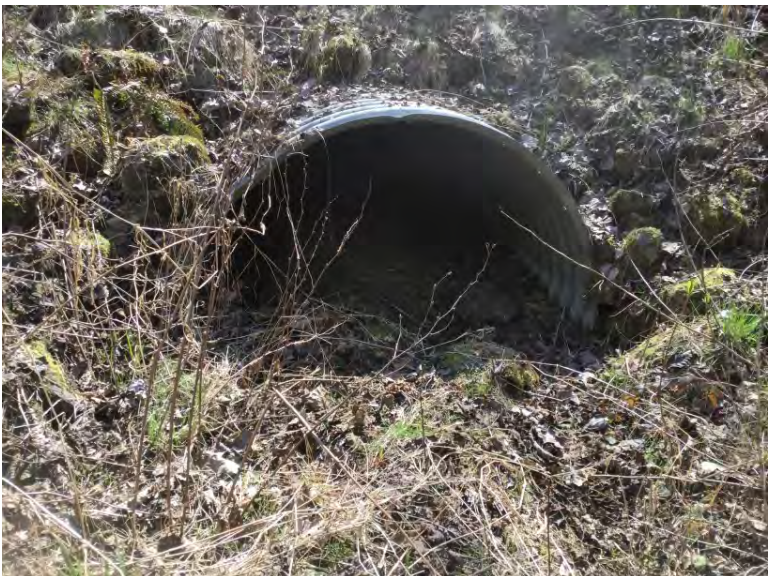
Inlet      Good
