CK-2504  
CK-2504A

Maisal FSR km

2020 Inspection

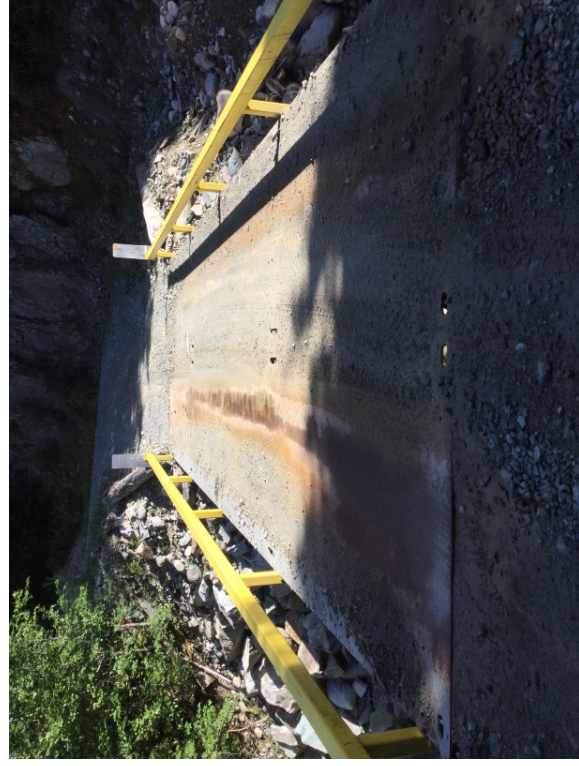
Steel Deck Plate      Fair      Wearing on wheel path

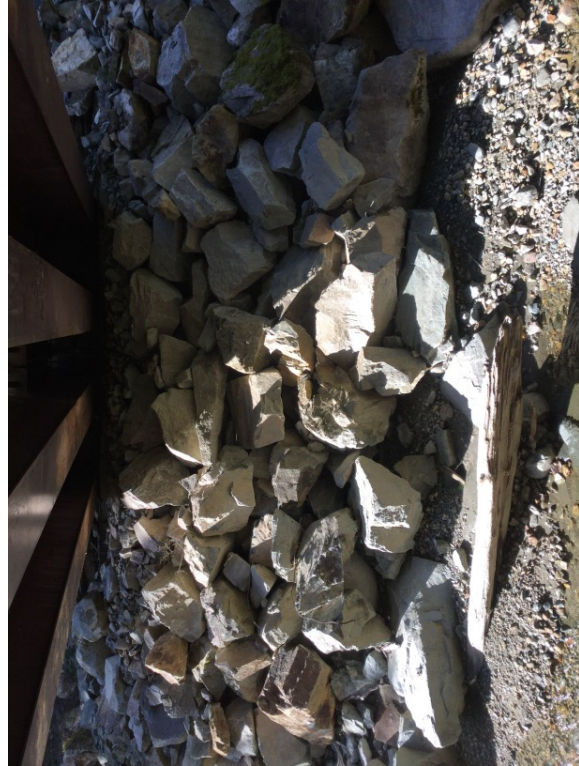
Left Bank Abutment when facing downstream

Caps or Sills Good 10' x 12" timbers bolted together

Ballast Wall Fair Old logs

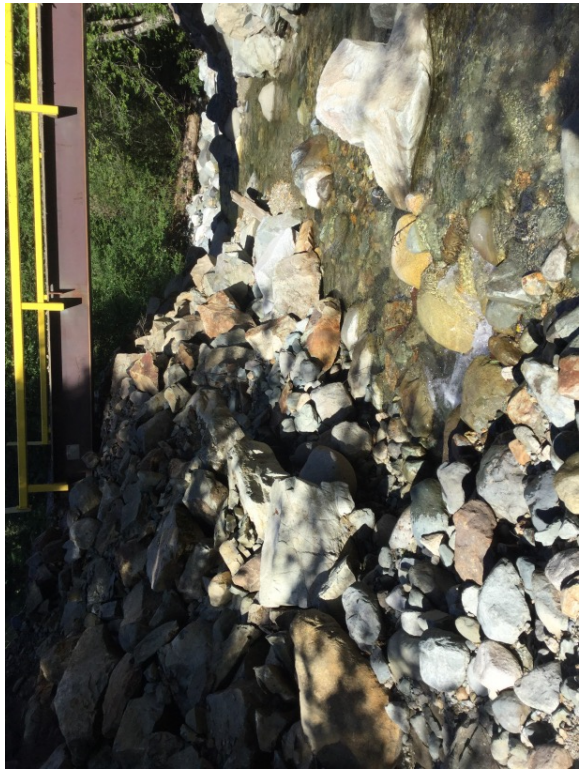
Riprap Fair 1.25:1 slope and not keyed into stream channel

riprap is 1.25:1 slope and not keyed into stream channel - monitor for scour over time

Upstream left bank riprap scour noted

Monitor the riprap condition. L100 or 91 tonnes load rating.
