CK-2518  
CK-2518A

AMERICAN 9.2km

2020 Inspection

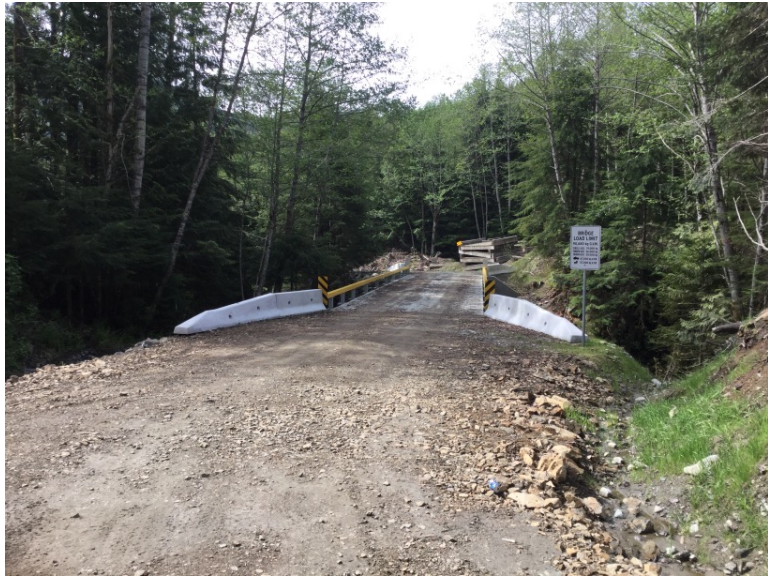
Approach from Left Bank when facing downstream

Alignment Fair

HC and VC right approach, HC left approach

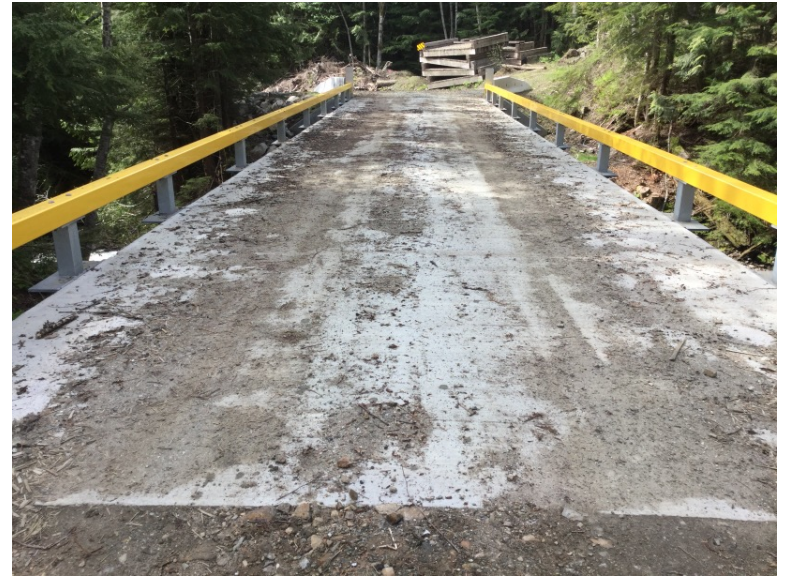
Overall Deck Condition      **Excellent**

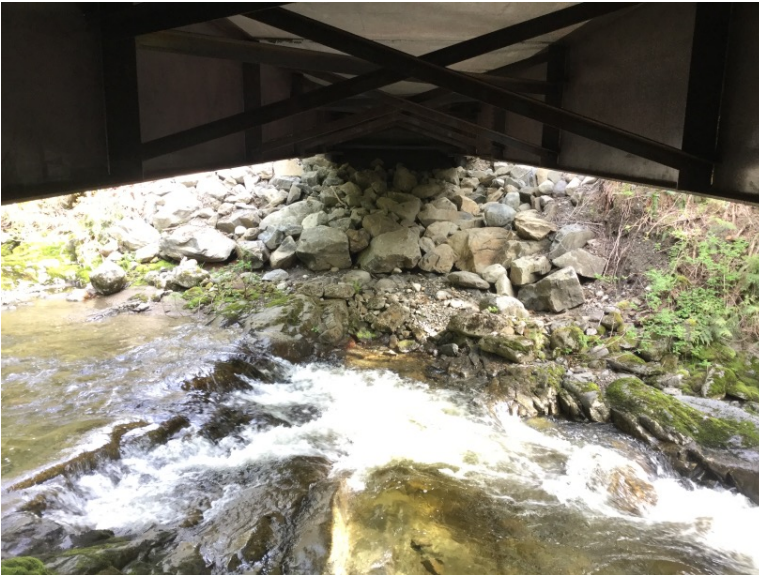
Left Bank Abutment when facing downstream

Bracing Unrated None, pipe height is short

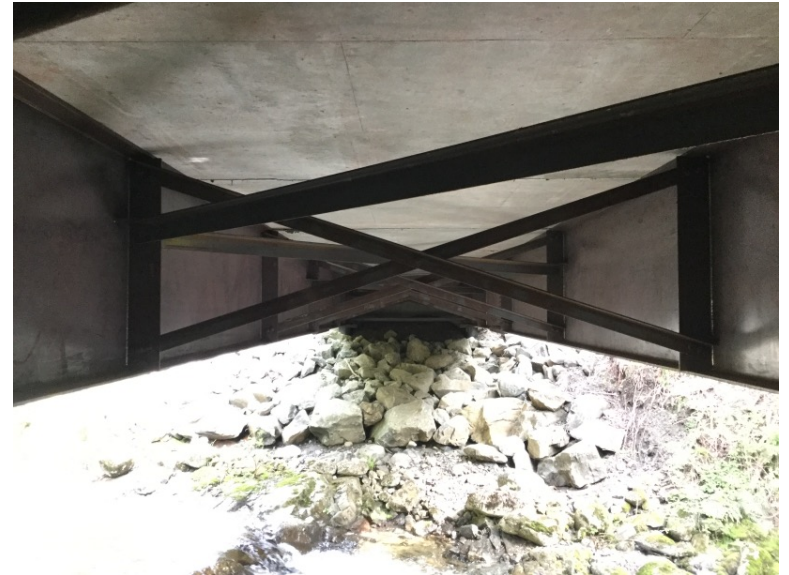
Superstructure

Girders    Excellent

Diaphragms    Excellent

Bracing    Excellent
