# BC Ministry of Forests, Lands, and Natural Resource Operations

## Log Stringer Bridge Inspection Report

| Site #: | CK-2524 | Structure Name: | CK-2524 | Road Name: | BIG SILVER | Inspection Date: | 2020/05/15 |
| KM: | 0.30 | User km: | 0.30 | Crossing Name: | Big Silver River | Next Inspection Date: | 2020/08/20 |

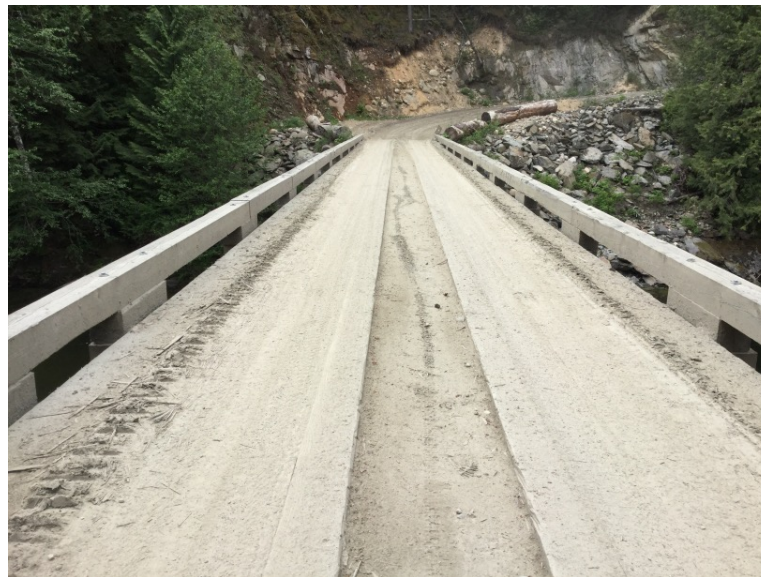
| Overall Deck Condition | Fair | |

Deck

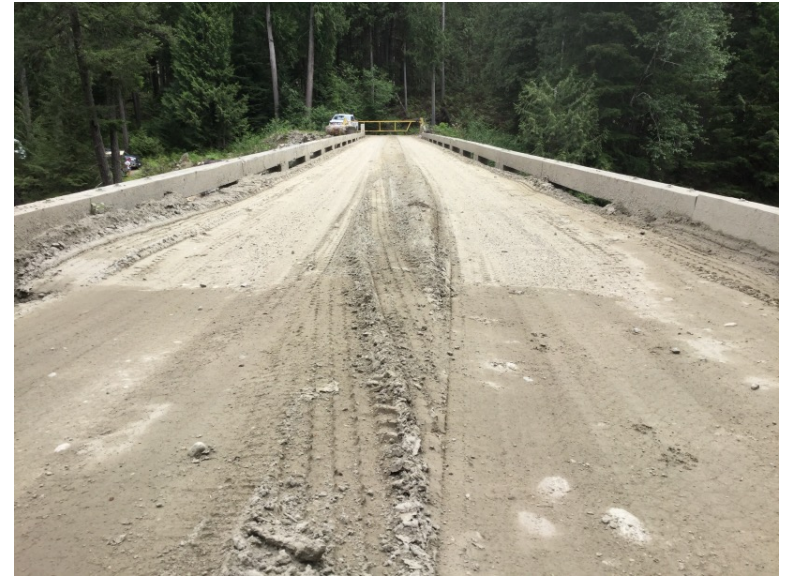
Sediment getting onto deck at right approach

| | 1 | Suggested | Medium | \$ | Clean sediment off deck | | | | | |
| <b>GENERAL</b> | PEng's Comment: | Remove sediment accumulations from the deck and monitor the crib condition at the broken tieback location. The current load rating of L100 or 91 tonnes to continue. | | | | | | | | |

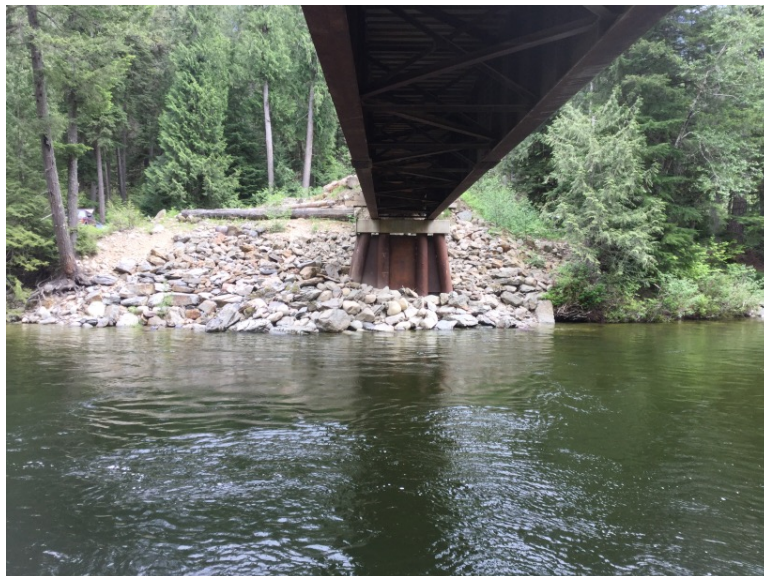
| Overall | Good | |

Pier

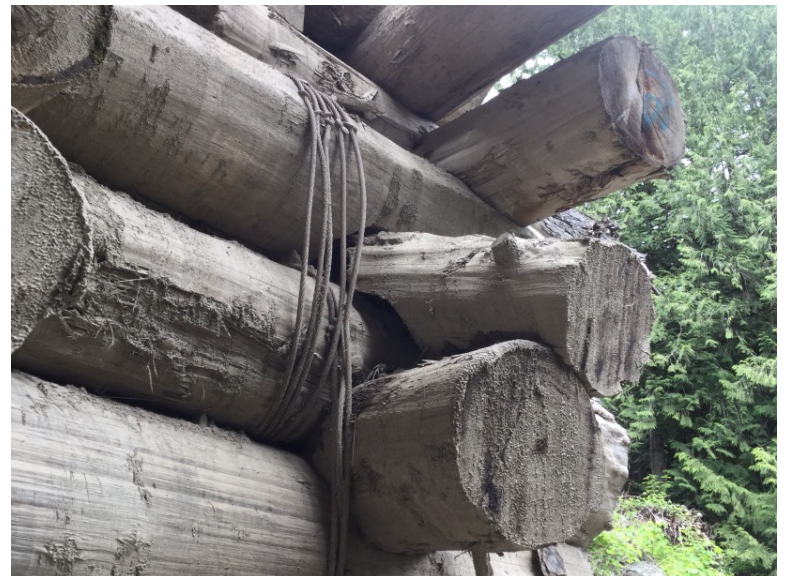
| Tie-backs | Fair | 1 broken tieback upstream, otherwise good condition |

Broken tieback at upstream right bank

| | 1 | Broken tieback and crib condition | | | | | | | | |

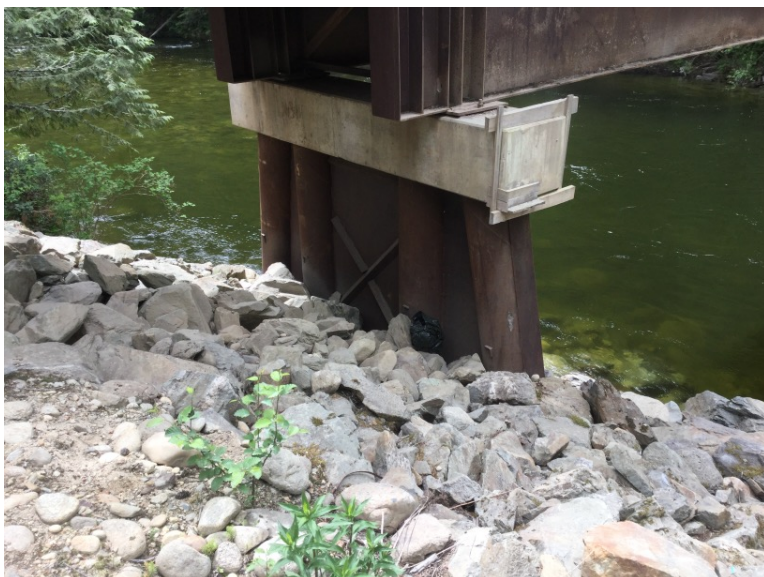
Pier

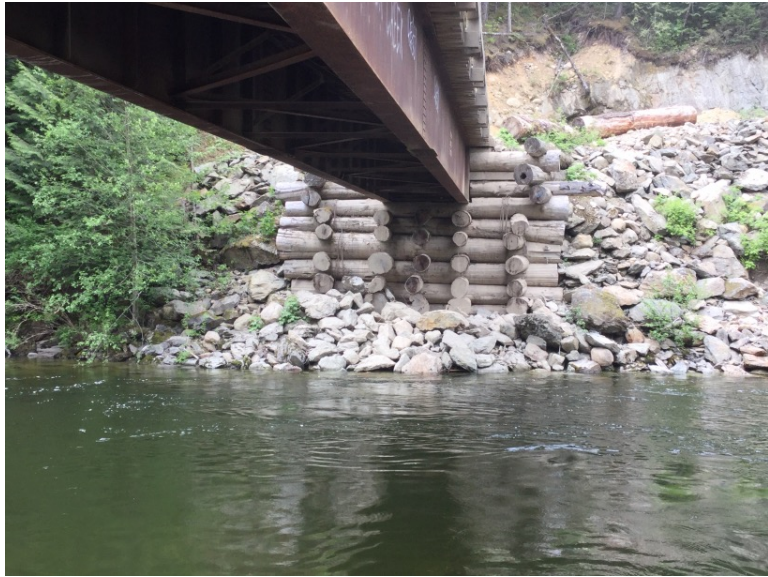
| Log/Timber Crib | Good | right bank only, 6 face logs high |
| Wing Wall | Fair | right bank only - part of crib |

Right Bank Abutment when facing downstream

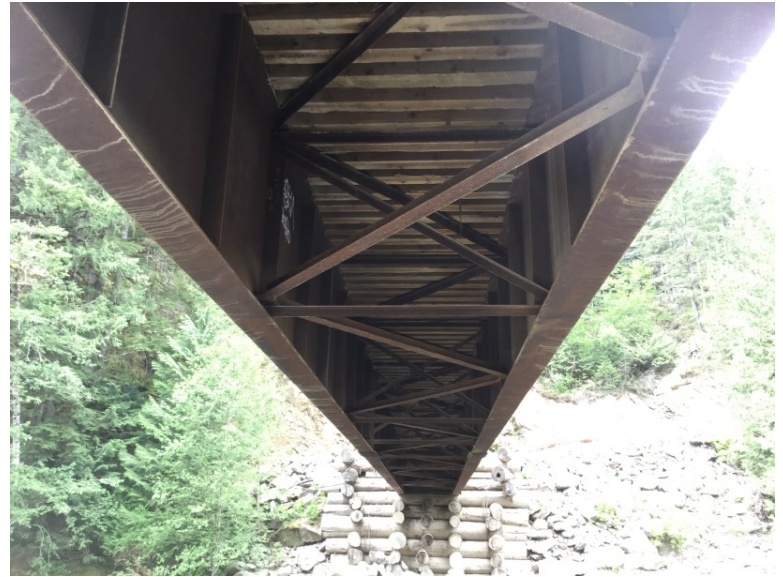
| Girders | Fair | | main span girders reused from previous install at this location and modified for jump span seat | | | | | | | |

Main span Superstructure

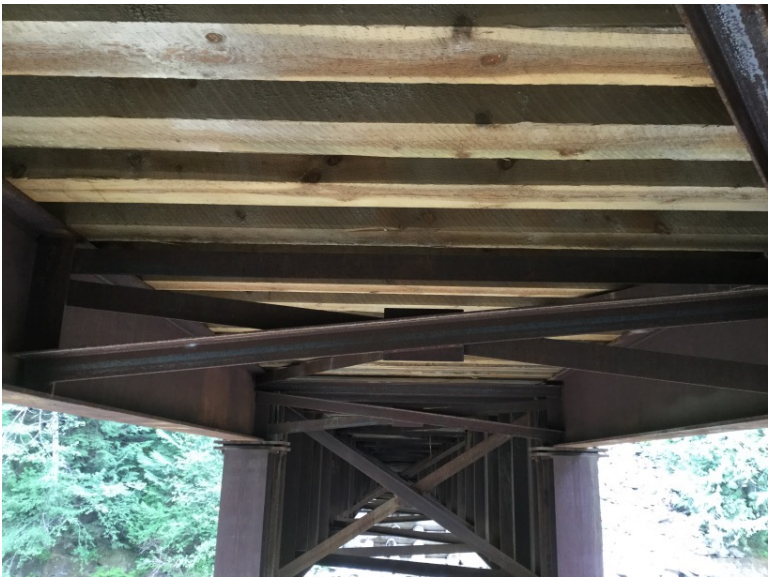
| Girders | Good | | jump span - 3 welded bays | | | | | | | |

Jump span superstructure
