CK-2525  
CK-2525

BIG SILVER 2.5km

2020 Inspection

Crossing Name Side Creek

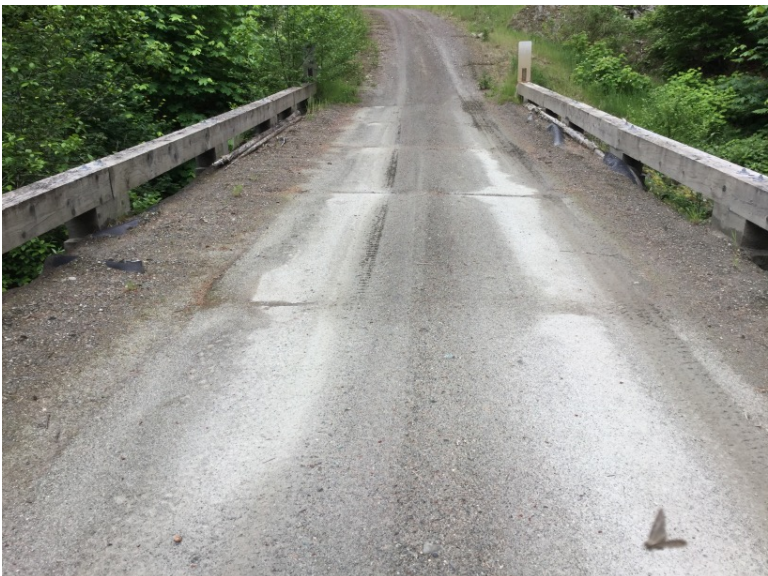
Running Surface      Fair      Sediment and debris on deck

Deck

| Repair Item | Repair Description |
|---|---|
| 4 Medium | Remove sediment and debris from deck |

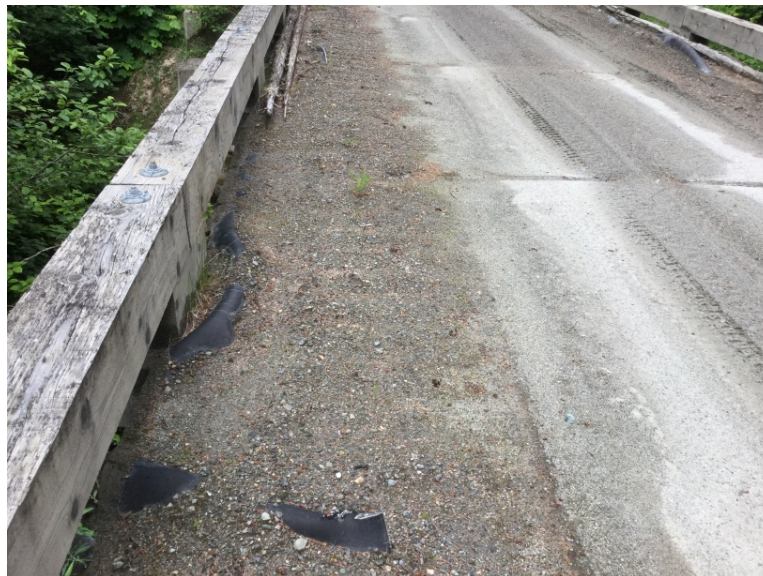
Rubber mats along both edges of deck

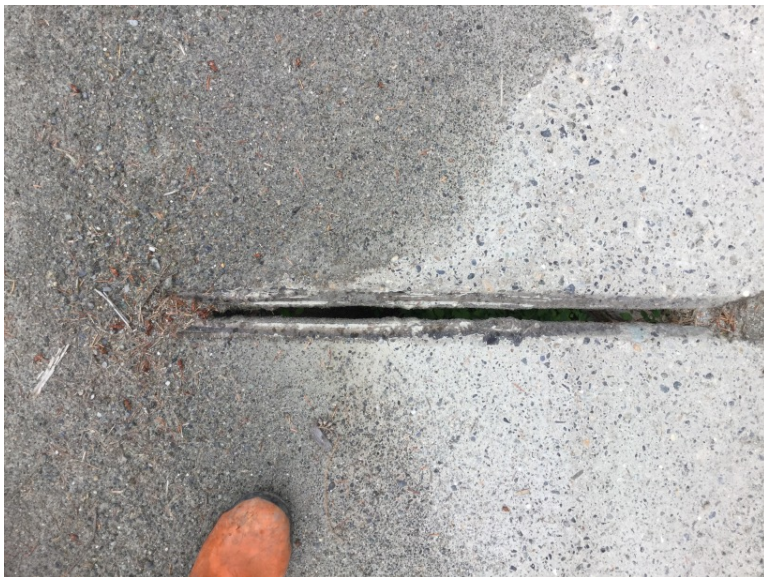
Deck Joints      Poor      Missing some seals completely and others failing

Missing deck joint seals

Repair damage to all concrete deck panels and ballast walls as per the Concrete Repair Guide for Concrete Bridge Components MoFLNRO (2017). Replace all deck panel joints (poured sealant backed with okum). Remove the sediment and debris from the deck and brush approaches. Repair the scoured riprap at the right bank and monitor. The current load rating of L75 or 68 tonnes to continue.

| Repair Item | Repair Description |
|---|---|
| 3 High | Replace all deck joint seals |

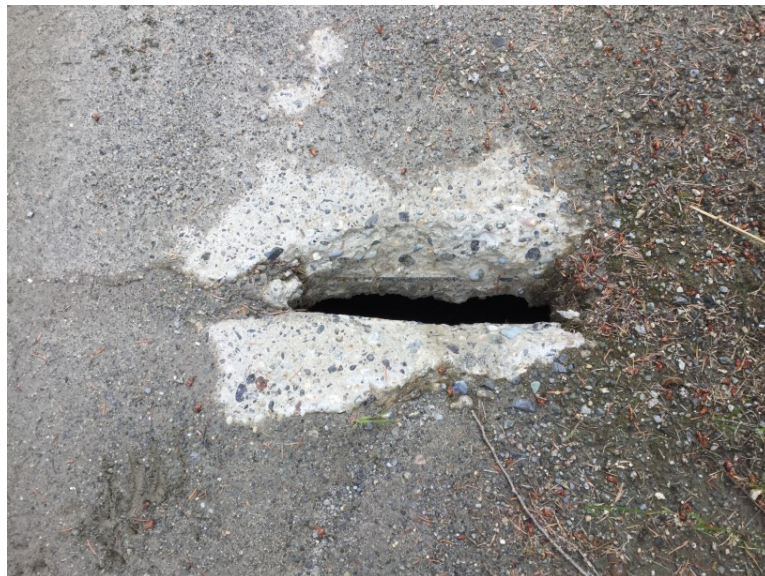
Concrete Deck      Fair      Damage noted on some panels

Damage to to ballast wall and deck panel at right approach

| Repair Item | Repair Description |
|---|---|
| 1 Structure. Concrete structural maintenance. m². Priority:Medium | Repair damage to concrete components |

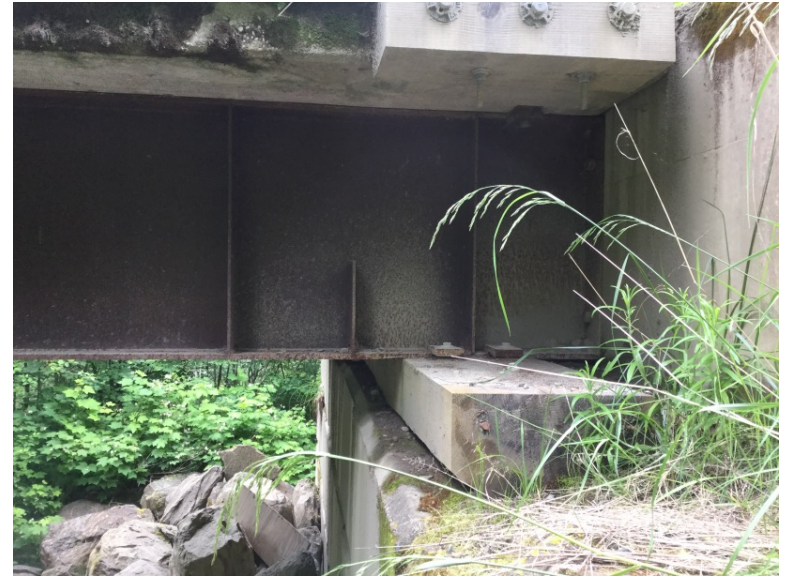
Bearing

Bearings Good

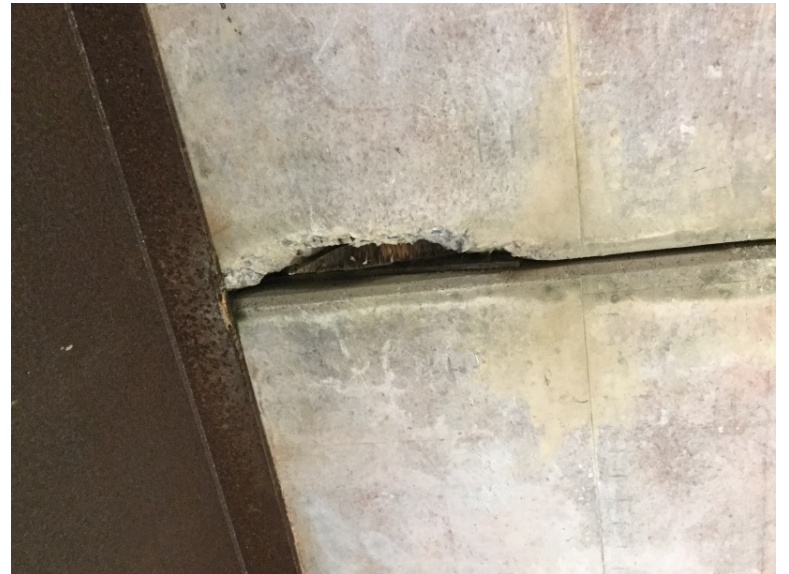
Damage to panel 1 at right approach

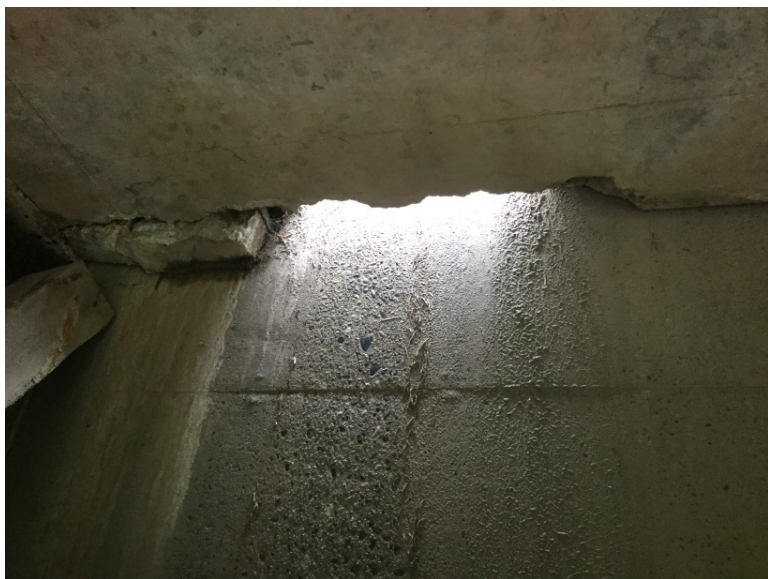
Damage to panel 1 at right approach

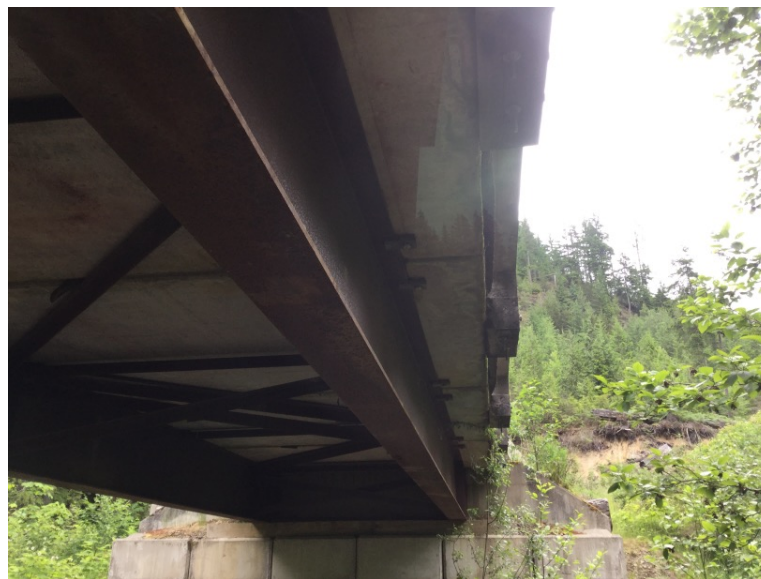
Deck clips

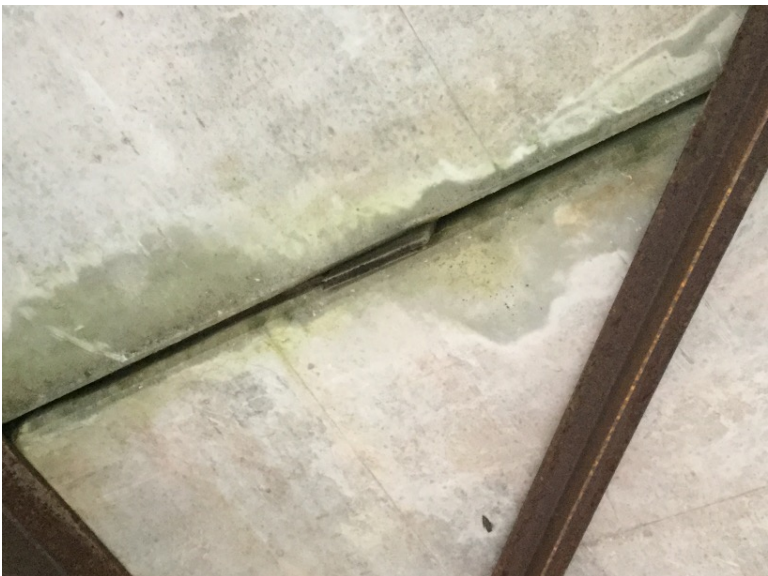
Material placed between

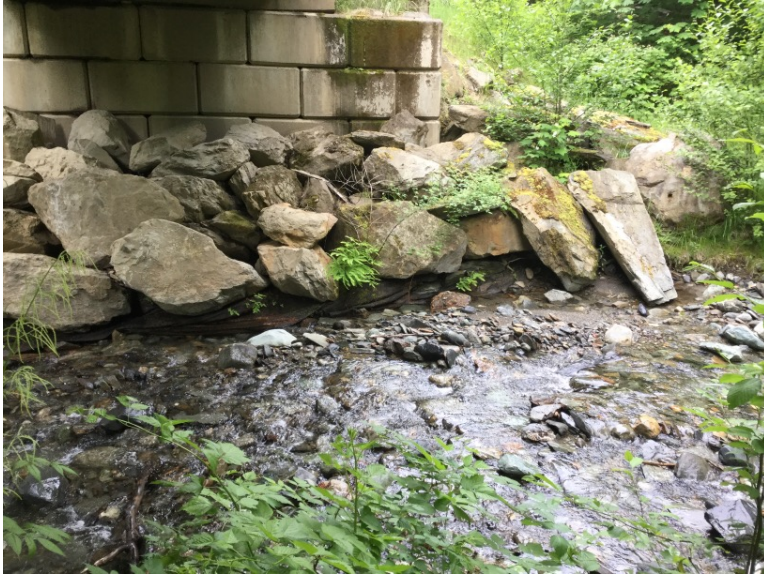
Riprap Fair Scour noted at right bank

Riprap scour at right bank

| Repair Item | Repair Description |
|---|---|
| 5 Medium | Repair scoured riprap at right abnk |

| Item | Monitor Description | Frequency |
|---|---|---|
| 1 | Riprap scour at right bank | |
