CK-2526  
CK-2526

HARRISON EAST 46.2km

2020 Inspection

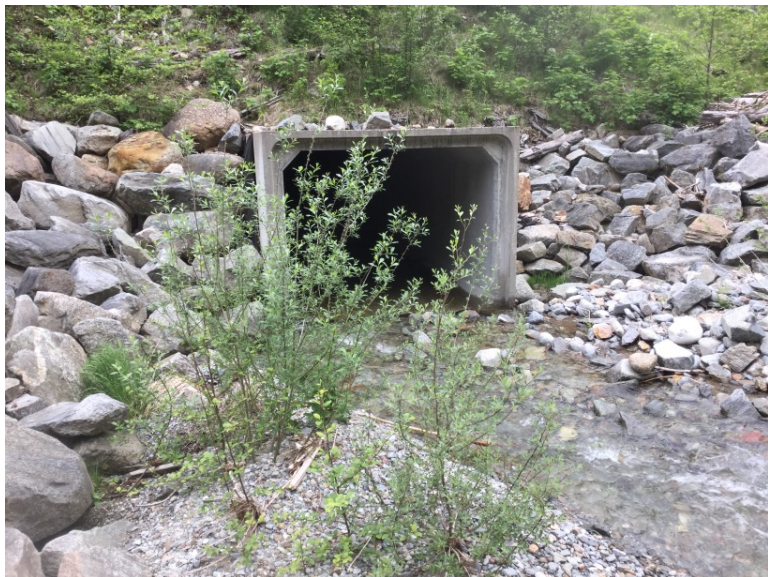
Inlet Good

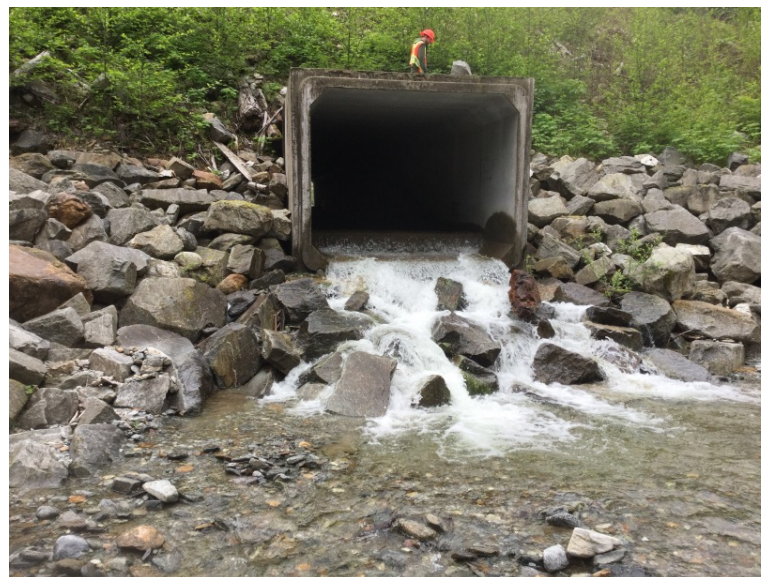
Outlet Good

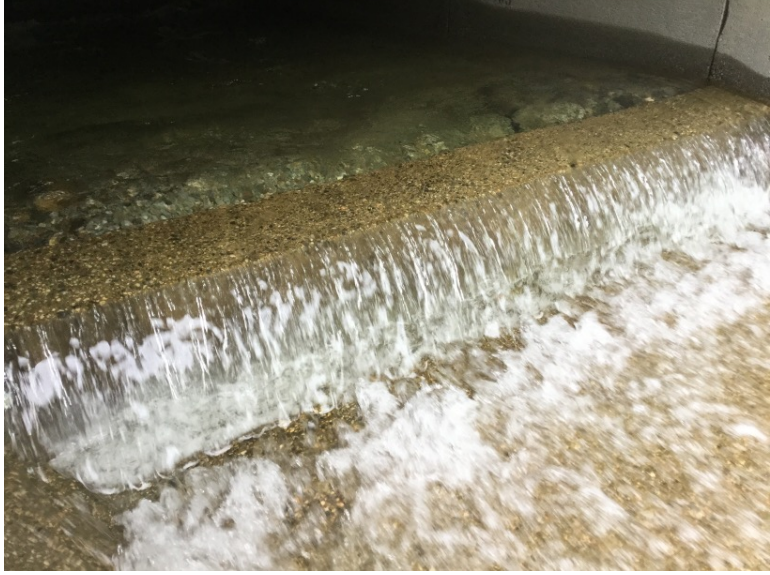
Baffles Good
