CK-2529

STS'AILES (WEST) 0km

2020 Inspection

| Structure Class | Major Culvert |

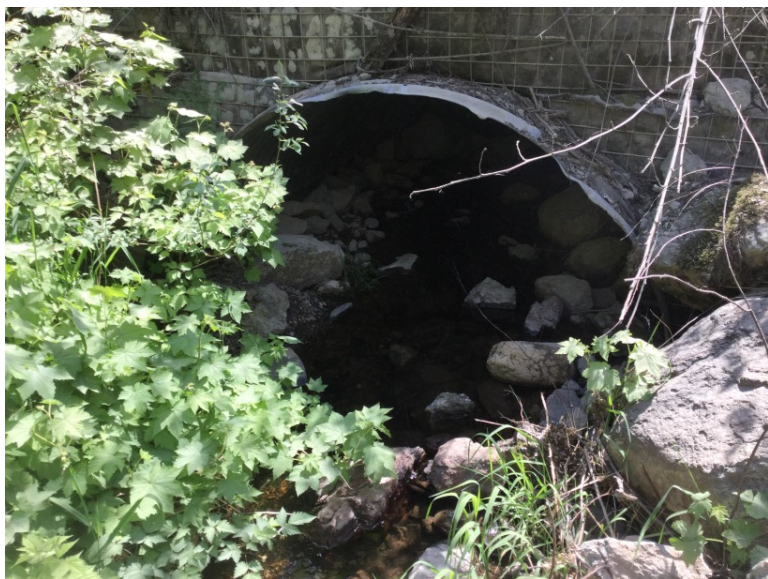
Inlet Good

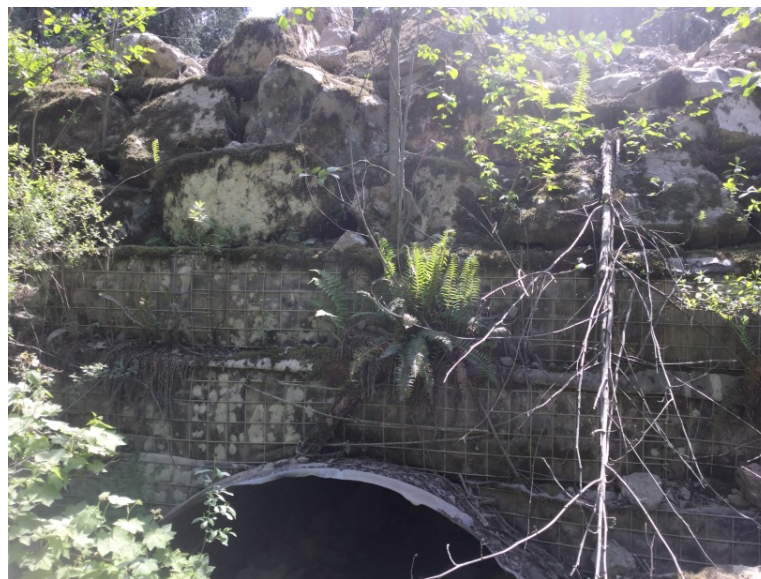
Headwall

Head Walls Good 4 wire mesh forms high (2 forms high above culvert) and stacked rock above that

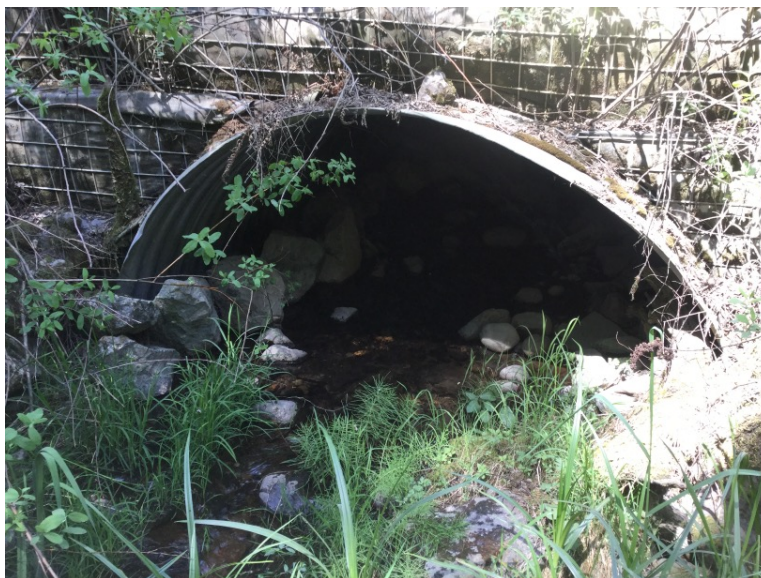
Outlet Good
