CK-2530  
CK-2530

HARRISON EAST 45.3km

2020 Inspection

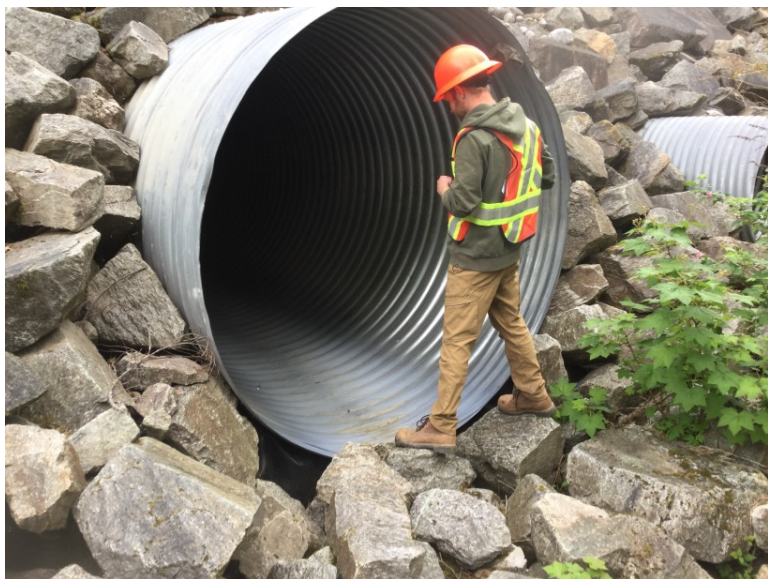
Inlet      Good

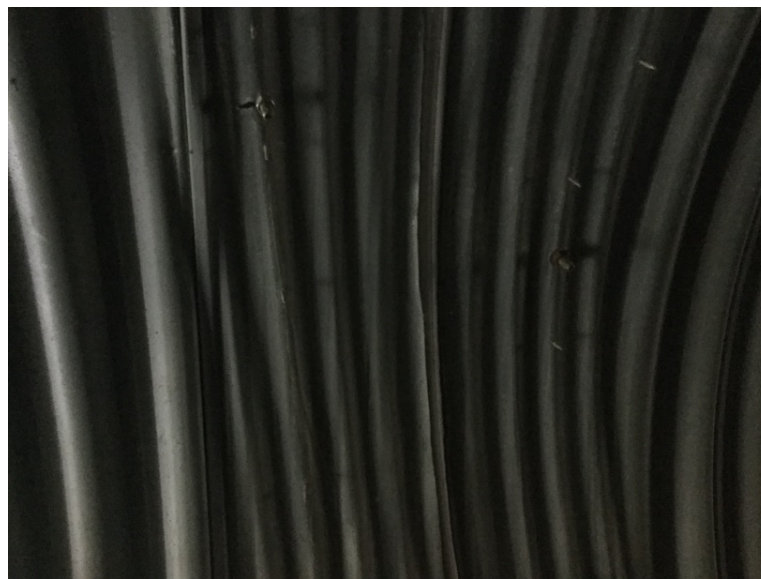
Coupler

Coupled Connections      Good

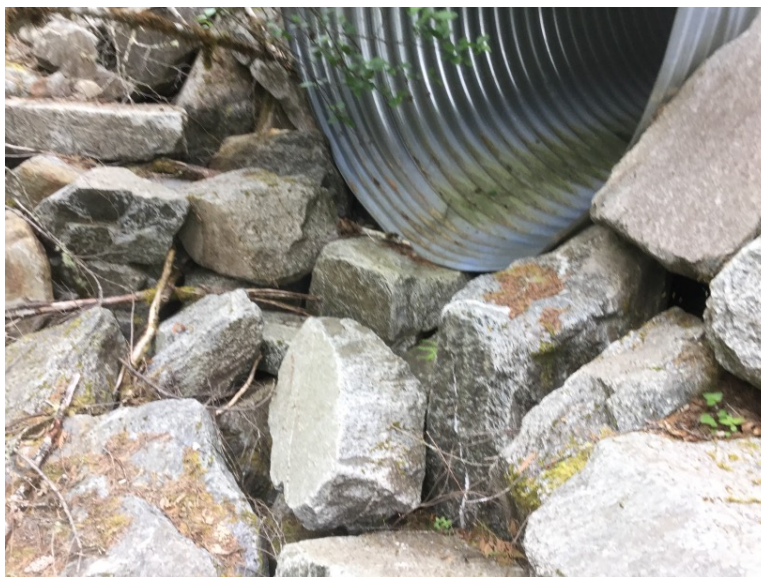
Outlet      Good

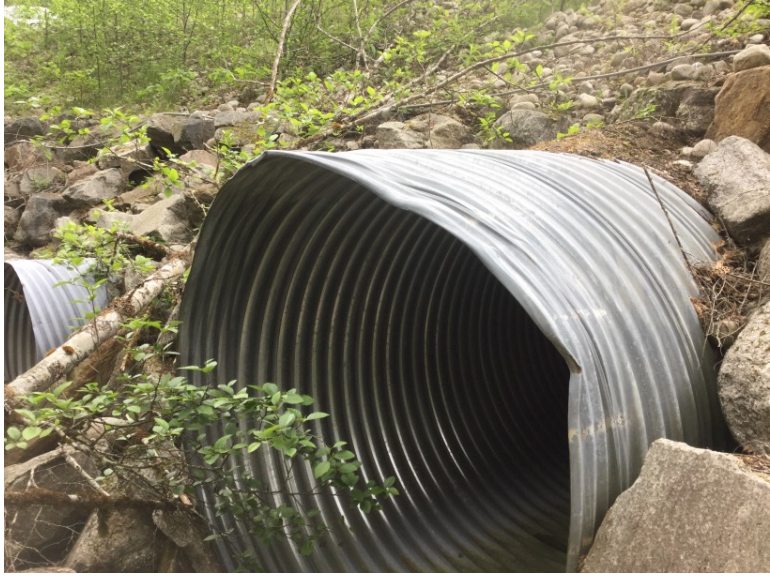
Roof      Good      Minor damage noted at outlet

Slight damage noted to roof
