CK-2533  
CK-2533

DEWDNEY 6000 0.03km

2020 Inspection

| Crossing Name | Dewdney Creek |

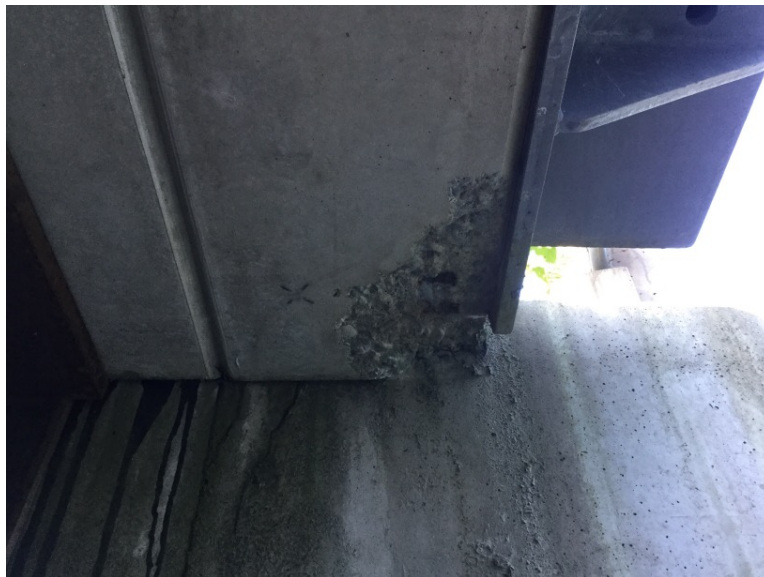
Concrete Deck      Good      2 small damaged sections noted - underside of both end panels

Downstream left bank deck damage

Repair damage to the underside of both end panels (upstream right bank and downstream left bank) consistent with the Concrete Repair Guide for Concrete Bridge Components (MFLNRO 2017). The current load rating of L100 or 91 tonnes to continue.

Repair damage noted to deck panels

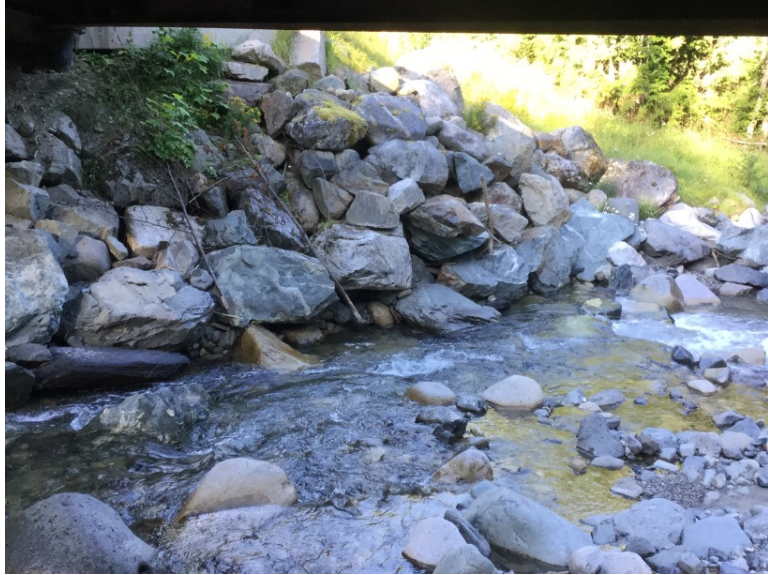
Downstream left bank has scoured - monitor

Downstream left bank

1 Downstream left bank riprap stability

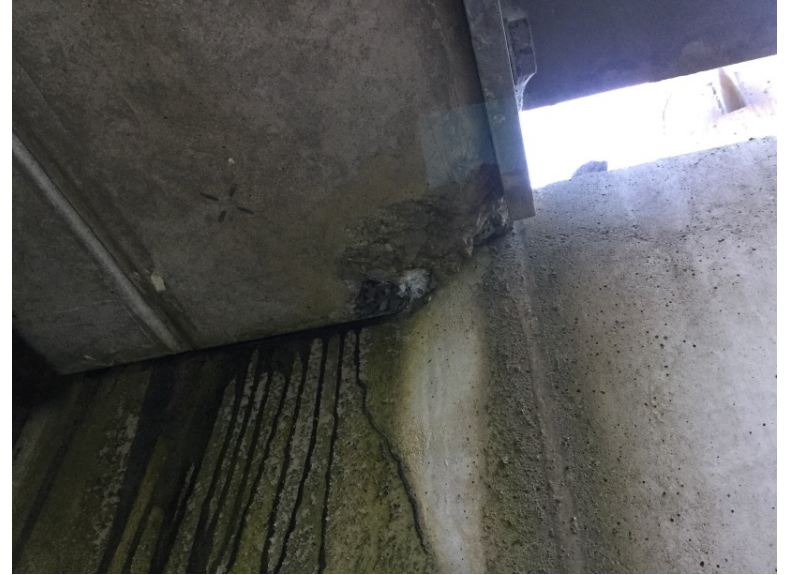
Upstream right bank deck damage
