CK-2534  
CK-2534

CHEHALIS km

2020 Inspection

Structure Class Major Culvert

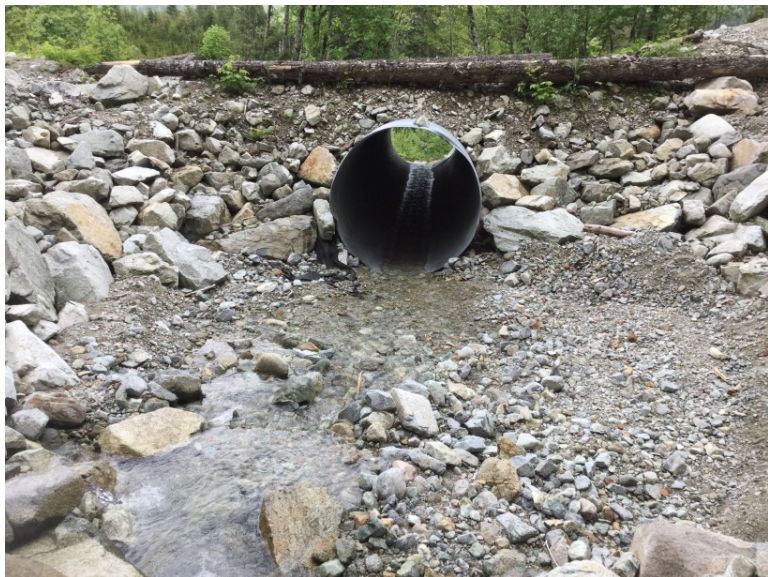
Inlet      Good

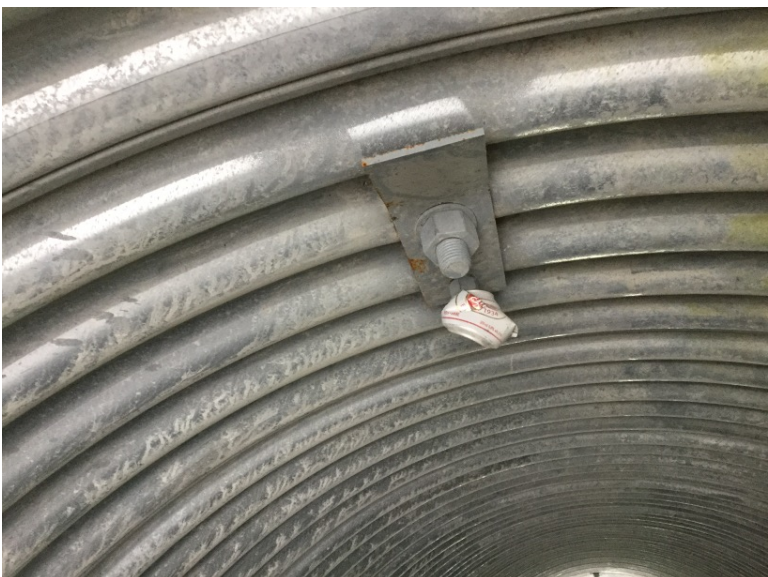
Lifting apparatus left intact

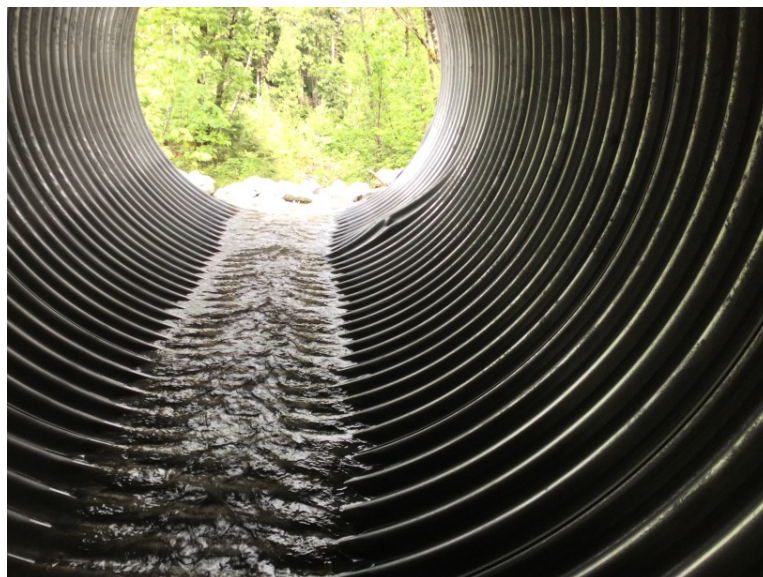
Floor      Good      Minor damage noted

Minor damage noted on floor

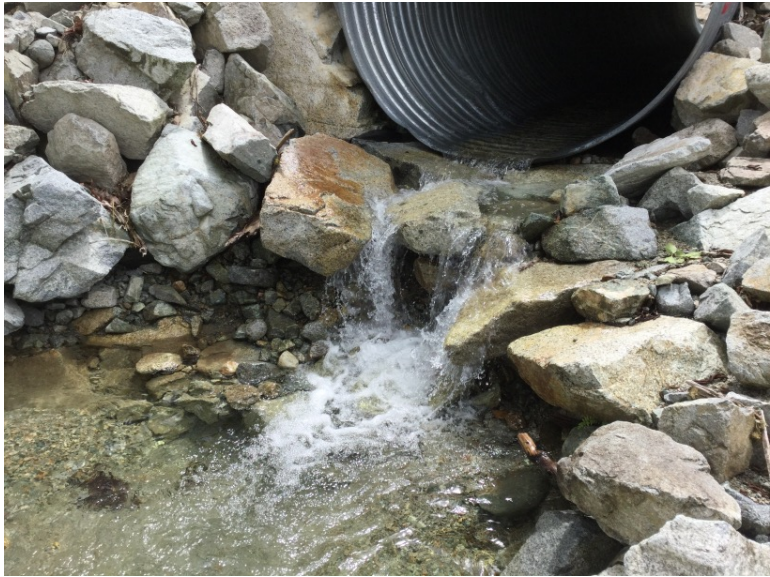
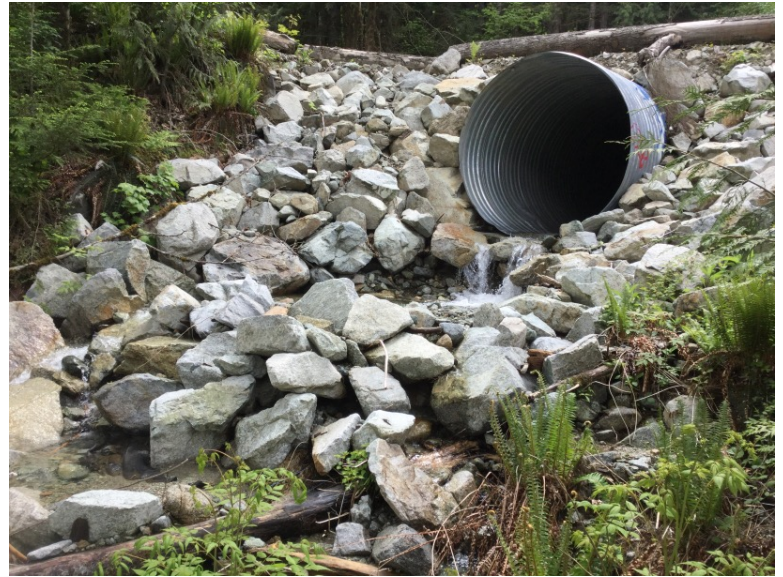
Outlet      Good      Stepped
