CK-2541  
TCH-2101

## CANTELON km

2020 Inspection

Superstructure Steel Box Beam

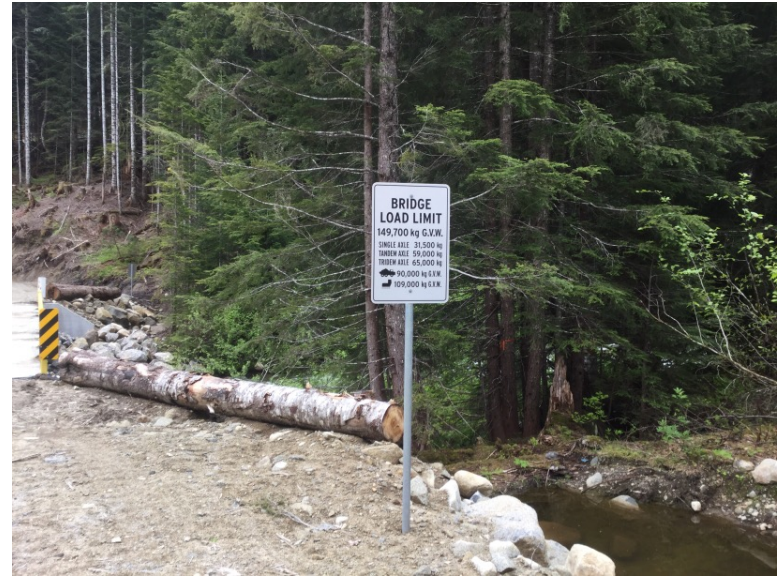
Load Rating Sign

Posted Load Rating See picture

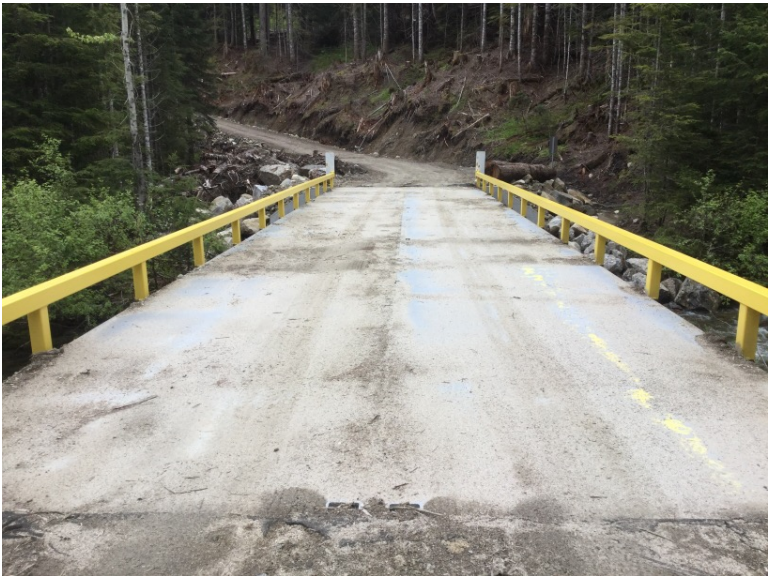
Overall Deck Condition      **Good**

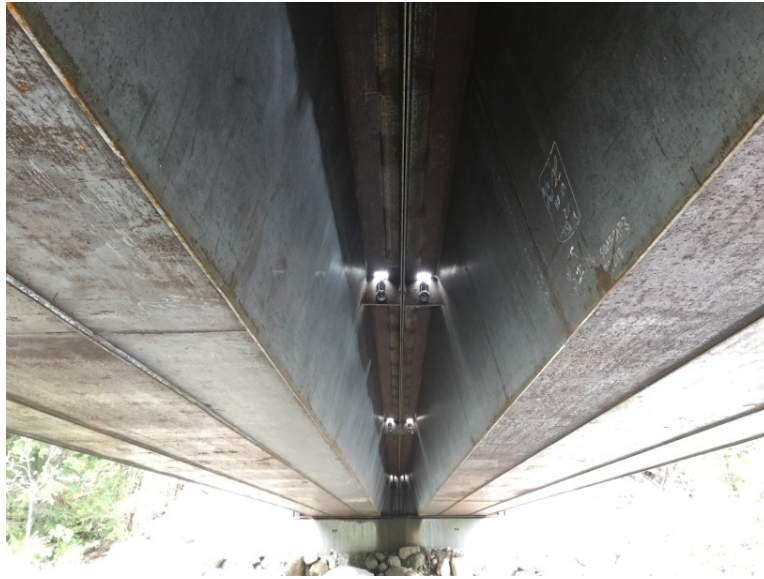
Superstructure

Girders **Good**
