CK-2544  
CK-2544

UZTLIUS km

2020 Inspection

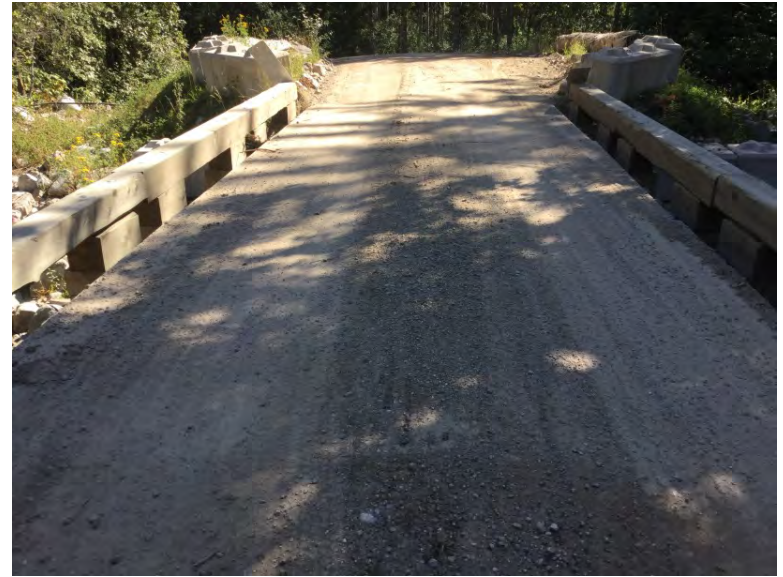
Overall Deck Condition      **Good**

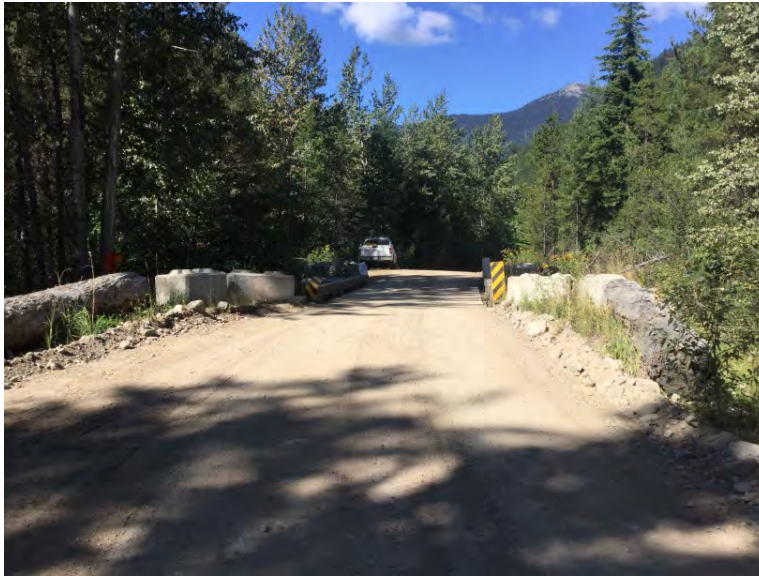
Approach from Left Bank when facing downstream

HC and VC left approach

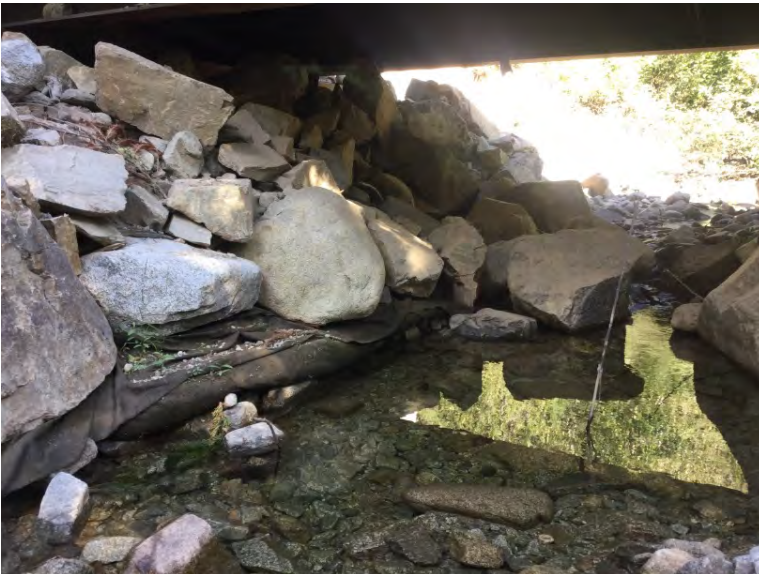
Riprap Poor Scour noted at both banks

Right bank riprap scour and failure

Repair the scoured riprap at both abutments. This will likely require removing the deck panels and steel girders to properly complete the repair. The bearing was still adequate at the time of inspection; however inspect the structure prior to completing the work and prior to activity. The current load rating of L100 or 91 tonnes to continue.

| Repair Item | Repair Description |
|---|---|
| 1 Channel. Add Riprap (placed). m³.<br>Priority:High | Repair scoured riprap at both banks |

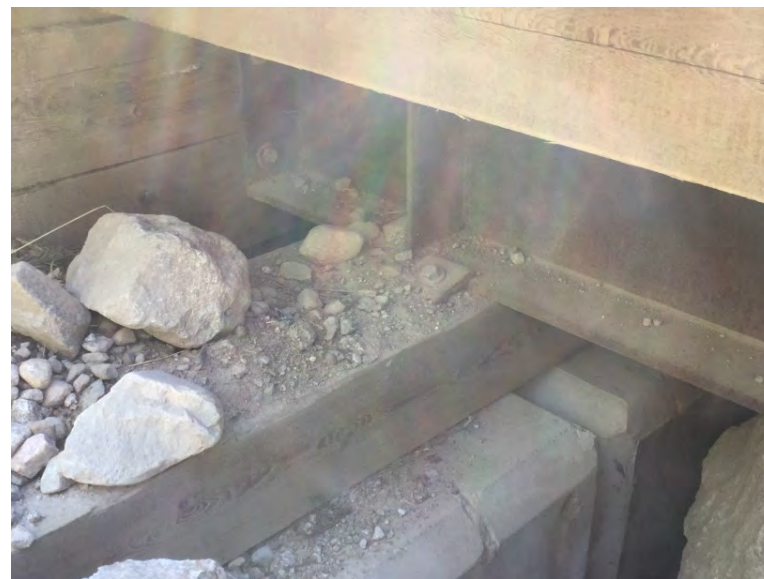
Bearing

Bearings Good
