CK-2547

EIGHT MILE km

2020 Inspection

| Structure Class | Temporary Bridge | | |

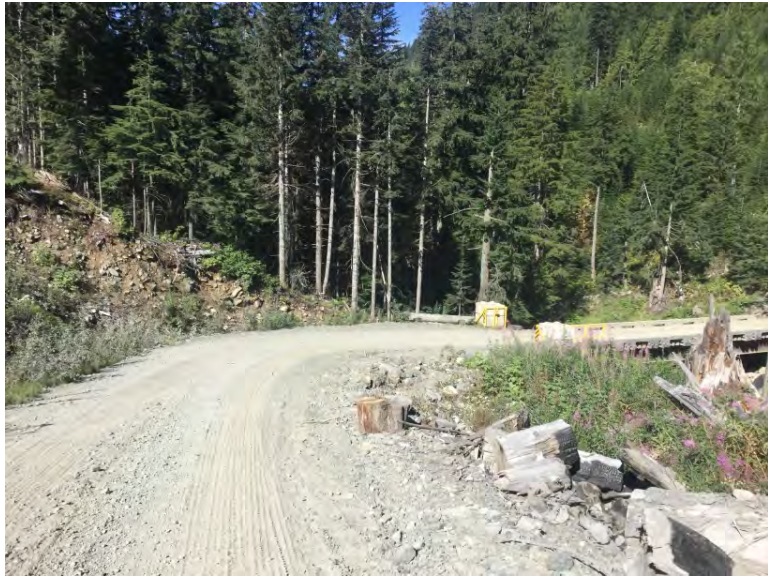
Approach from Left Bank when facing downstream

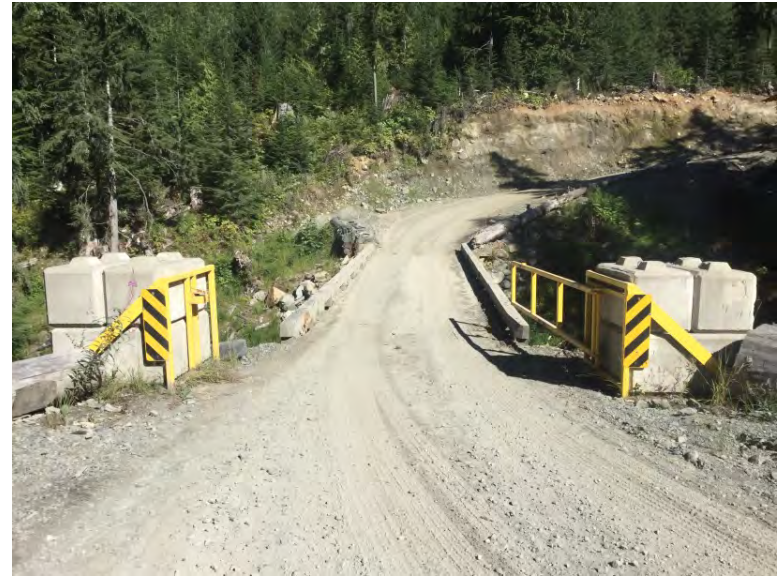
Approach from Left Bank when facing downstream

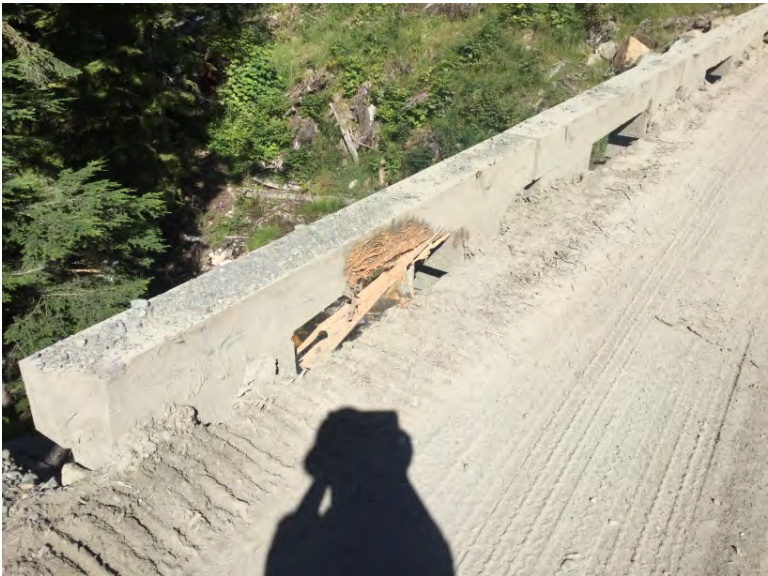
Indication of a strike at downstream left bank - still in fair condition

Guard Rail

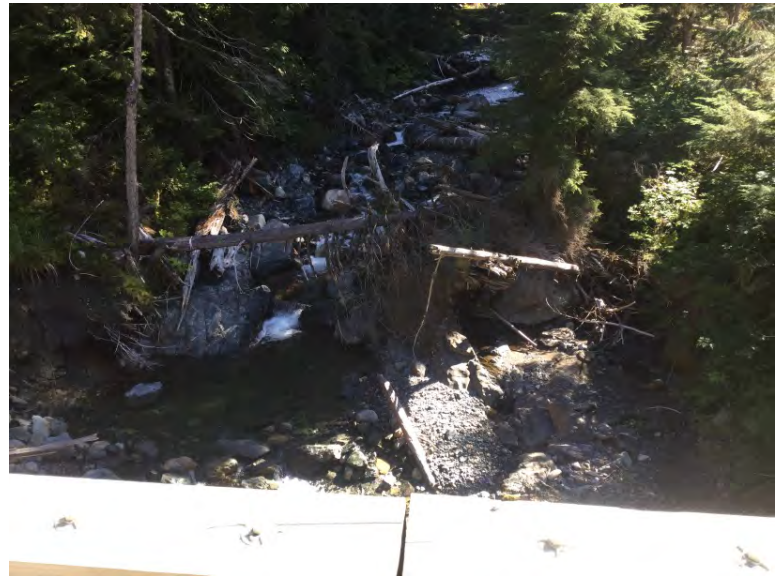
Upstream from Crossing

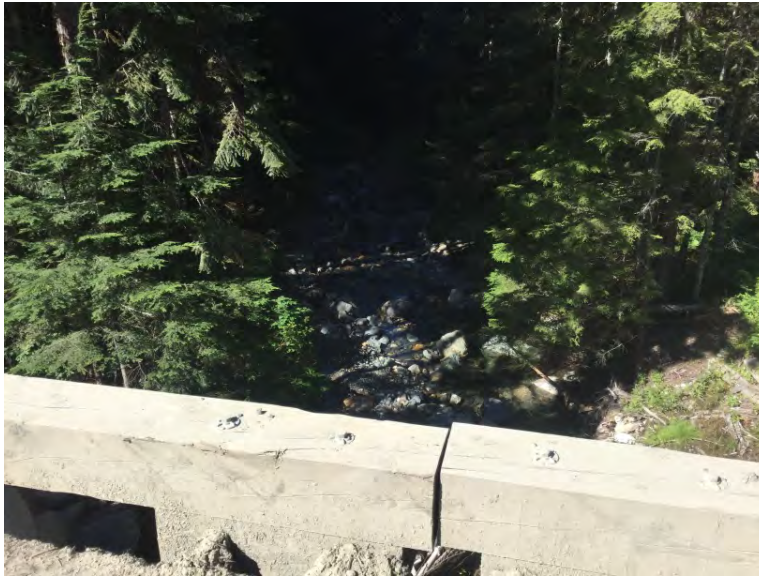
Downstream from Crossing

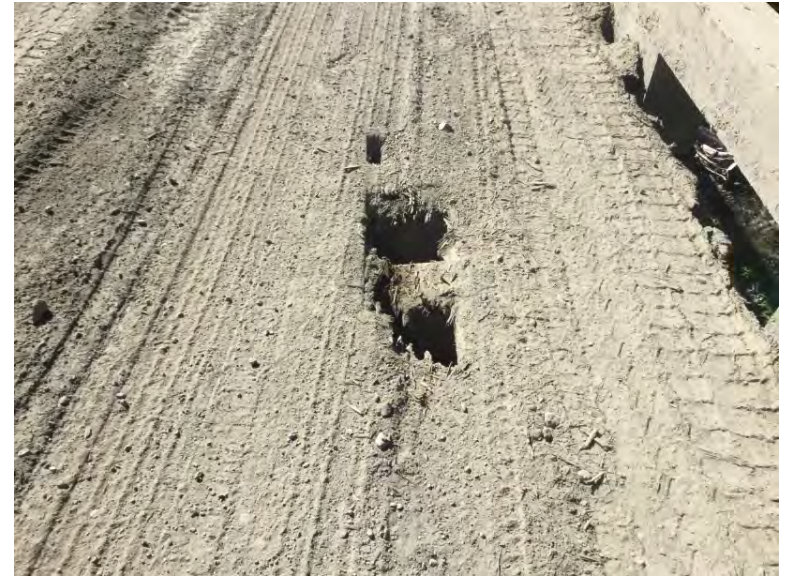
Right bank panel requires a single 4"x10"x10' plank

Plank wear

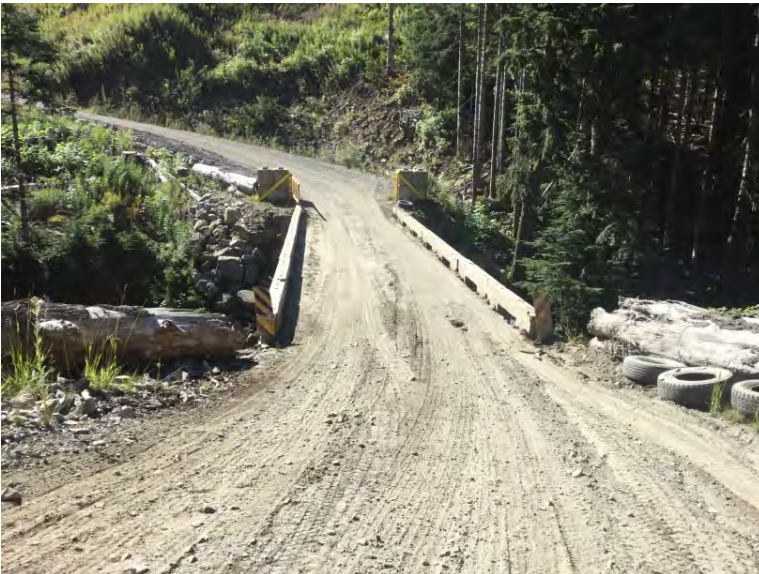
Approach from Right Bank when facing downstream

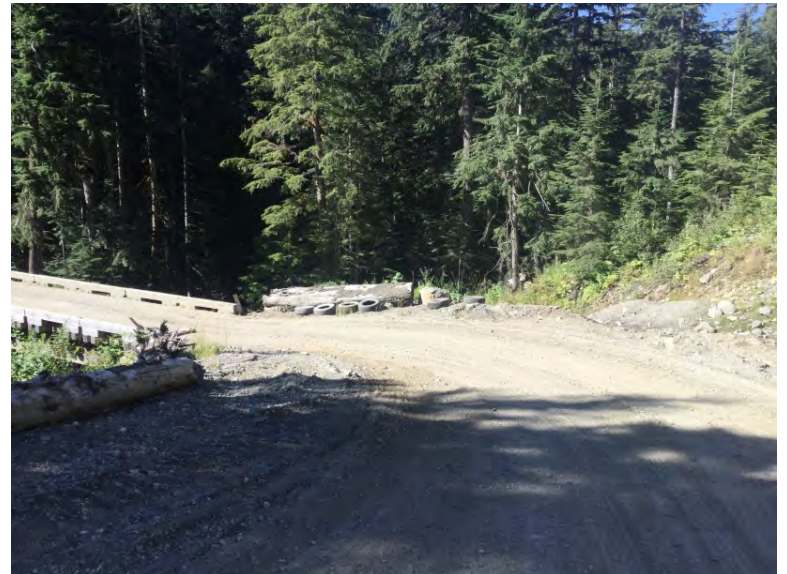
Approach from Right Bank when facing downstream

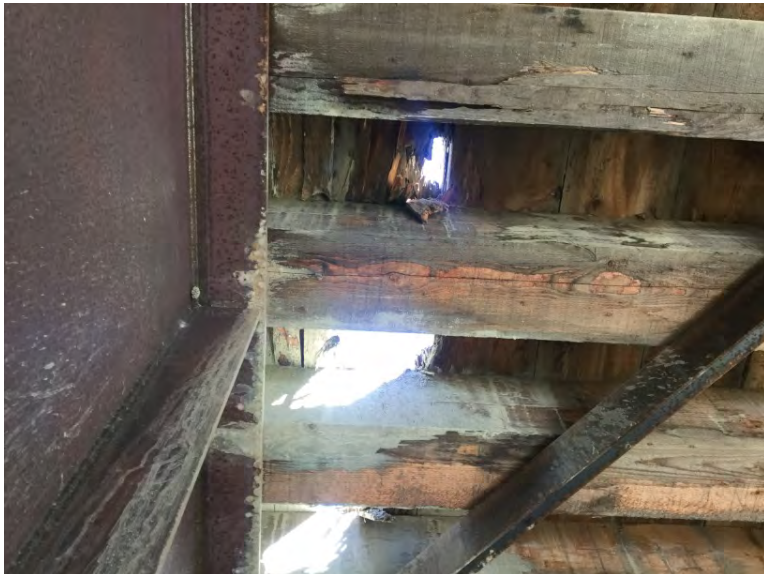
There is a hole in the deck located in the first panel, downstream right bank that requires a single 3300mm long x 100mm thick x 250mm wide (10' long x 4" thick x 10" wide) replacement deck plank (Douglas fir). I recommend replacing this ASAP or premature wear to the cross ties will commence. Also, the fill slope at the downstream left bank is eroding and a tension crack was noted on the very outside edge of the road. While this is not a safety issue at present the fill slope will continue to erode and may extend into the running surface over time. I recommend replacing this material ASAP. The current load rating of BCL-625 (63 tonnes) can continue as long as the above noted repairs are completed. Monitor the fill slope and deck plank condition until the works are completed.

Hole in deck

| Repair Item | Repair Description |
|---|---|
| 1 Structure. Minor redecking (wearing surface). 100mm x 250mm x 3300m. Priority:High | Replace 3.3m length of deck plank (100mm x 250mm) at right bank, first panel |

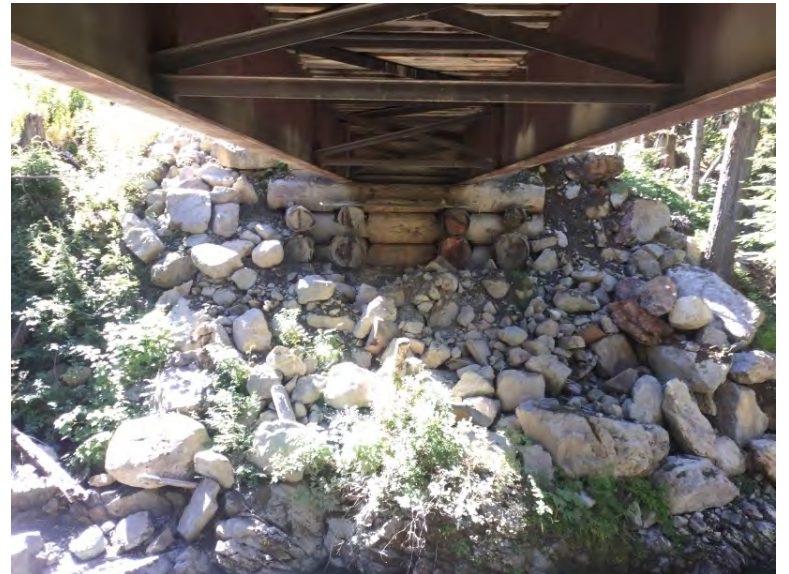
Left Bank Abutment when facing downstream

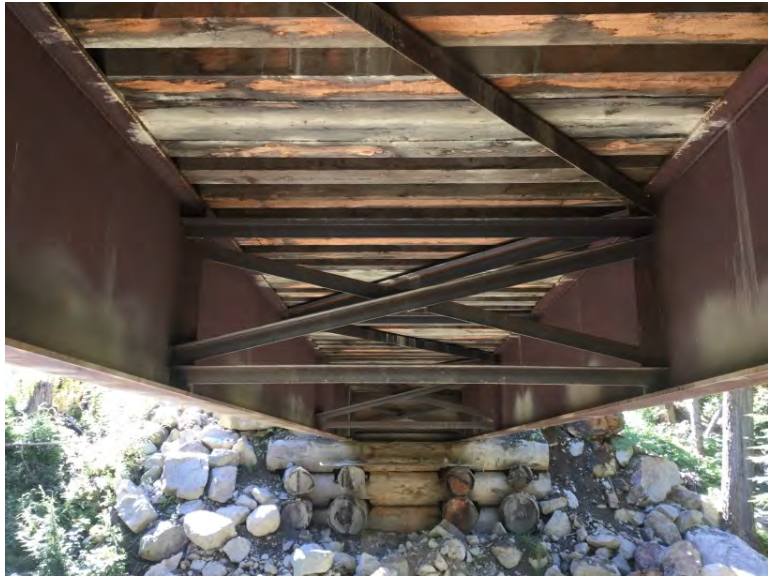
Superstructure

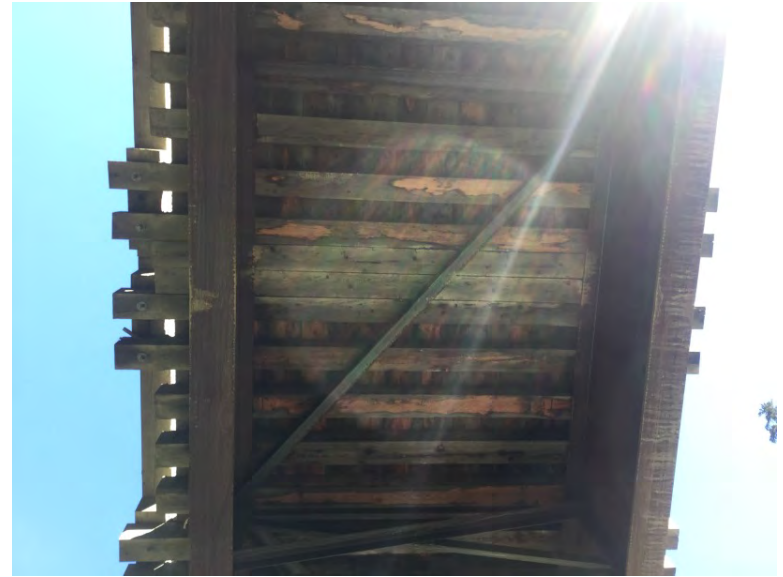
Deck from underneath

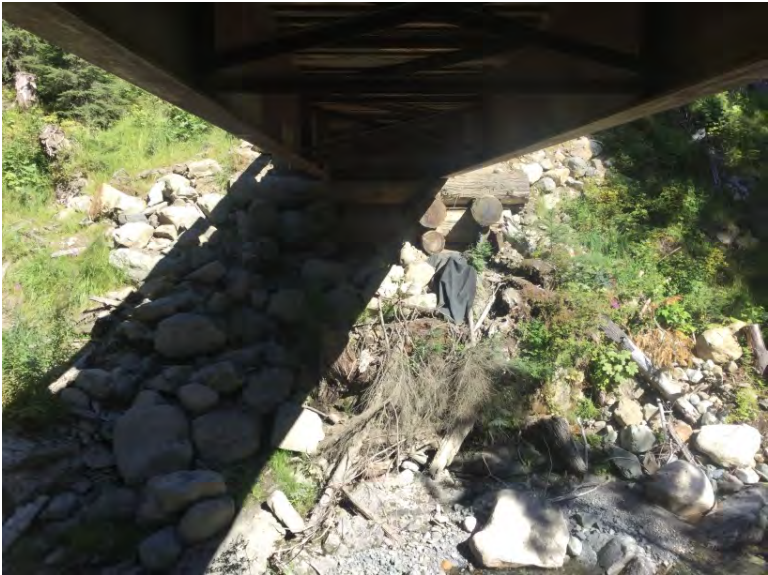
Right Bank Abutment when facing downstream

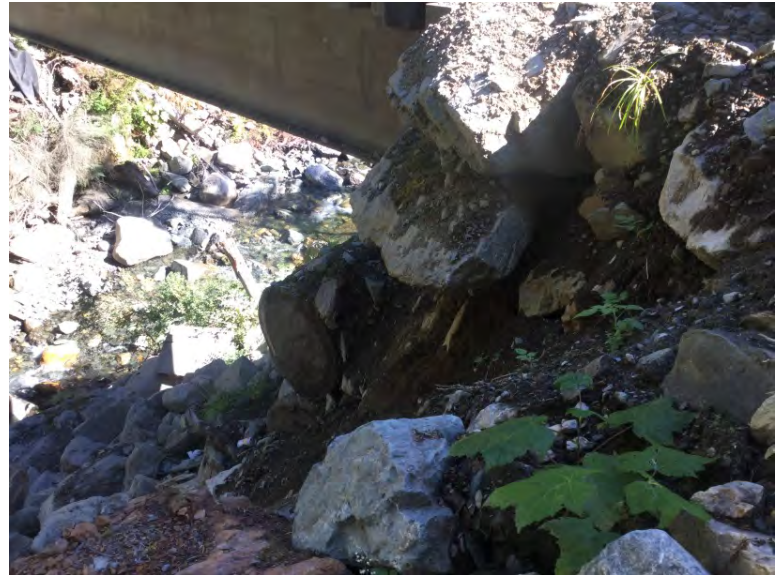
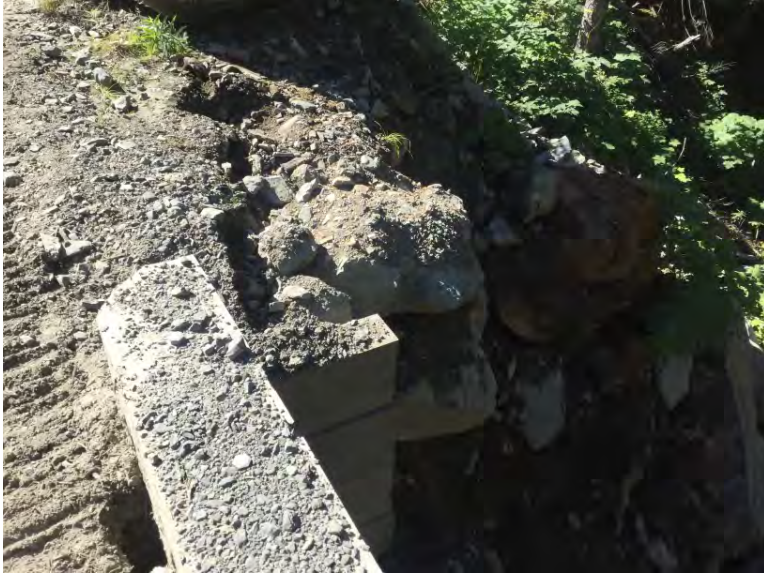
Poor downstream left bank as it's over steepened and eroding

Downstream left bank fill erosion

| Repair Item | Repair Description |
|---|---|
| 2 | Repair failing fill slope at downstream left bank |

| Item | Monitor Description | Frequency |
|---|---|---|
| 1 | Fill condition at downstream left bank | Annual |
