CK-2559

Mount Thurston 0.4km

2020 Inspection

| Structure Class | Temporary Bridge |

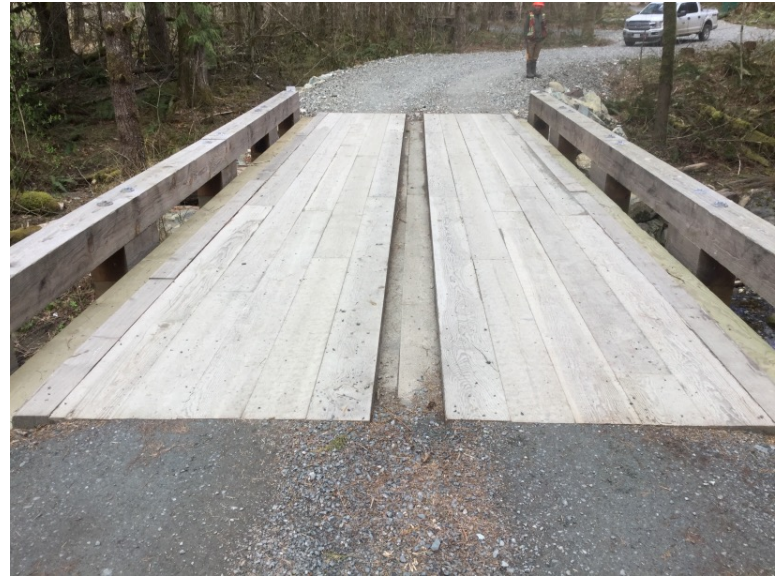
Overall Deck Condition      Good

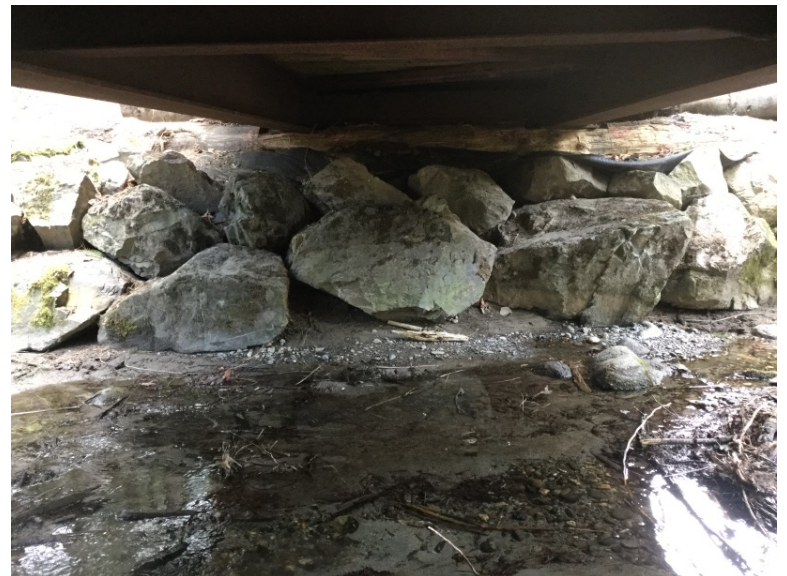
Left Bank Abutment when facing downstream

Single log sills

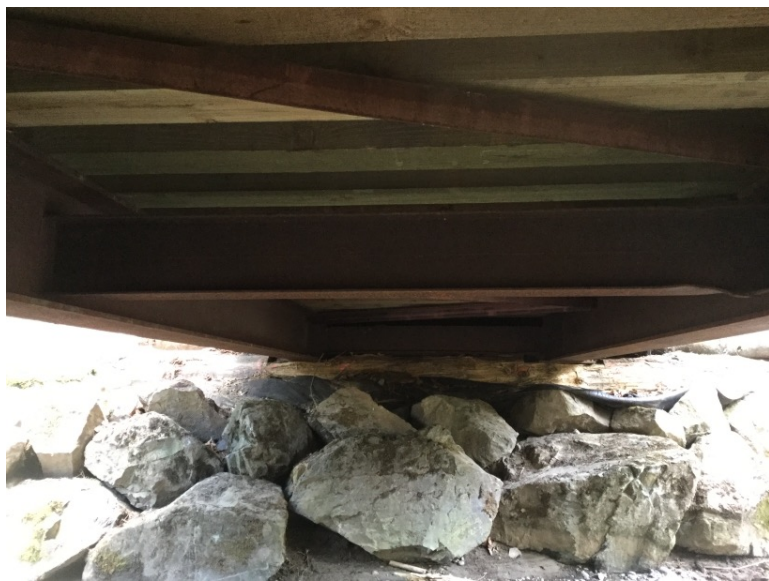
Superstructure

Recycled girders with light corrosion

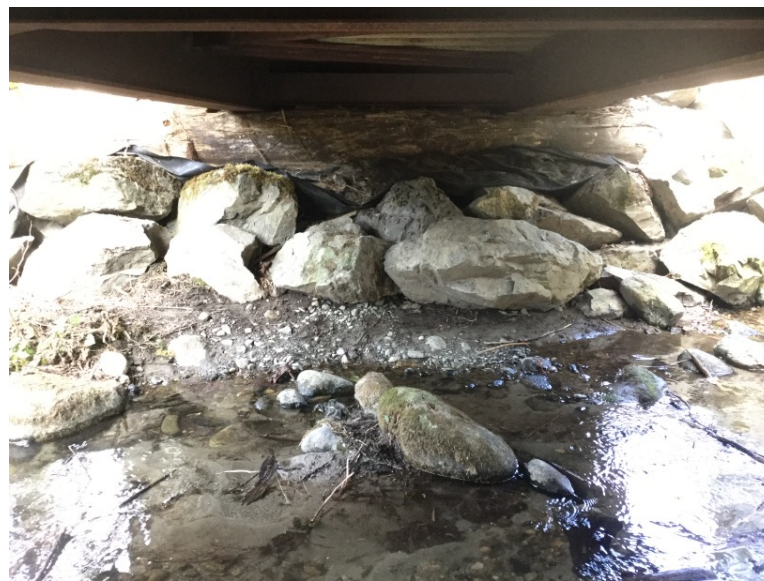
Right Bank Abutment when facing downstream

Timbers right bank and logs left
