CK-2565  
CK-2565

AMERICAN 1.8km

2020 Inspection

Terraspan Steel Box Culvert

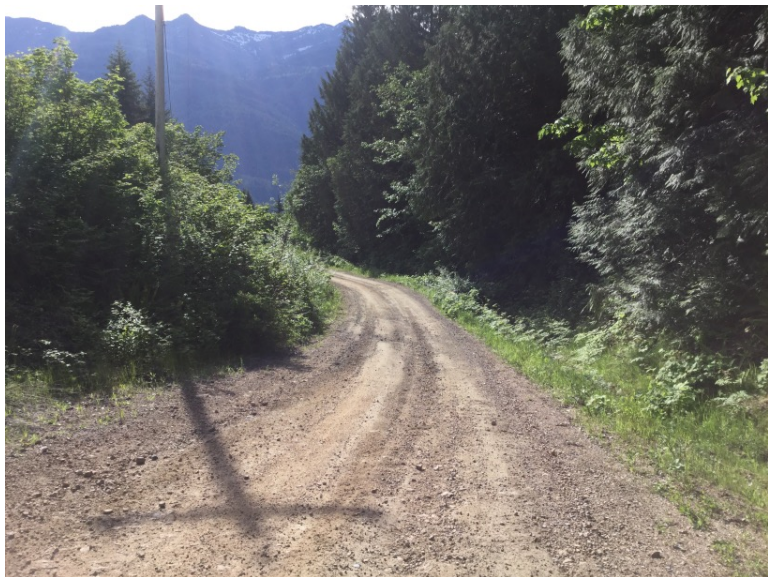
Approach from Left Bank when facing downstream

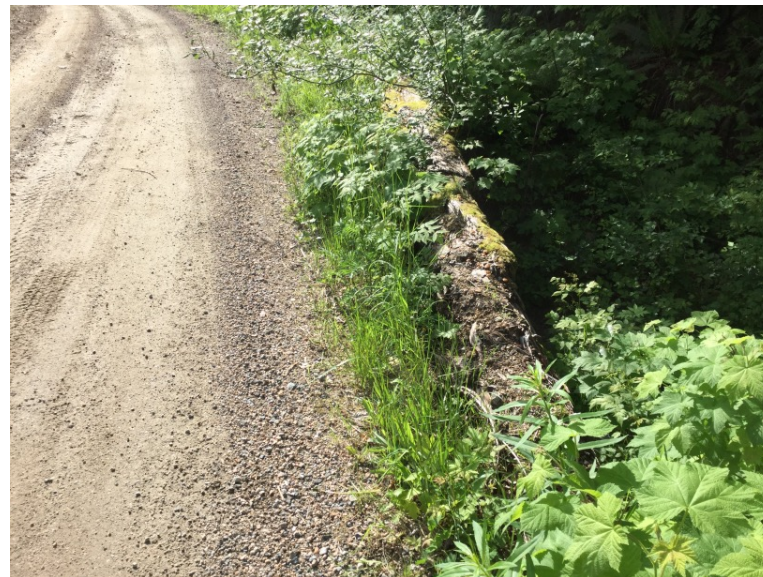
Upstream log curb outside wire mesh forms

| Repair Item | Repair Description |
|---|---|
| 1 Approach. Approach fenders (install). # of units. Priority:Medium | Add 6m x 600mm diameter log curbs at both upstream and downstream location, inside wire mesh baskets |

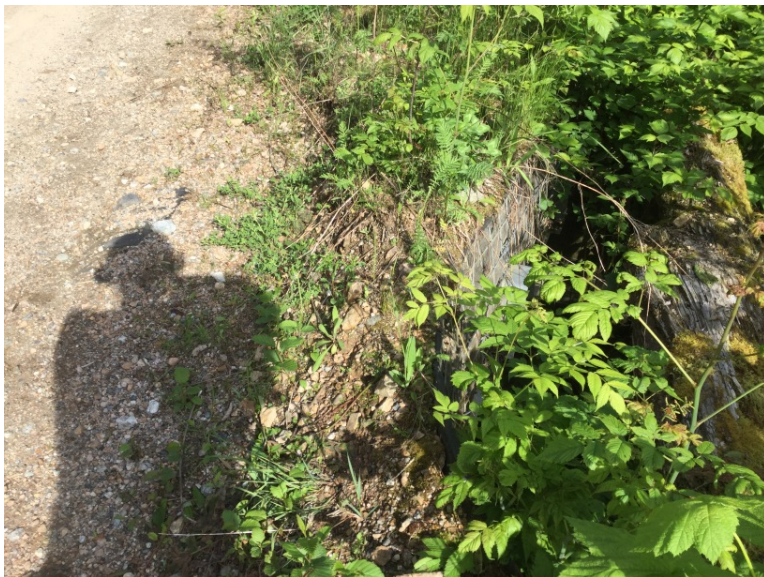
Downstream fill retention facing exposed to grader activity

The Terraspan Box Culvert Design and Installation Details indicate the L100 design vehicle; however there was a change in the substructure at the time of construction and no indication if that loading was attained. Limit loading to BCL-625 or 63 tonnes. Add log curbs to help protect the welded wire forms from being damaged by grader activity. Add scour protection to the downstream woods abutment. Brush both approaches.

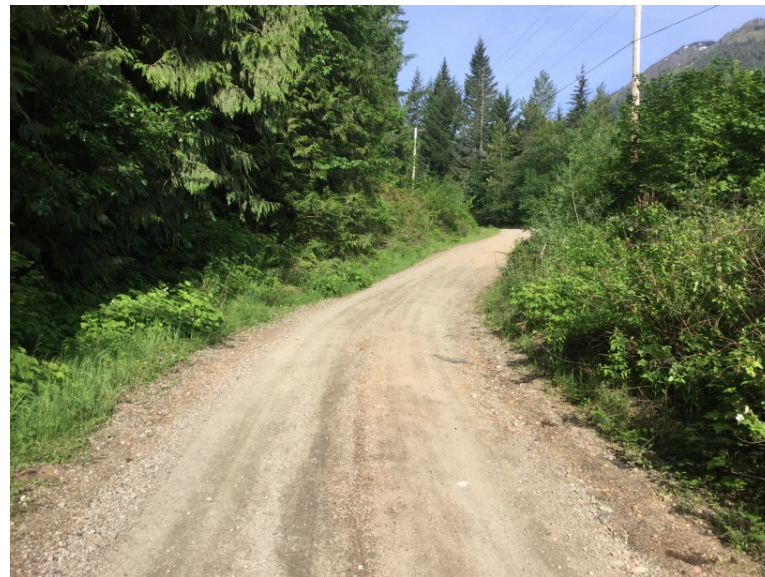
Approach from Right Bank when facing downstream

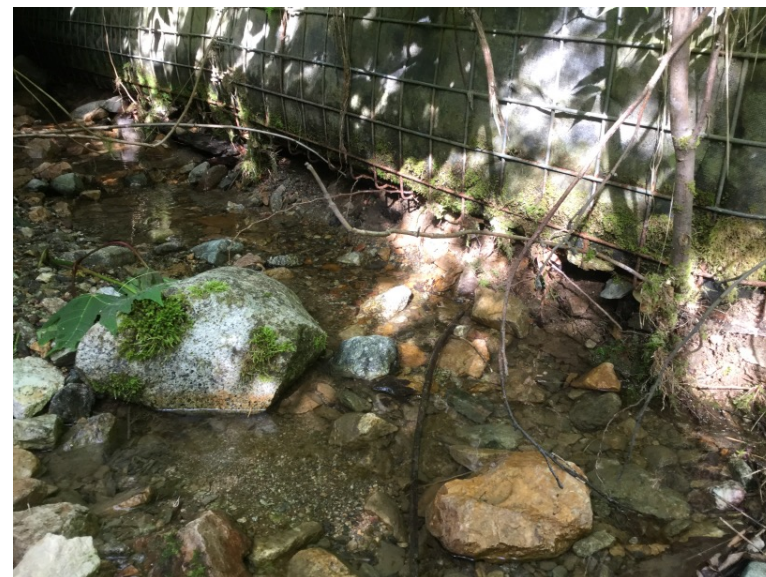
Bearings Fair Downstream left bank minor scour noted but no settlement apparent

Foundation scour under downstream left bank abutment

| Item | Monitor Description | Frequency |
|---|---|---|
| 1 | Foundation scour at downstream left bank | Routine Inspection |
