CK-2158  
CK-2158

HUNTER 4.9km

2021 Inspection

Crossing Name East Fork Hunter Creek

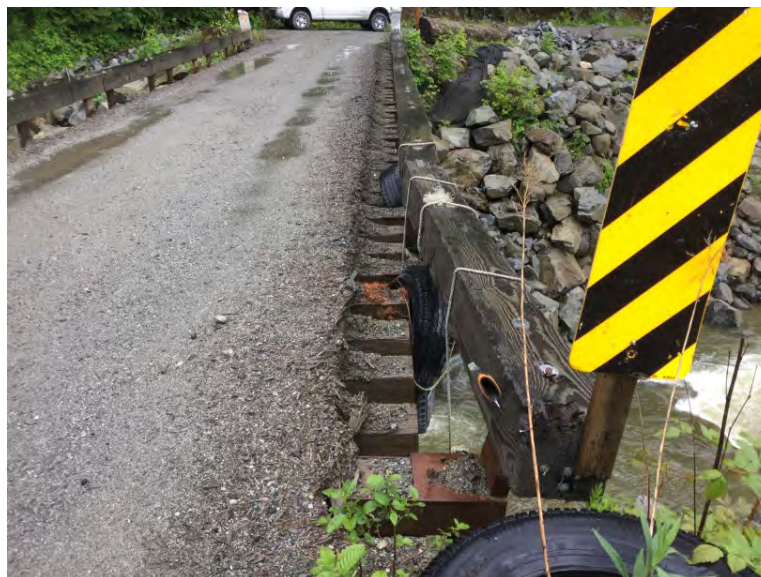
Downstream right bank guardrail has been struck

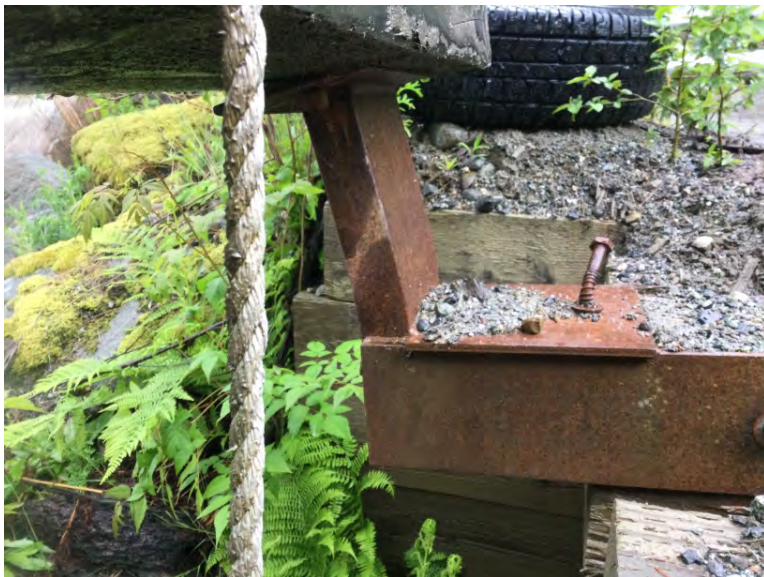
Damage noted to downstream right bank riser and corresponding cross tie

Downstream right bank riser 1 damage

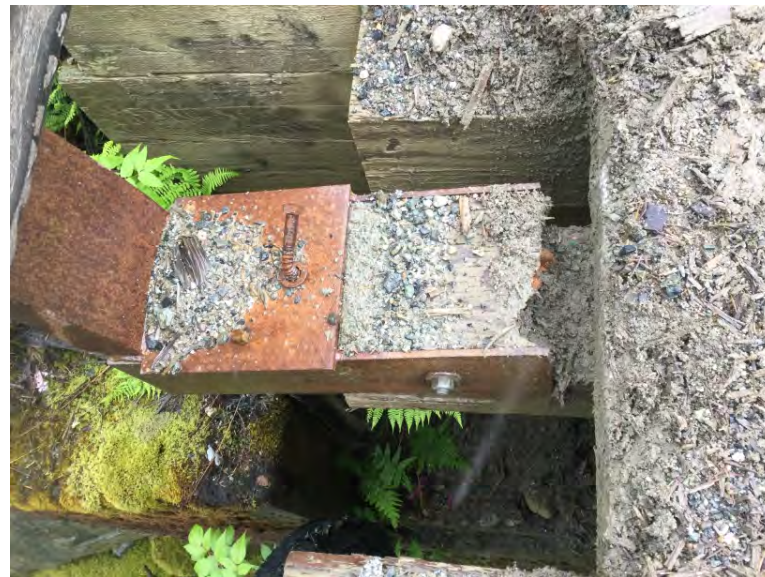
Treated, single cross tie has damage at downstream right bank at first riser connection. A 300mm long x 30mm thick x full width piece has sheared off the cross tie. The riser connection at this location is no longer functional and this cross tie should be replaced.

Cross tie damage at downstream right bank

| Repair Item | Repair Description |
|---|---|
| 2 Priority:Medium | Replace single tie at right bank abutment |

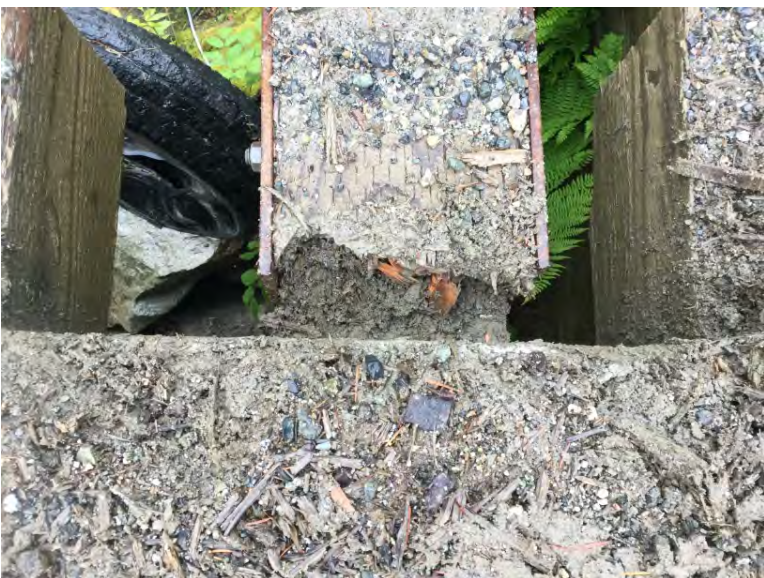
Downstream right bank cross tie damage

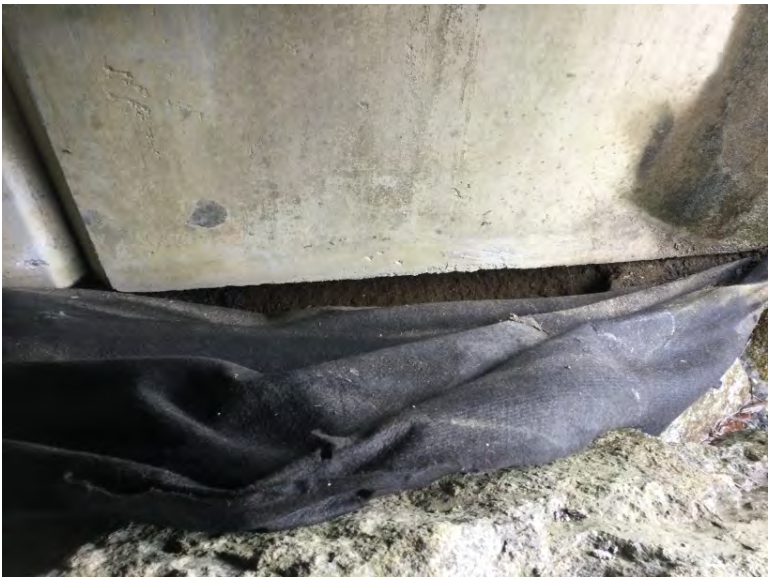
Foundational material under the lock block directly under the downstream left bank girder has eroded. The lock blocks are sloping/settling towards the downstream end. Until full bearing can be reinstated limit loading to 30 tonnes. In the meantime I recommend monitoring the site. Post load rating signs.

Fill under downstream girder lock block has eroded

| Repair Item | Repair Description |
|---|---|
| 1 Substructure. Lock blocks<br>- Priority:High<br>Structure. Cross tie<br>maintenance | Reinstall foundational material under left bank lock blocks |

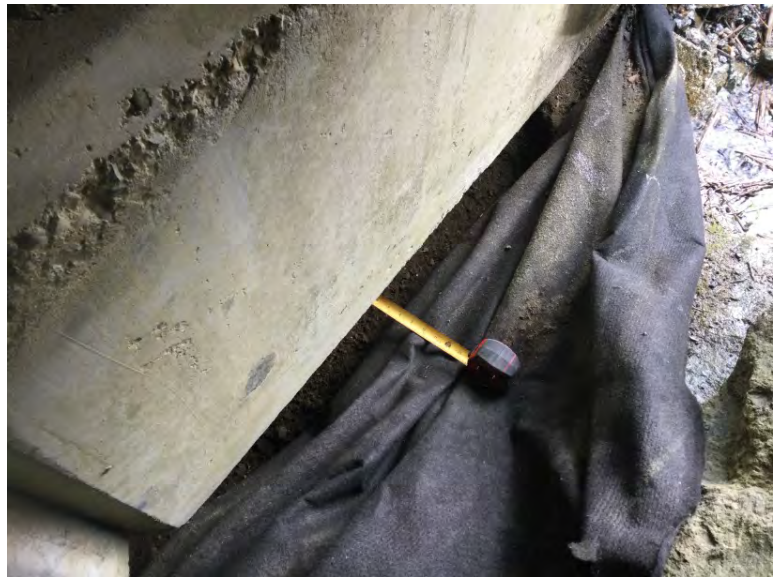
Fill under downstream girder lock block eroded up to 170mm depth behind face  
x 1100mm width

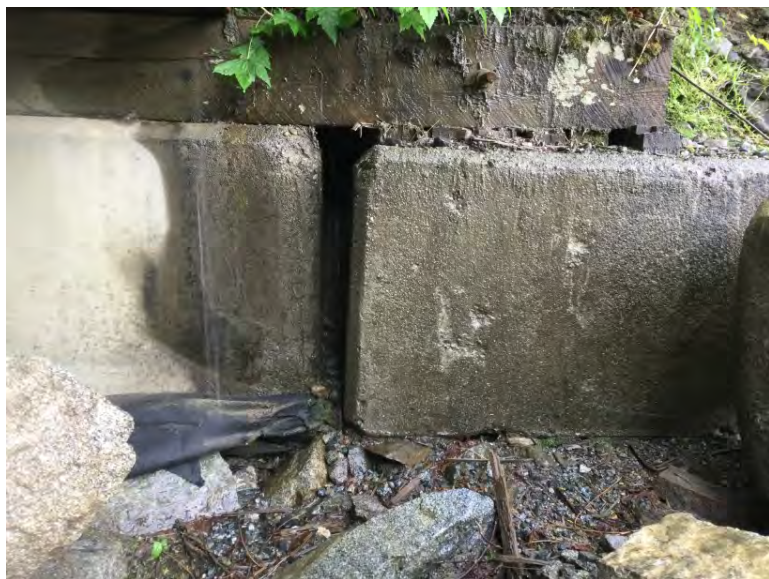
Good right bank; downstream left bank lock blocks settling due to eroding/settling foundation material, timber cap has been shimmed between it and the downstream lock block

Downstream lock block left abutment

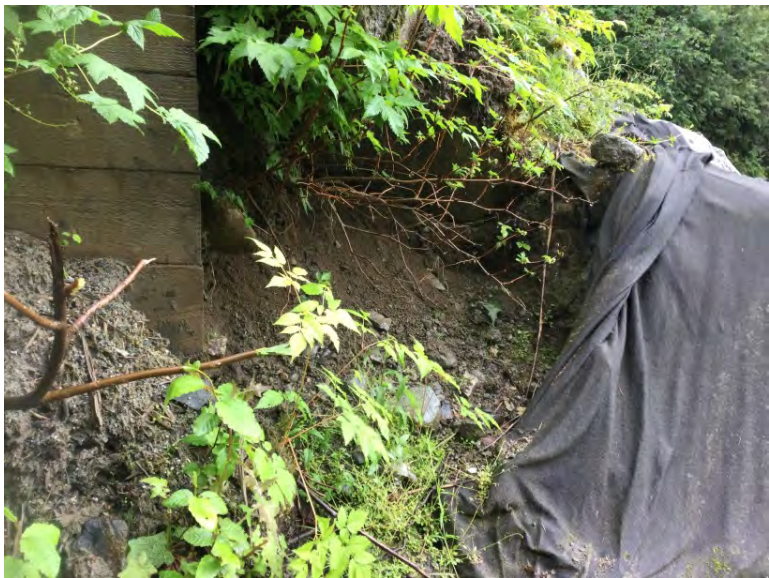
Downstream left bank fill erosion

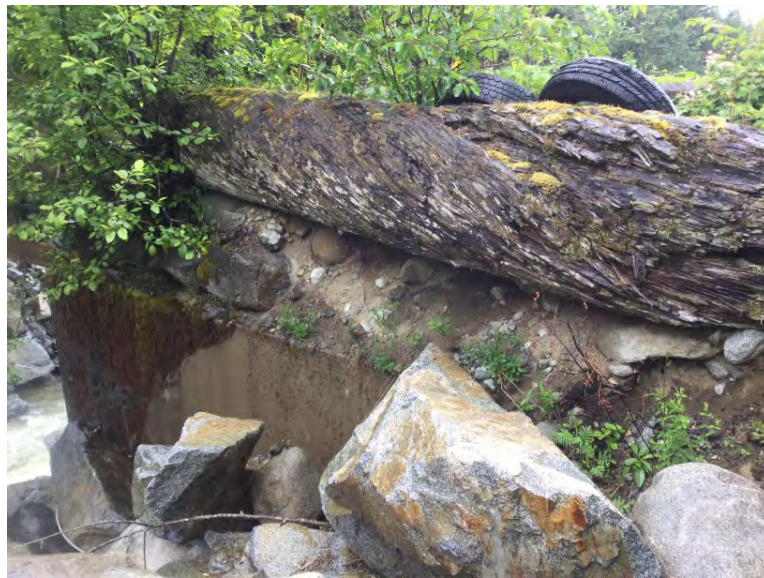
Old logs - large diameter but rotting at right approach

Upstream right bank fender log is largely unsupported behind

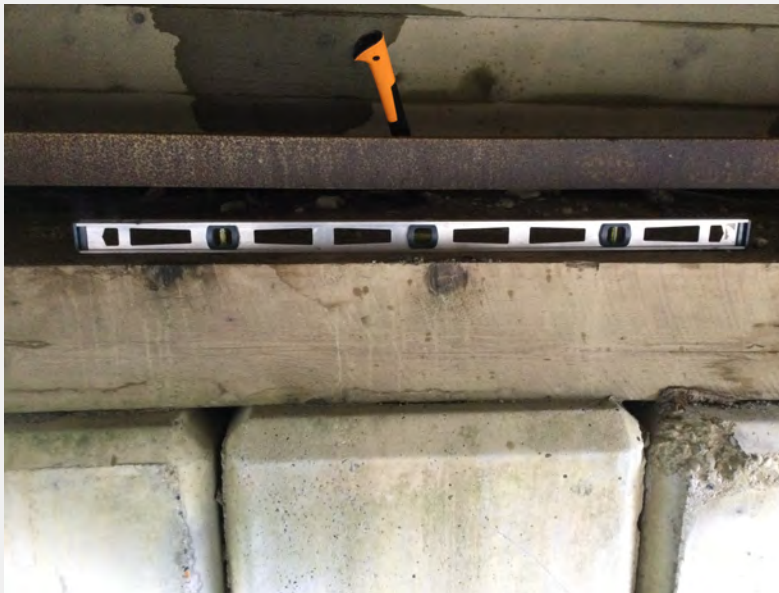
Treated timber right bank - good; timber sill at left bank fair

Top of timber sill sloping approximately 20mm downstream over 1200mm length at center of abutment

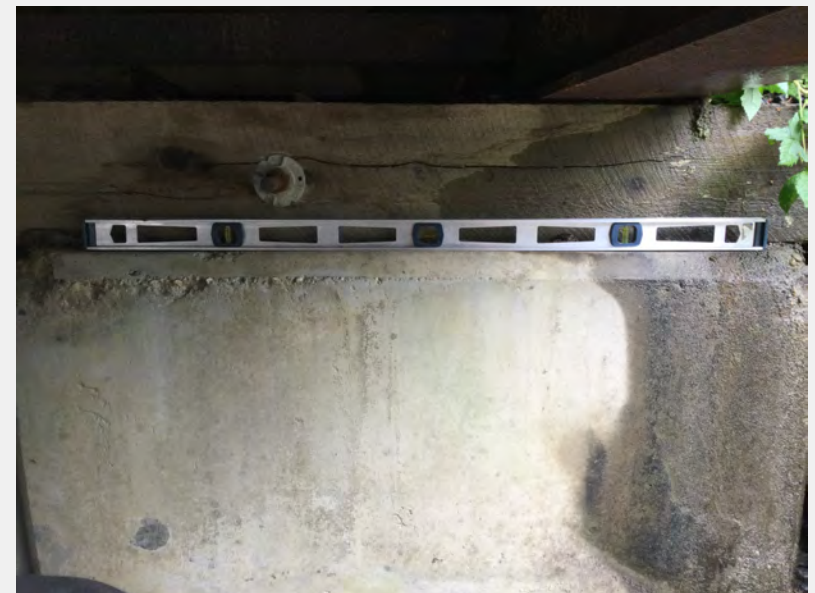
CIP right bank - good; lock blocks left bank are in good shape but are settling - poor

Lock block under downstream girder sloping approximately 40mm downstream over 1200mm length
