CK-2547  
CK-2547

EIGHT MILE 6.0km

2021 Inspection

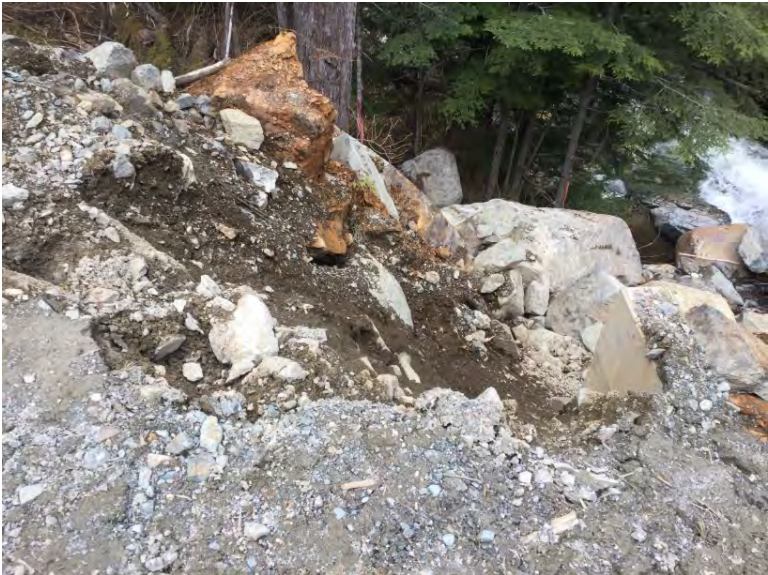
The fill-slope at the downstream left bank has now failed and the resulting slope is over-steepened and eroding. Repair/replace the fill-slope in this location by keying large diameter rock into the existing riprap and building back up with 250 kgs Class riprap, no steeper than 1H:1V slope. The fill-slope should be trimmed to a uniform surface prior to placement. Ensure the rock is well keyed into the existing riprap and manipulated as necessary to provide a mass stability and a regular surface with a minimum of voids to ensure a stabilized running width sufficient for the expected traffic. Until both these repairs (timber deck repair/replacement and downstream left bank fill-slope repair) are completed limit loading to L30 or 27 tonnes. Post load limit sign.

Fill Poor Approach fill at downstream left bank has failed, the resulting slope is over-steepened and eroding

Fill slope has failed down stream left approach

| Repair Item | Repair Description |
|---|---|
| 2 HIGH | Repair failed fill-slope at downstream left bank |

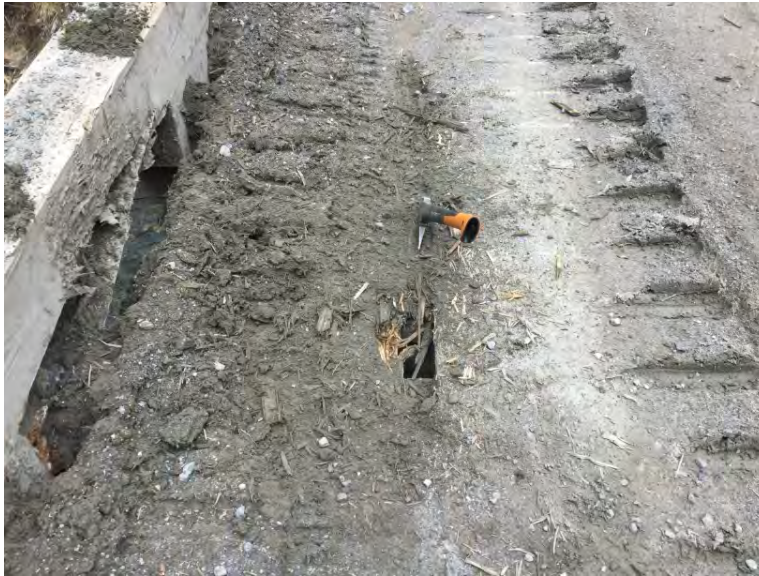
2 locations where holes have developed. Entire downstream wheel path has excessive wear

Hole in deck in Panel 1 at downstream left approach

| Repair Item | Repair Description |
|---|---|
| 1 HIGH | Replace timber deck panels |

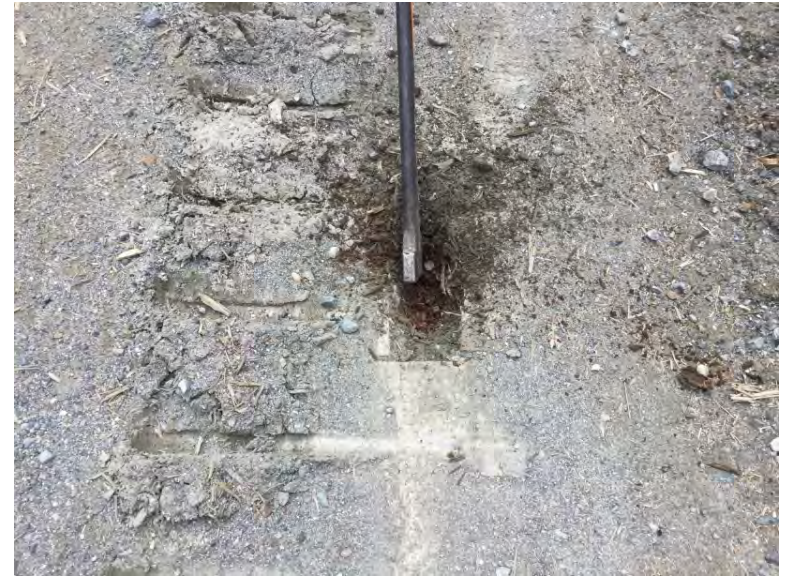
The timber planks are showing excessive wear and decay, especially on the downstream wheel path location. There's a single cross tie noted with excessive decay (see picture), while others were end splitting and some heavily saturated. The structure ID notes 2015 fabrication, with installation in 2016; however in a review of the asbuilt documentation it does not appear as though the timber deck panels were new at the time of this installation. A temporary repair of replacing the worn planks along each wheel path and placing additional cross ties on either side of any poor condition ones could be explored; however not recommended. Given the expected use over this structure in the foreseeable future I recommend replacing all the timber deck panels now, prior to industrial activity.

Timber plank condition (Poor) at Panel 2 wheel path - downstream left approach

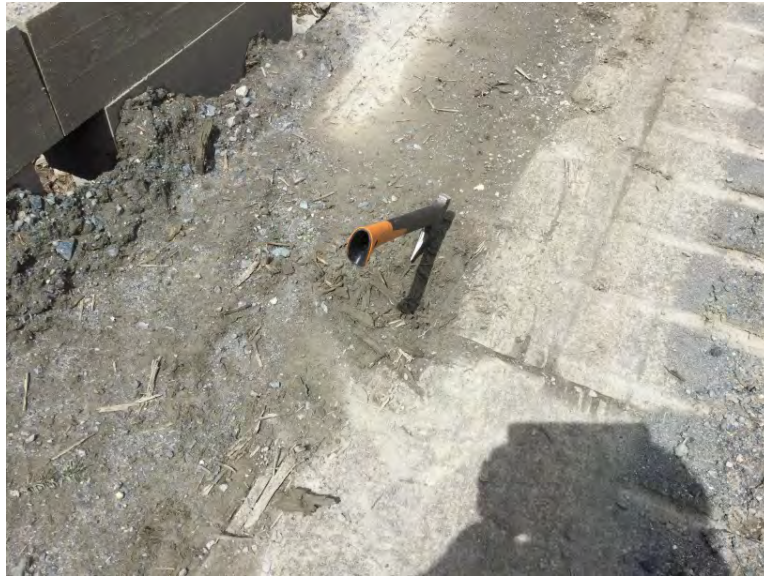
Timber plank condition on Panels 4 and 5 at downstream wheel path location

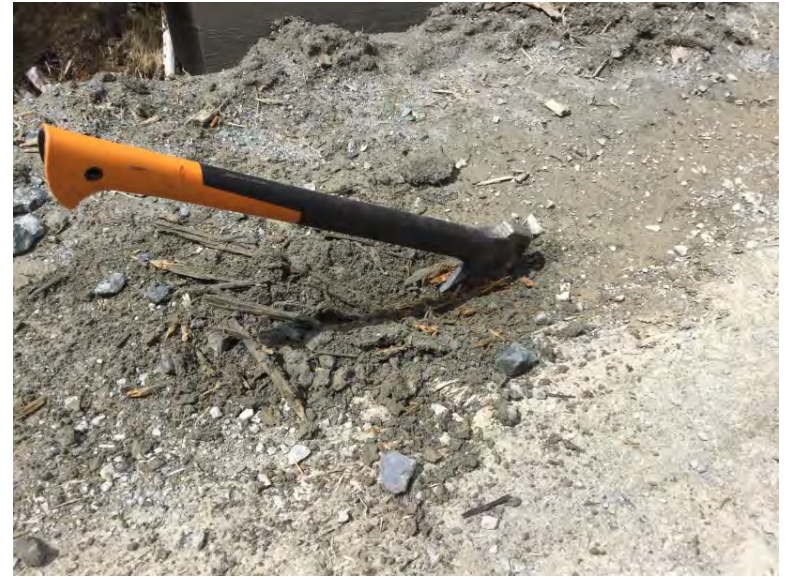
Timber plank condition (Poor) in Panel 5, downstream wheel path

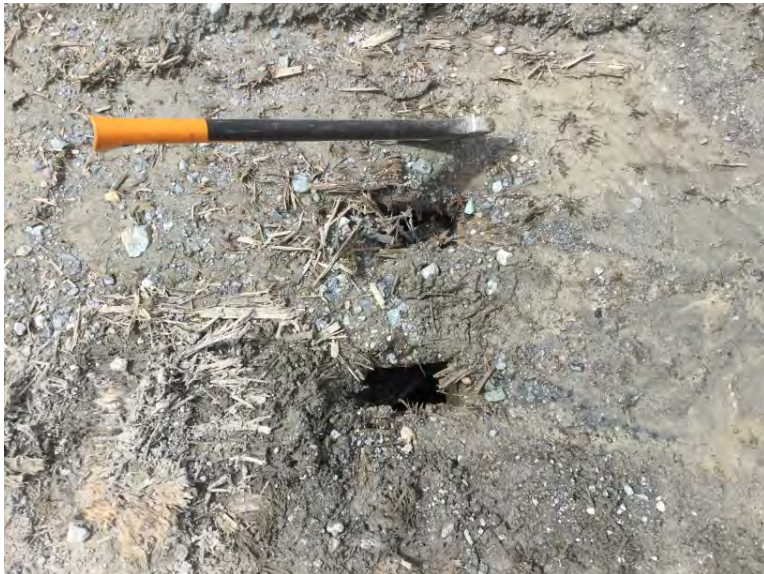
Timber plank condition (Poor) in Panel 7, downstream wheel path

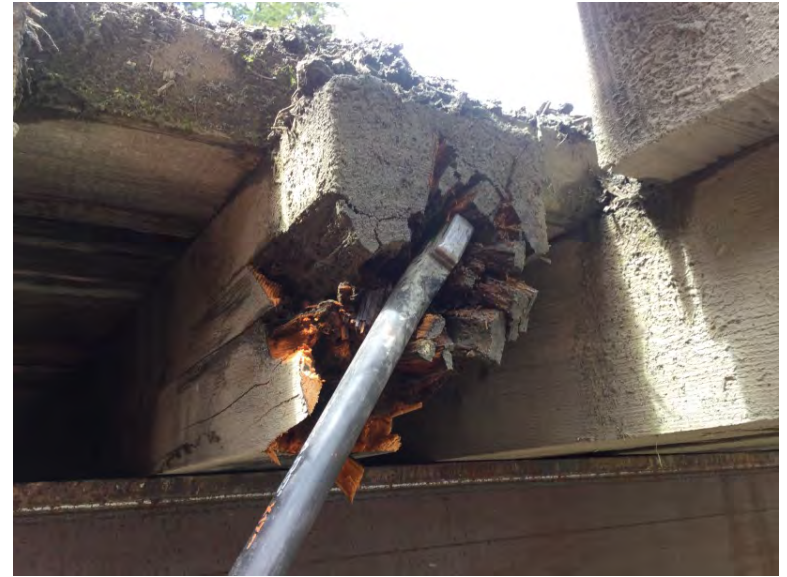
A single cross tie is heavily decayed, while multiple others are either heavily saturated at their ends or end splitting

Panel 1 upstream tie condition

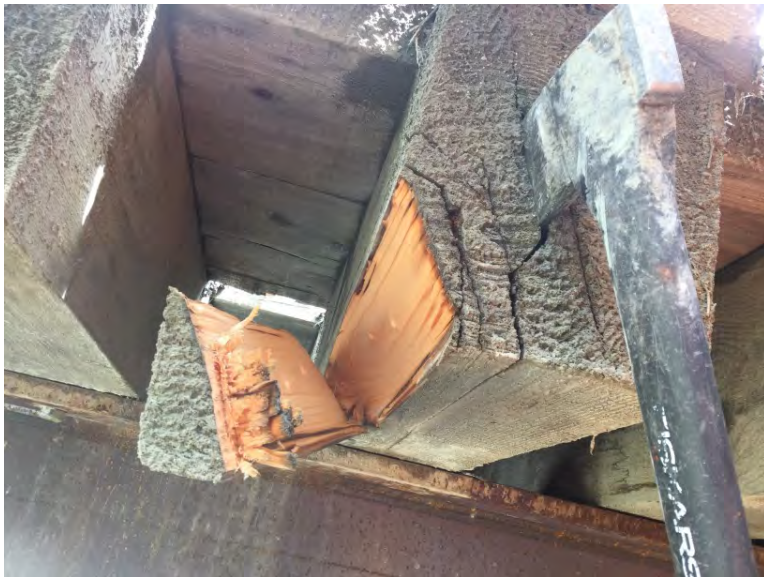
Panel 1 down stream cross-tie condition

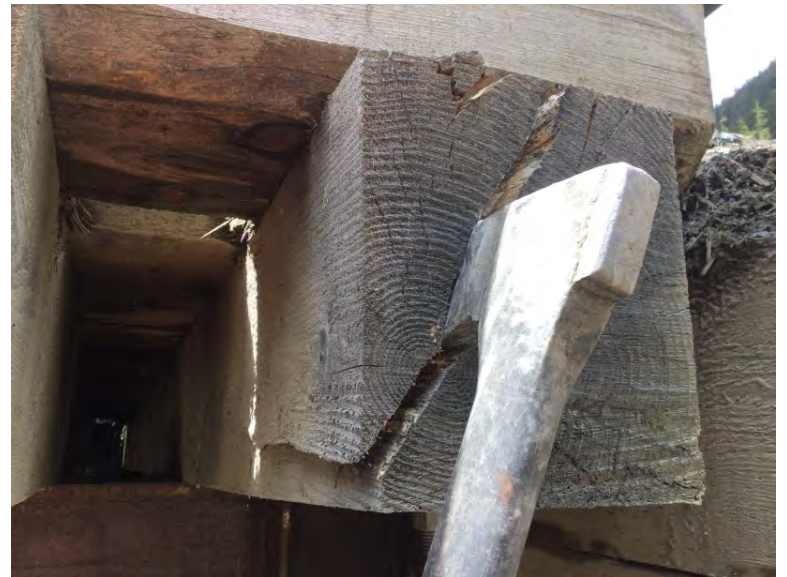
Panel 7 upstream cross-tie condition
