CK-2002  
CK-2002

AMERICAN 4.6km

2022 Inspection

Crossing Name Three Mile Creek

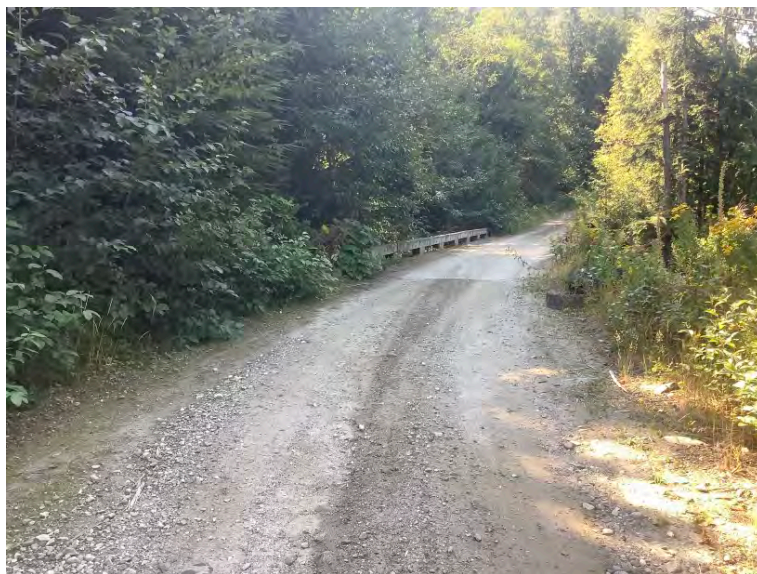
Approach from Right Bank when facing downstream

Fender Condition Poor Rotten guide logs, recommend replacing all 4 corners

2 Approach. Approach fenders Install 4 new barriers  
(install). # of units.  
Priority:Medium

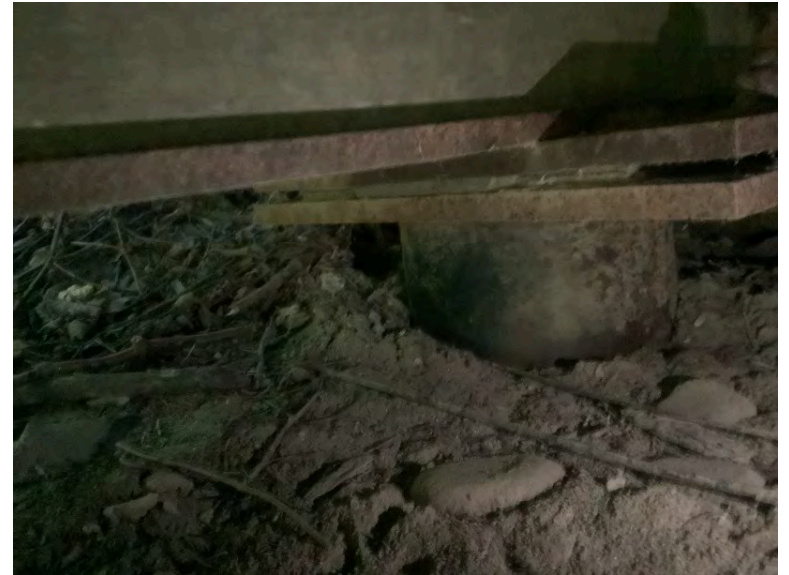
Bearing

Bearings Fair Minor bulging
