CK-2005  
CK-2005

## ANDERSON 2.7km

2022 Inspection

Crossing Name Gilt Creek

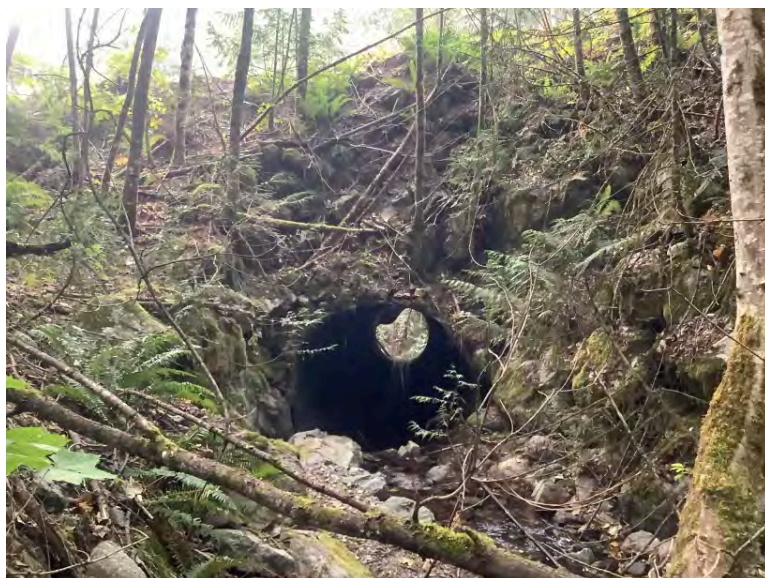
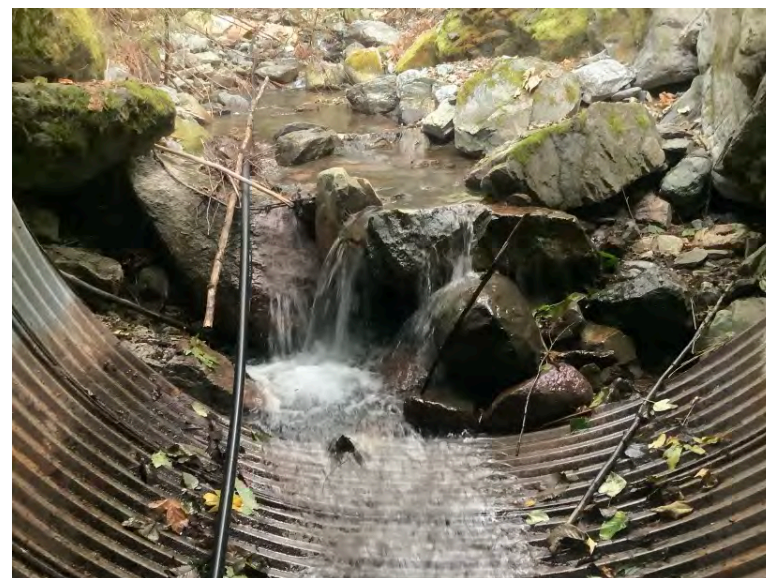
Fill Fair Oversteepened at both outlet and inlet. Actively eroding. Currently not impacting running width.

Inlet Fair 50cm of material stacked directly upstream of inlet.

| Item | Monitor Description | Frequency |
|---|---|---|
| 1 | Oversteepened slopes at both inlet and outlet | Routine Inspection |

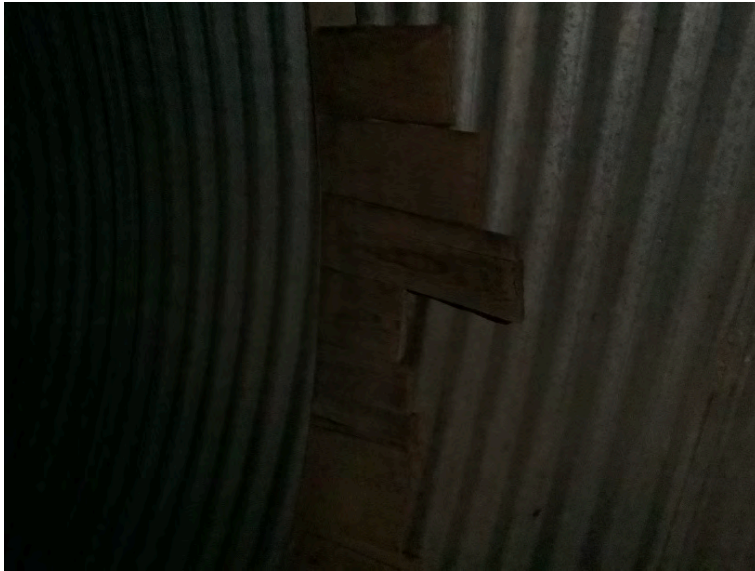
Timber shims

Coupled Connections Fair Wood shims both side walls are tight

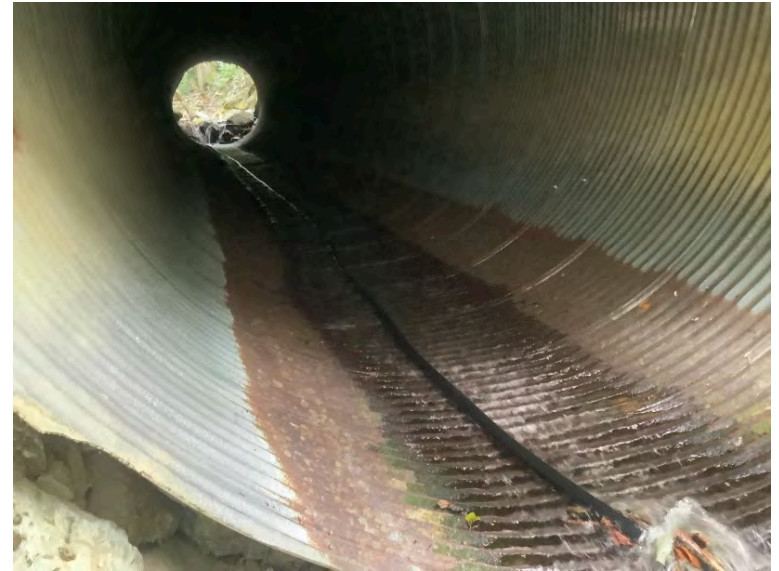
Culvert Floor

Floor Fair Corrosion on floor.

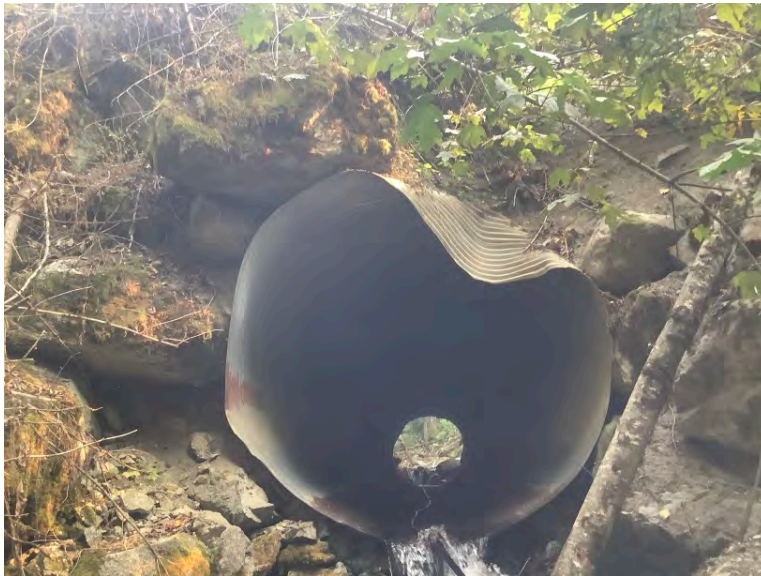
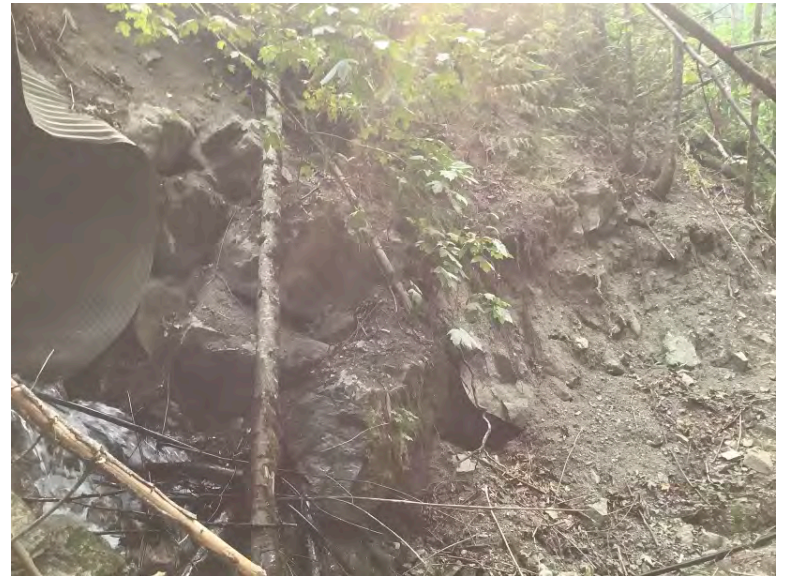
Outlet Fair Damage from large rock falling onto outlet. One large rock still perched directly above

Roof Fair Damage at outlet
