CK-2007  
CK-2007

ANDERSON 13000 0.1km

2022 Inspection

Crossing Name Anderson River

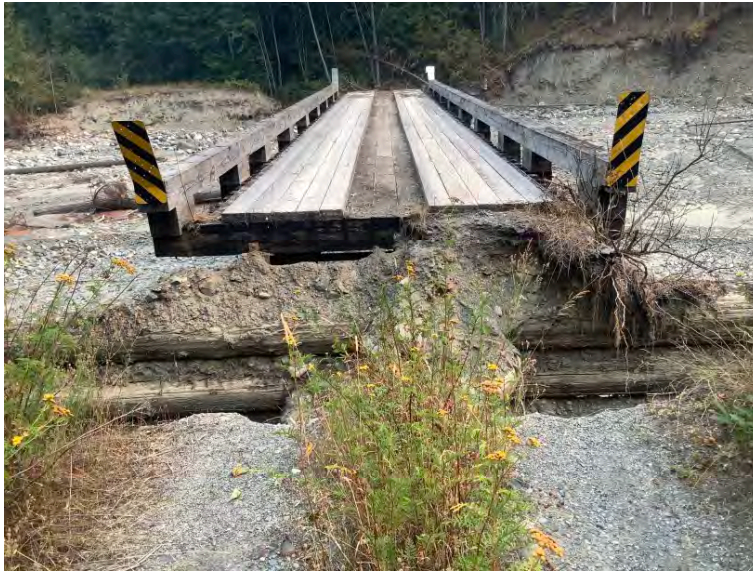
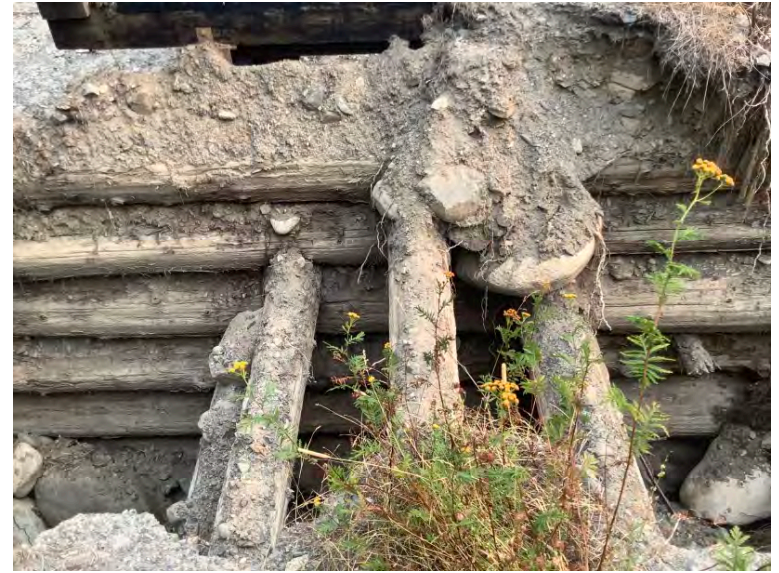
Approach from Left Bank when facing downstream

HC to town, no road remains to woods

Washed away

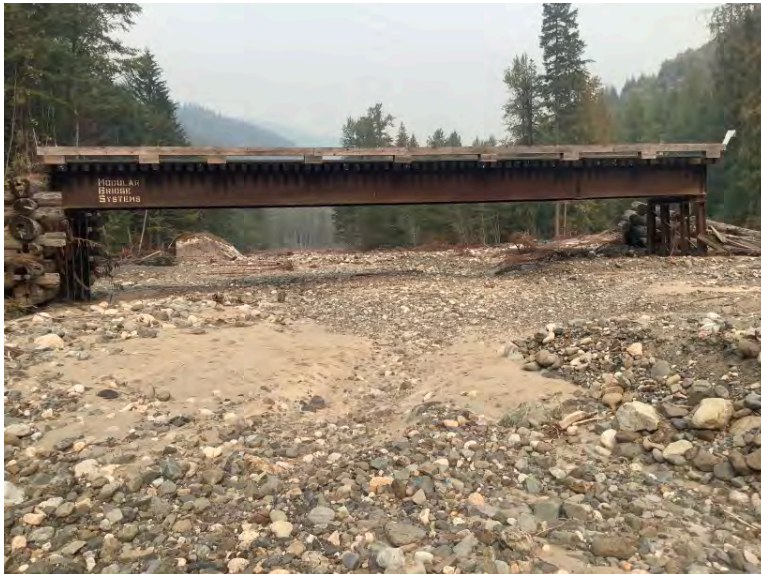
Upstream Profile

Comments Bridge now over flood plain. River is flowing 60m to washed out high chain approach. Superstructure likely fit for re use does not appear to be damaged or have any deformation.

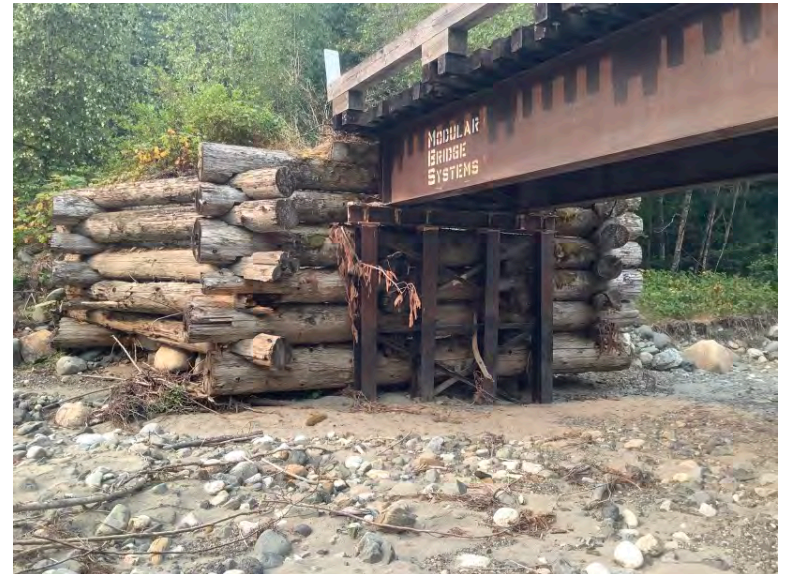
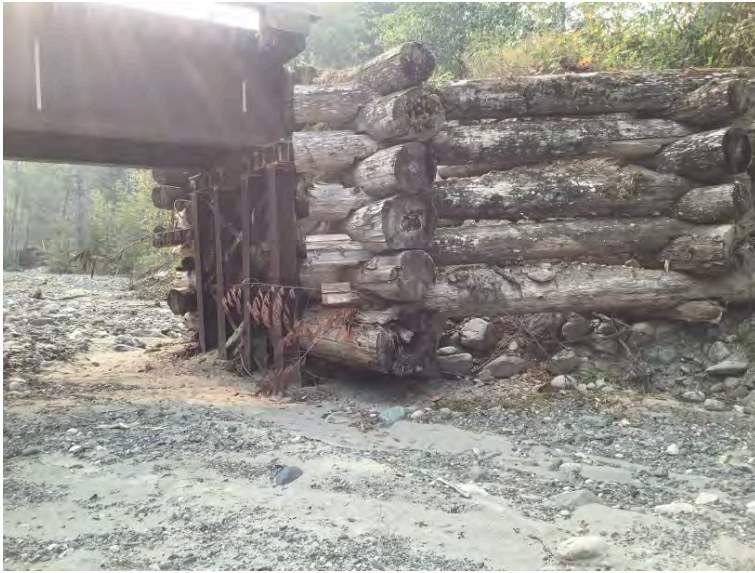
Left Bank Abutment when facing downstream

Poor-Town fill eroded, woods has failed. Few face logs remain on site remainder of crib washed away.

Town piles appear vertical. Woods leaning slightly to creek. Bridge no longer over creek. Piles likely to be removed when road works and new structure installed. If creek retrained to old
