CK-2011  
CK-2011

BLUE MOUNTAIN 300 0.1km

2022 Inspection

Crossing Name Copper Creek

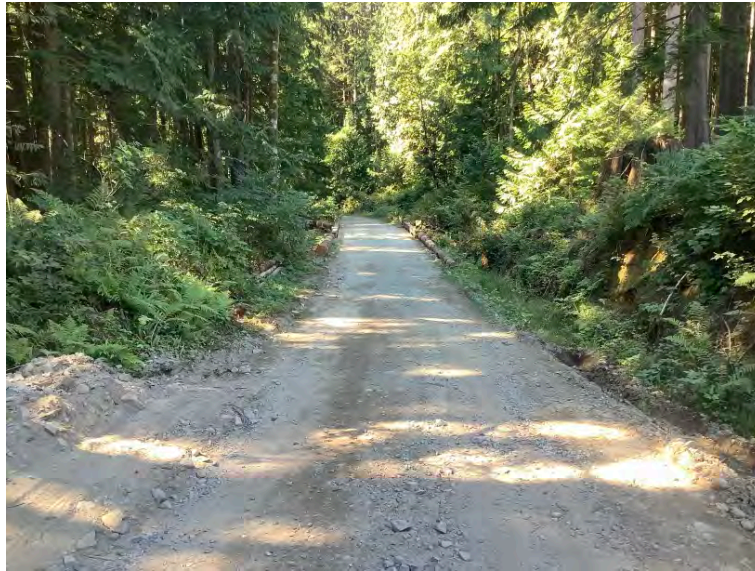
Approach from Left Bank when facing downstream

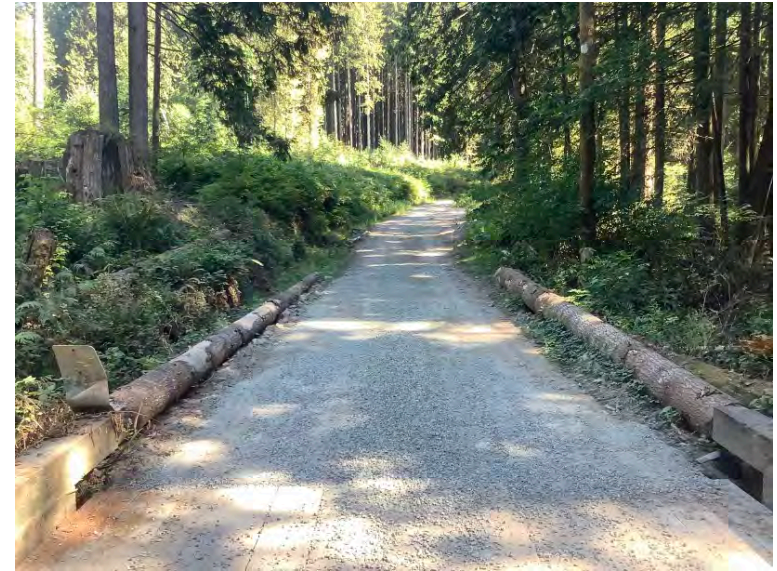
Approach from bridge deck of Left bank approach when facing downstream

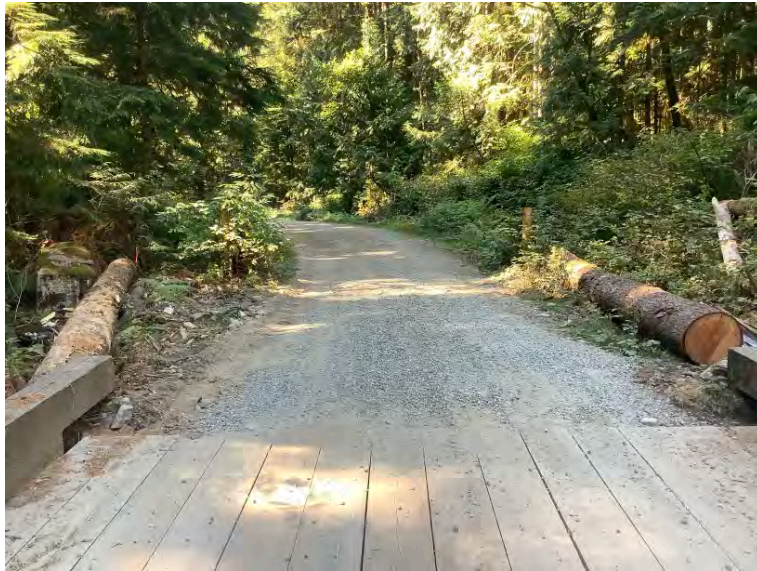
Approach from bridge deck of Right bank approach when facing downstream

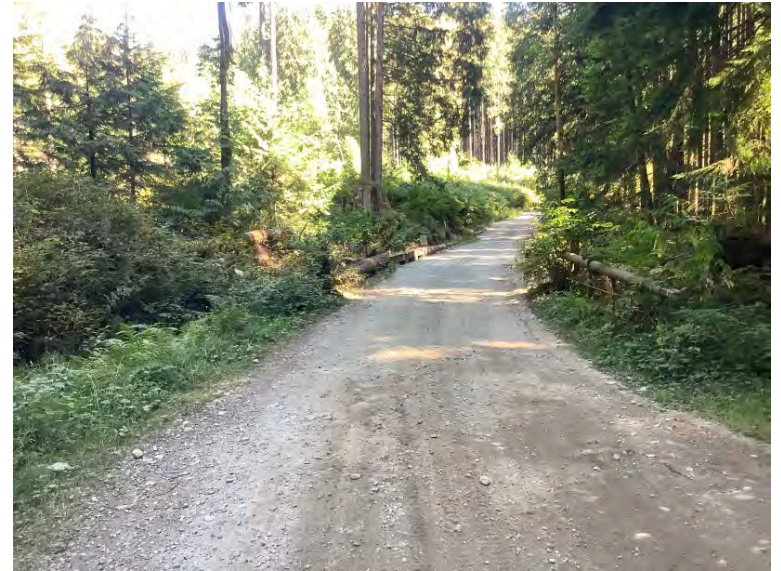
Approach from Right Bank when facing downstream

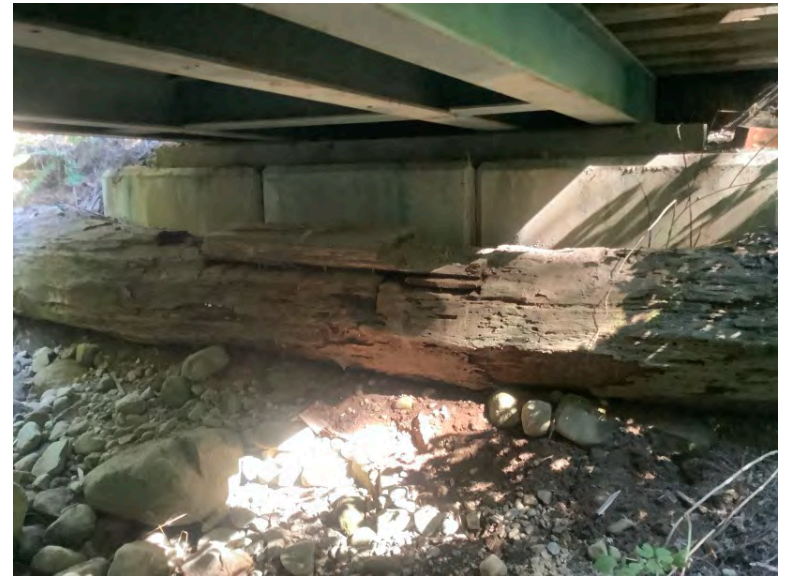
Blocks, one row visible behind old sill logs

Old sill logs act as riprap

Left Bank Abutment when facing downstream

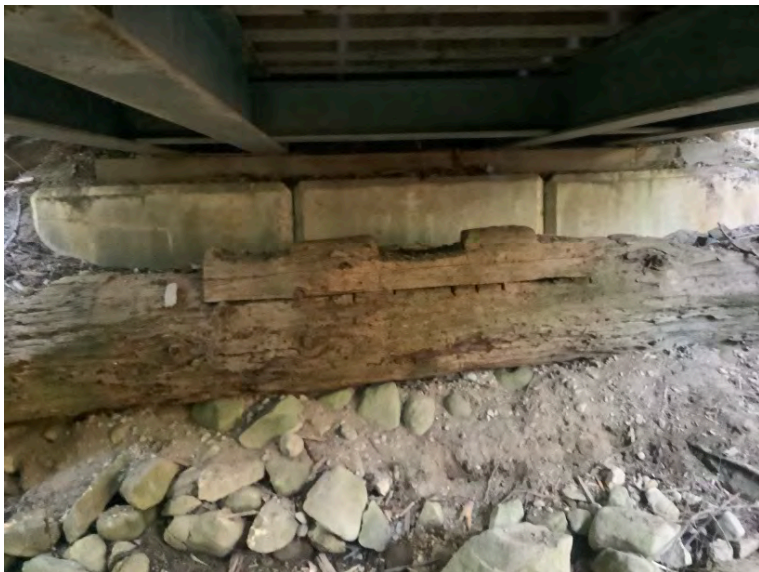
Right Bank Abutment when facing downstream

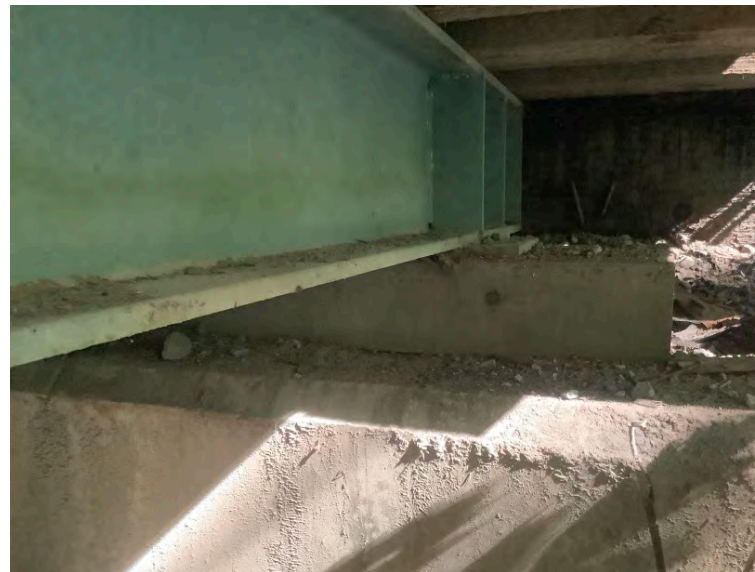
Bearings Good

Bearing

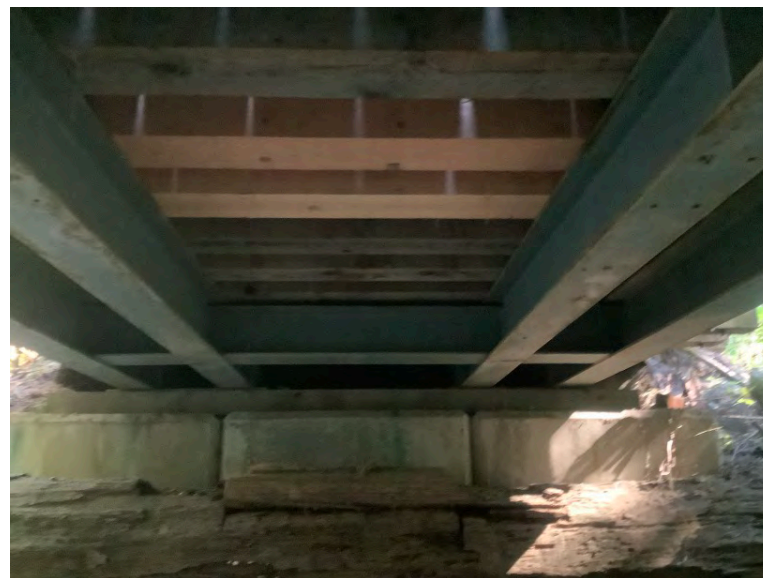
Girders Good

All welded

Superstructure
