CK-2012  
CK-2012

BLUE MOUNTAIN 300 0.8km

2022 Inspection

Crossing Name McFadden Creek

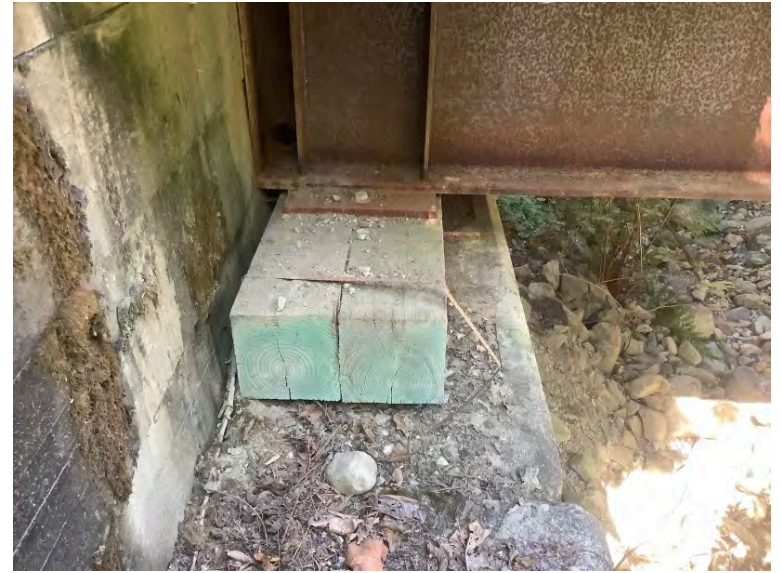
Bearing

Bearings Good

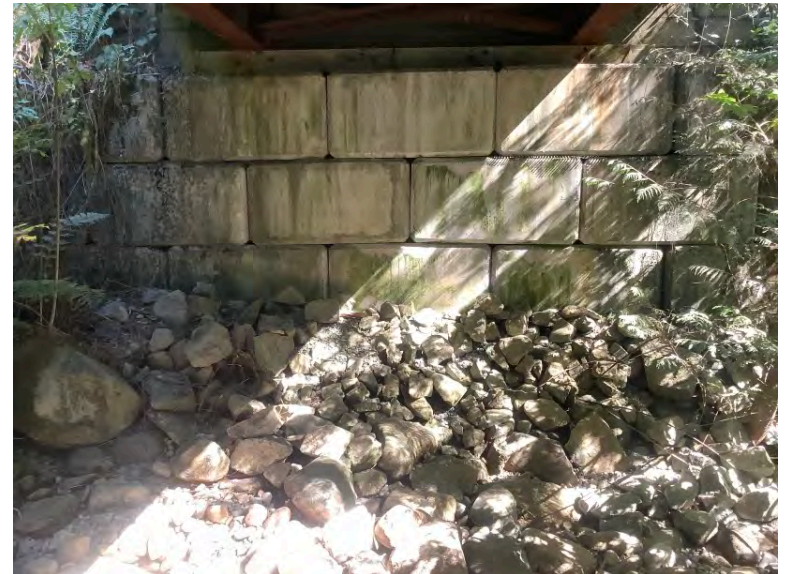
Left Bank Abutment when facing downstream

Concrete Good 3 high block wall, no settlement. Geogrid between tiers

Riprap Fair Actively scouring on both sides of channel

| Item | Monitor Description | Frequency |
|---|---|---|
| 1 | Monitor riprap for further scour | Routine Inspection |

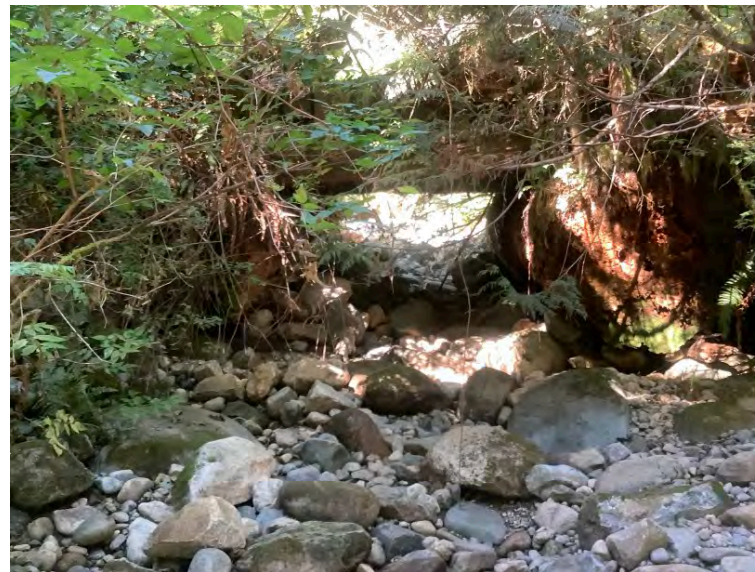
Upstream from Crossing

Comments Monitor both riprap slopes. Woods is further deteriorated than town. Old wbc remains in channel directly upstream of structure.

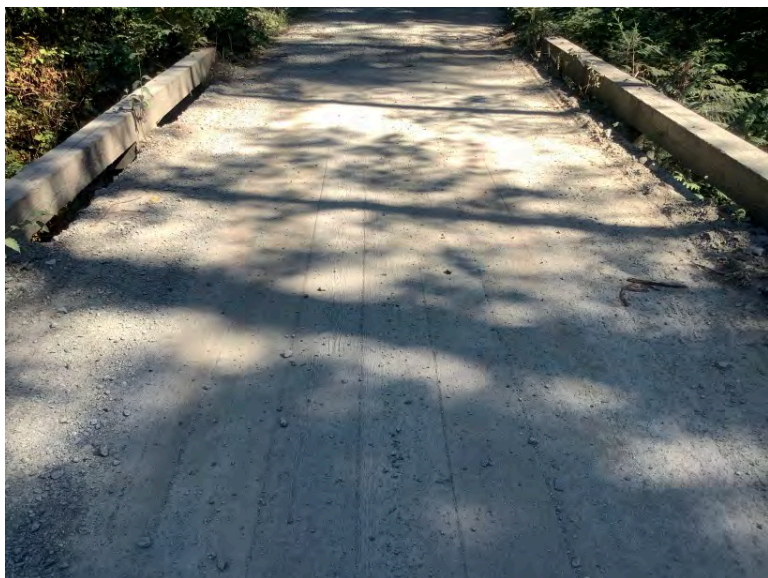
Overall Deck Condition Fair
