CK-2053  
CK-2053

LIUMCHEN 0.2km

2022 Inspection

Crossing Name Tamihi Creek

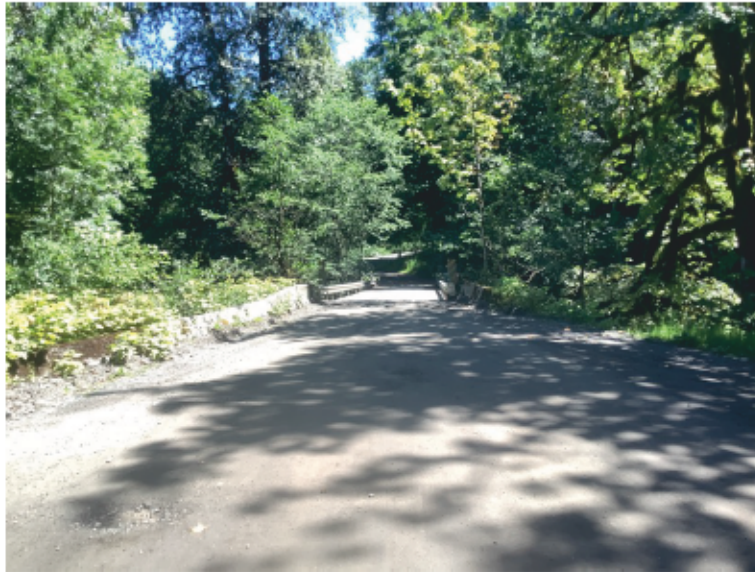
Approach from Left Bank when facing downstream

| Repair Item | Repair Description |
|---|---|
| 1 Approach. Bridge Ahead Signs. 1 # of signs. Priority:Low | Left approach |

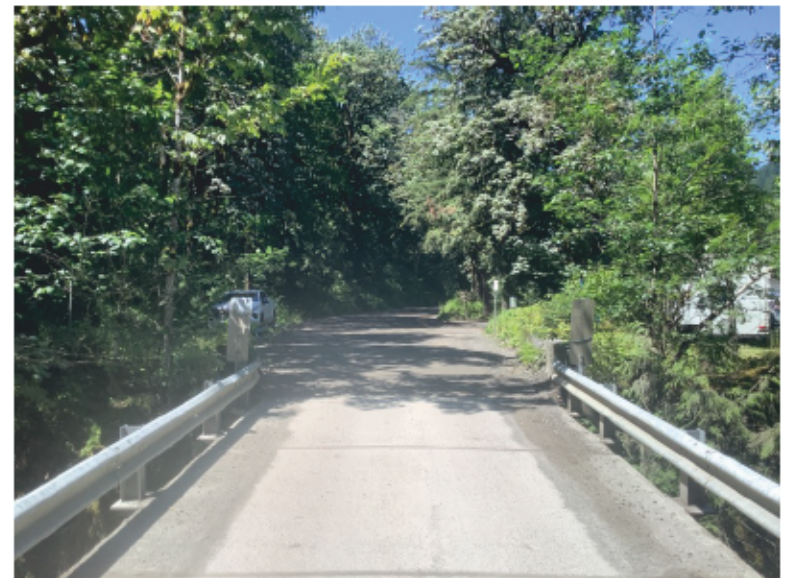
Road Surface Fair

Minor potholes forming

Approach from bridge deck of Left bank approach when facing downstream

| Repair Item | Repair Description |
|---|---|
| 4 Approach. Approach surfacing grading. m. Priority:Low | Minor potholes forming |

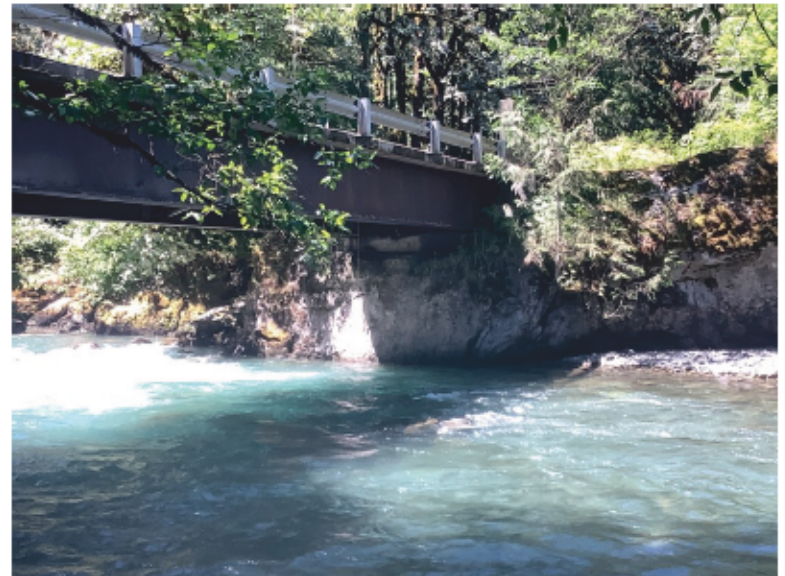
Caps or Sills Unrated

Unaccessible on left side.

Left Bank Abutment when facing downstream

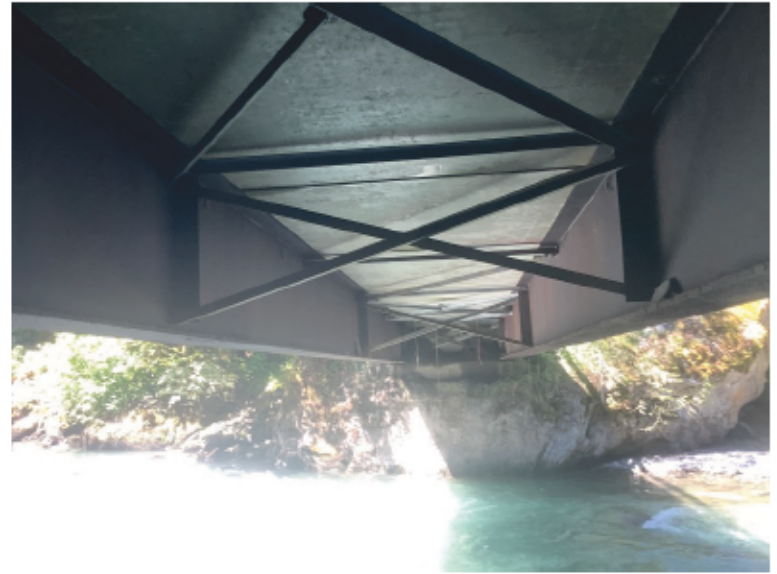
Girders Fair

Scaling noted throughout. Does not to be at load limiting

Bracing Fair

Scaling

Superstructure

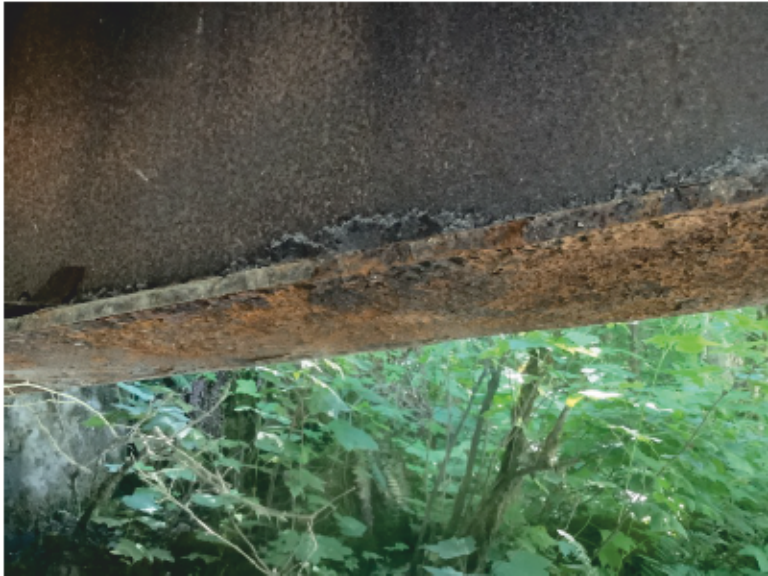
Superstructure

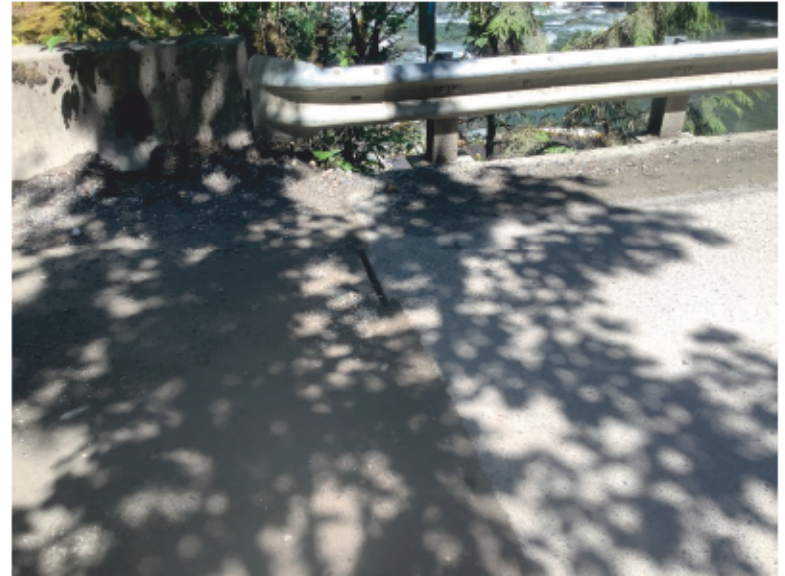
Ballast Wall Good

Treated Timbers. Joint on left bank has slight gap.

Deck joint between timber ballast walls
