CK-2055  
CK-2055A

LIUMCHEN 2.5km

2022 Inspection

Crossing Name Deer Creek

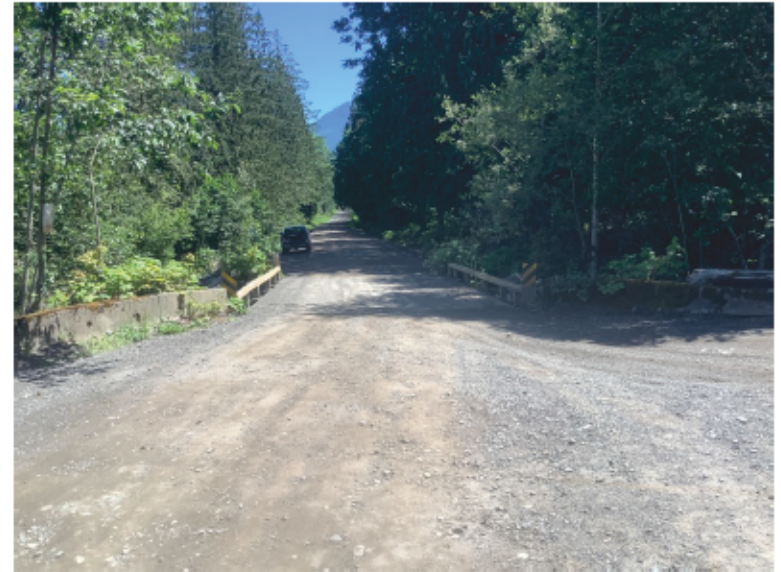
Approach from Left Bank when facing downstream

Left approach missing

| Repair Item | Repair Description |
|---|---|
| 1 Approach. Bridge Ahead Signs. 2 # of signs. Priority:Low | Install bridge ahead signage |

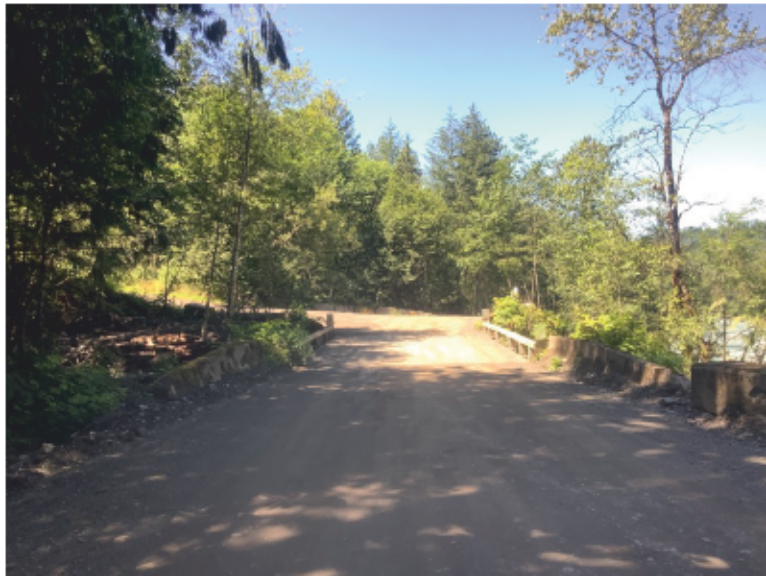
Approach from Right Bank when facing downstream

Minor pot hole on right bank approach. 0.5m before girder end

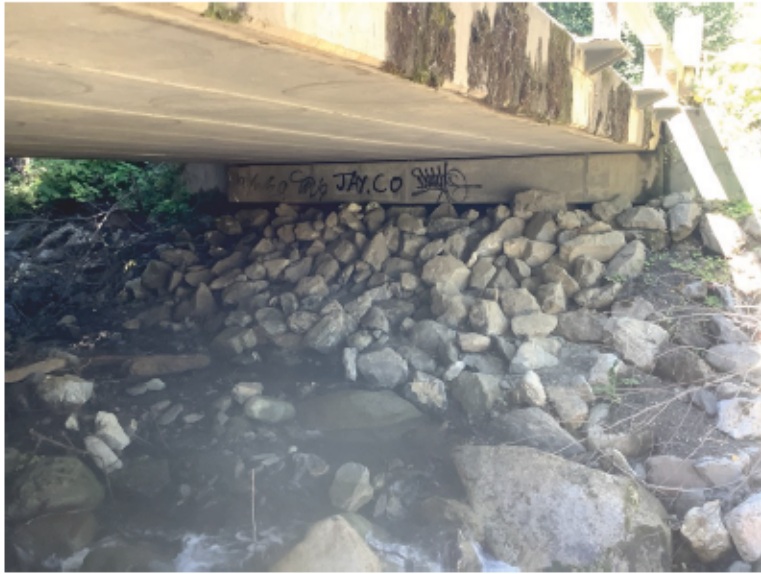
Left Bank Abutment when facing downstream

Oversteepened. Appears stable. Up and down stream appear to have have additional rock and armouring installed.

Starting to flake
