CK-2061  
CK-2061

LIUMCHEN EAST 4.2km

2022 Inspection

Crossing Name Liumchen Creek

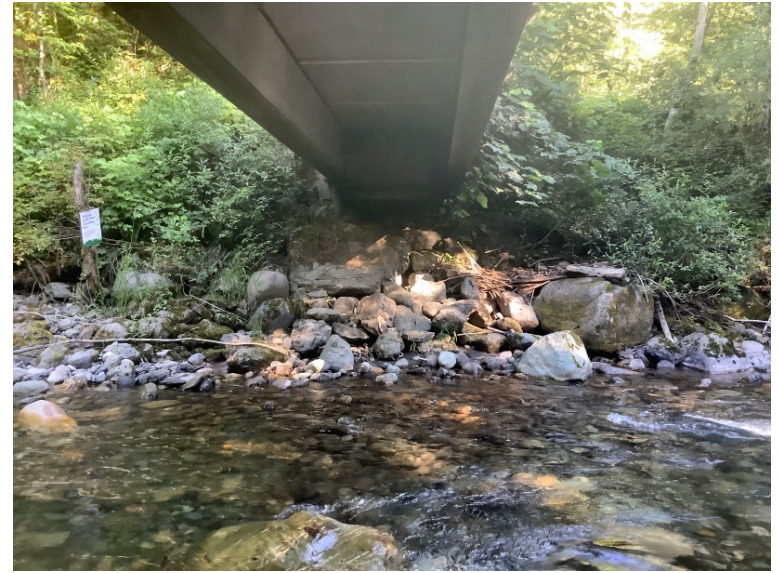
Left Bank Abutment when facing downstream

Appears to have been mobilized and some loose rocks present. Monitor for continuing movement/scour.

| Item | Monitor Description | Frequency |
|---|---|---|
| 1 | Riprap stability | Routine Inspection |

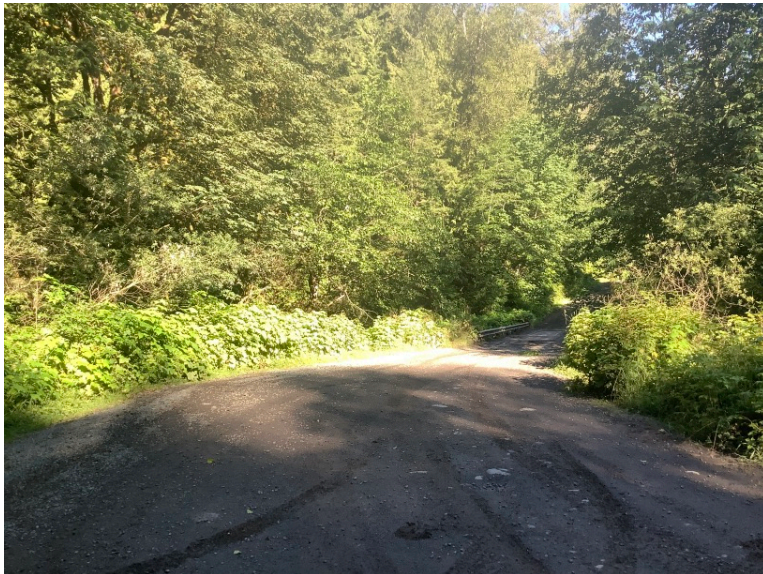
Approach from Right Bank when facing downstream

Requires ballast both ends

| Repair Item | Repair Description |
|---|---|
| 5 Approach. Approach surfacing grading. m. Priority:Low | Prior to industrial activity |

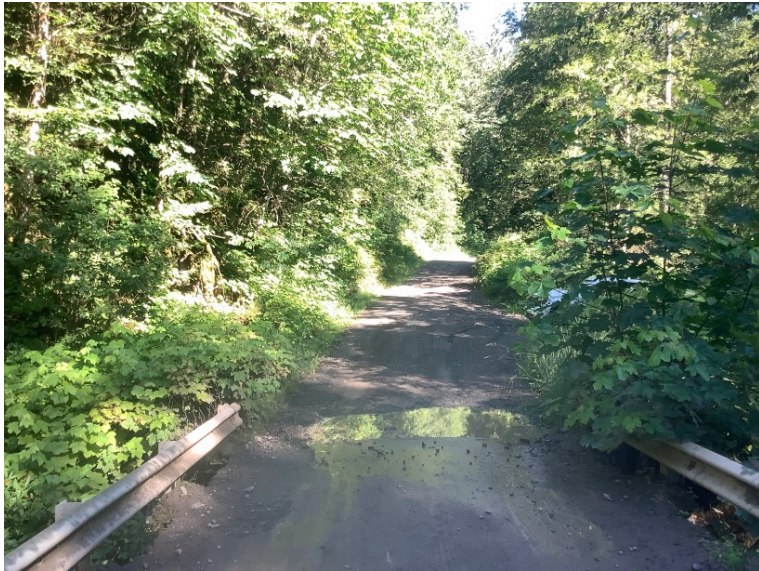
Approach from bridge deck of Left bank approach when facing downstream

Overall Deck Condition Fair Deck requires cleaning, installing sediment guards would limit sediment into creek.

| Repair Item | Repair Description |
|---|---|
| 2 Structure. Clean Deck. # of delineators. Priority:Low | Prior to industrial activity |
