CK-2064  
CK-2064

TAMIHI 6.3km

2022 Inspection

Crossing Name Tamihi Creek

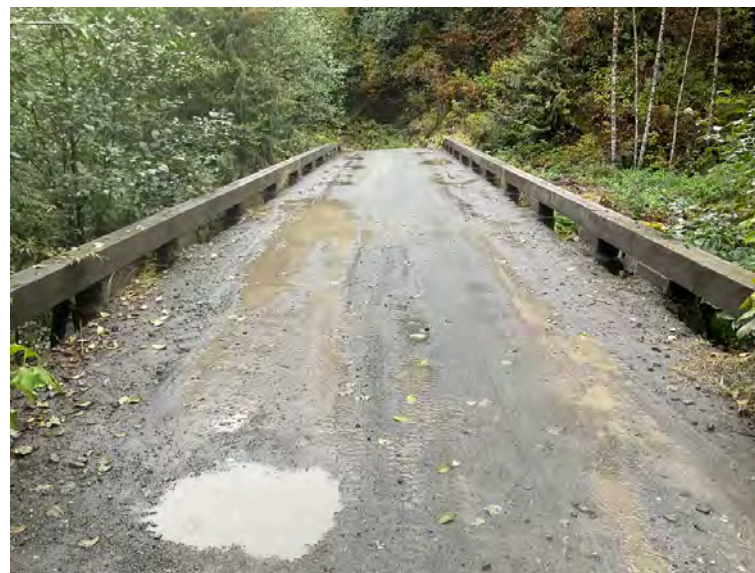
Deck

Running Surface      Fair      Sediment on deck

| Repair Item | Repair Description |
|---|---|
| 2 Structure. Clean Deck. # of delineators. Priority:Medium | Clean deck |

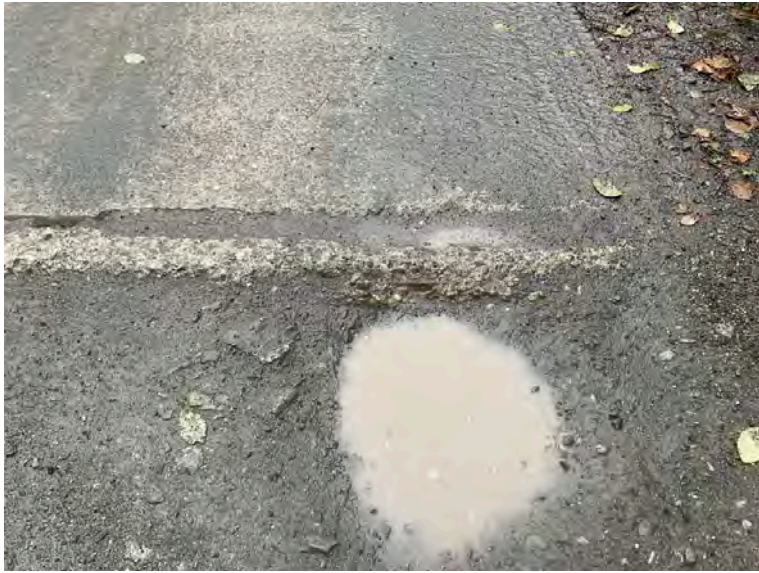
Right bank ballast wall

Ballast Wall Fair Damage noted to top surface at right bank

| Repair Item | Repair Description |
|---|---|
| 3 Structure. Concrete structural maintenance. m². Priority:Medium | Repair damage to right bank ballast wall and deck panel 1 |

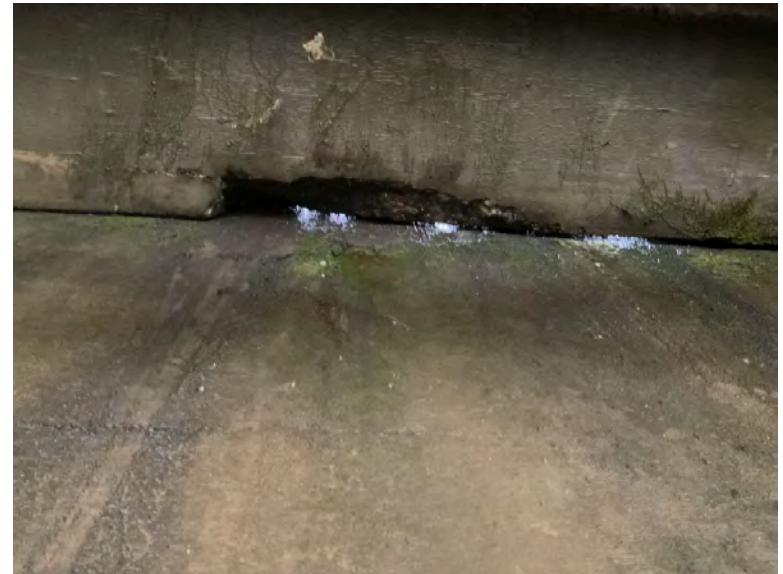
Damage to panel 1 right bank

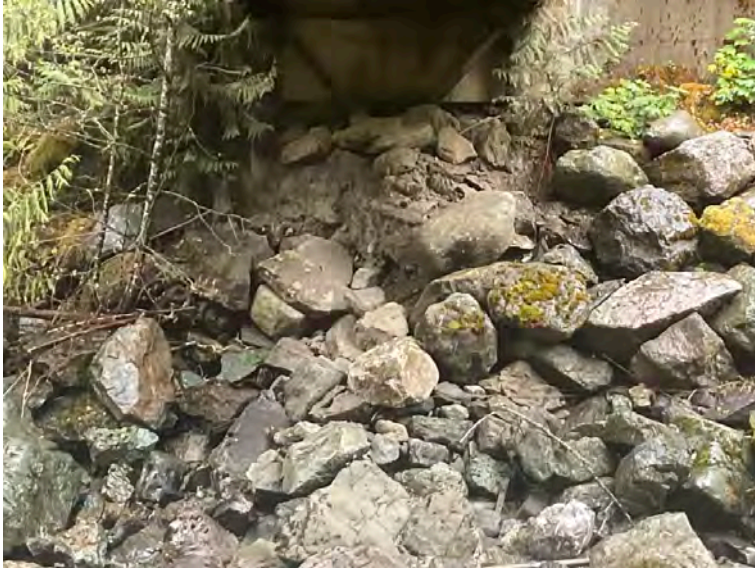
Riprap Fair Eroded at downstream right bank - requires repair

Right Bank Abutment riprap erosion

| Repair Item | Repair Description |
|---|---|
| 5 Channel. Add Riprap (placed). m³. Priority:Medium | Repair eroded riprap at right bank |
