CK-2067  
CK-2067

TAMIHI 10.6km

2022 Inspection

Crossing Name Tamihi Creek

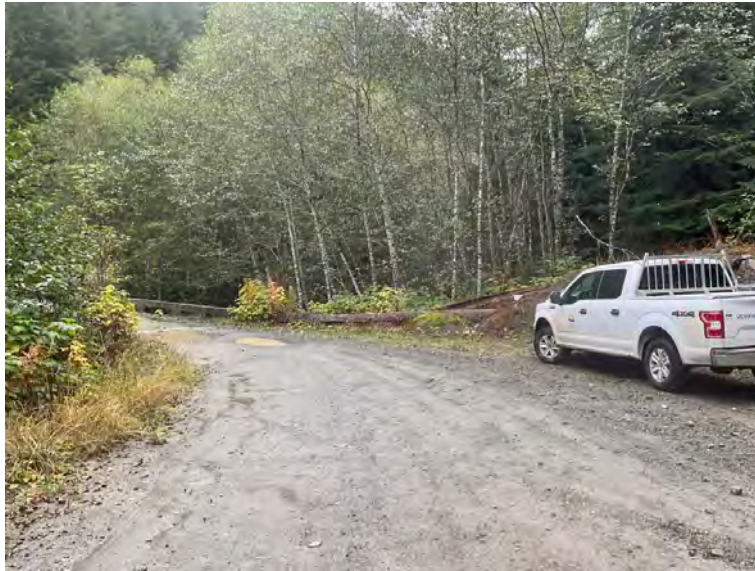
Approach from Left Bank when facing downstream

Large potholes at each approach

| Repair Item | Repair Description |
|---|---|
| 3 Approach. Area/sight line brushing. m².<br>Priority:Medium | Brush and grade approaches |

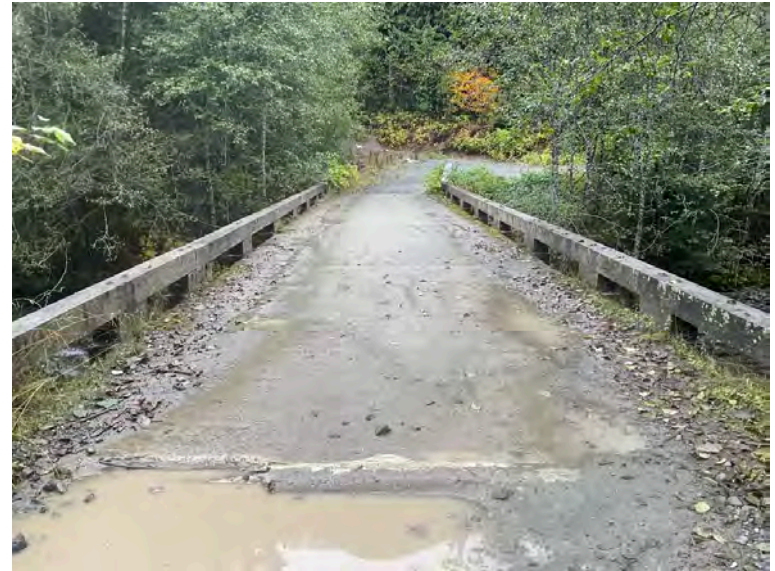
Concrete Deck      **Fair**      Damage noted to the first panels at each approach

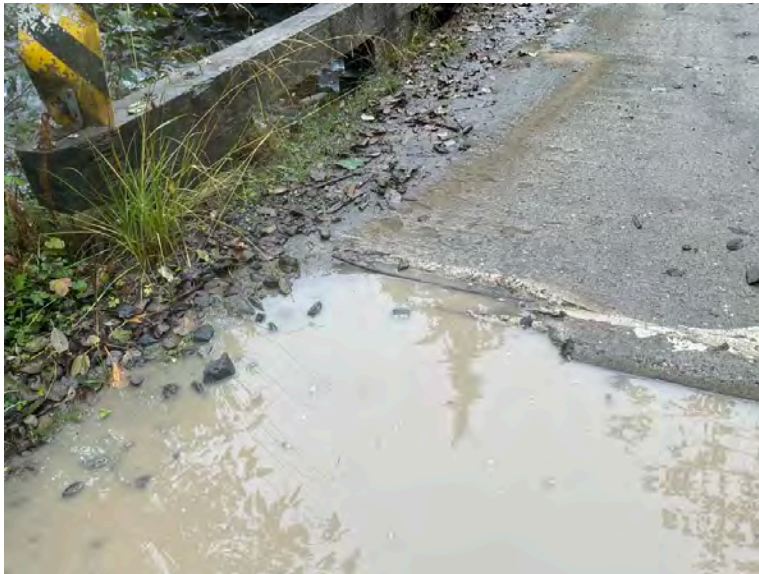
Damage to tops of both

Left bank ballast wall and panel damage

| Repair Item | Repair Description |
|---|---|
| 2 Structure. Concrete structural maintenance. m².<br>Priority:Medium | Repair damage to ballast walls and panels |

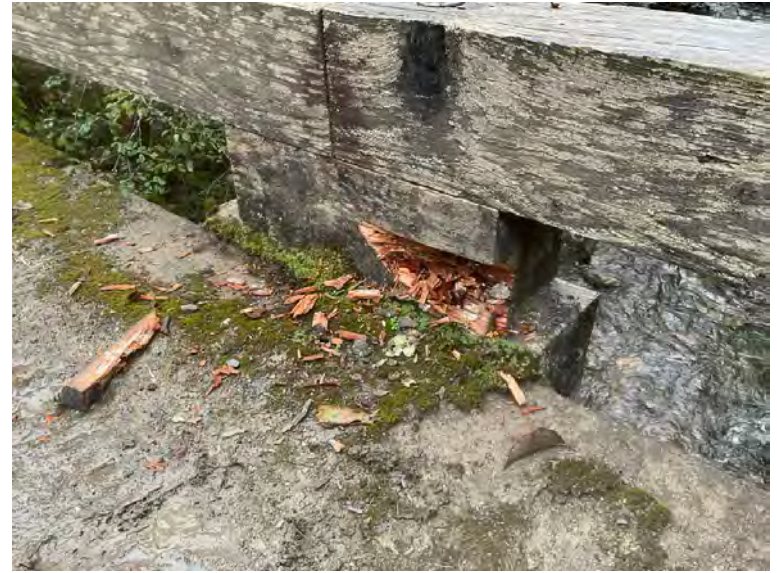
Guard Rail

Curb Rail/Blocks/Posts      **Poor**      Rotten

Hardware      **Poor**      Loose rail

Overall Deck Condition      **Poor**      Due to rail condition

| Repair Item | Repair Description |
|---|---|
| 1 Structure. Full Curb Replacement. .<br>Priority:Medium | Replace the guardrail, risers, blocks and delineators |

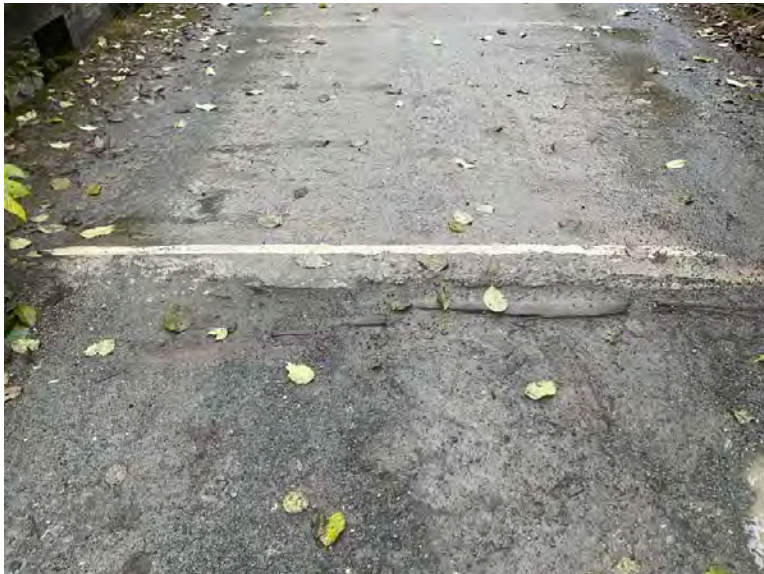
Right bank ballast wall damage

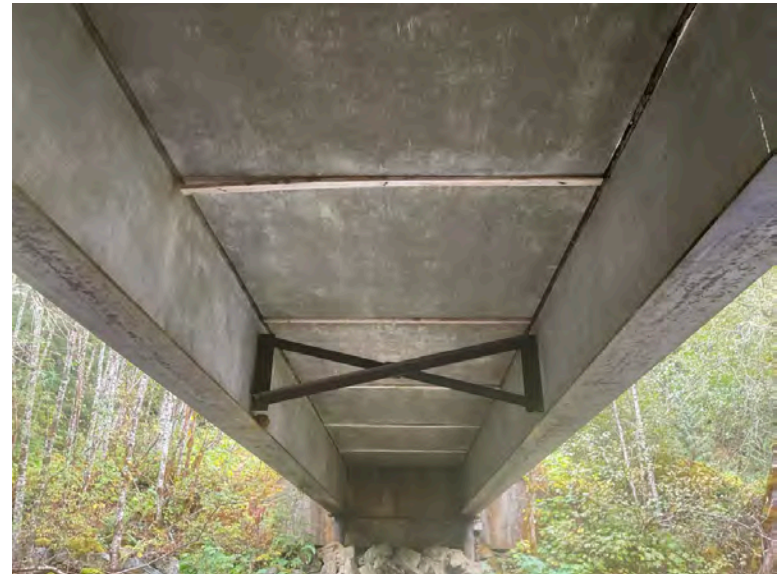
Superstructure

Composite - hairline cracks noted throughout
