CK-2068  
CK-2068A

SLESSE 6.1km

2022 Inspection

Crossing Name Slesse Creek

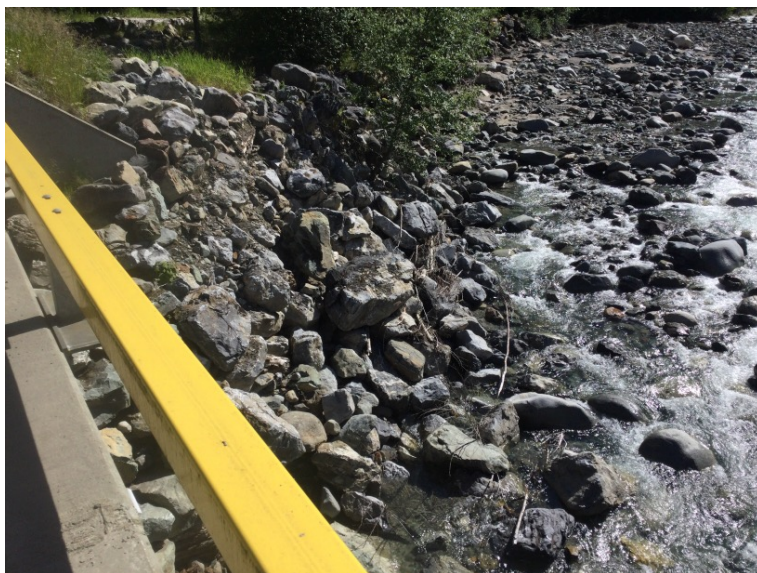
Riprap Poor Eroded at both abutments - repair prior to Fall precipitation events

Upstream right bank riprap erosion

| Repair Item | Repair Description |
|---|---|
| 2 Channel. Add Riprap (placed). m³. Priority:High | Add placed riprap to both bank abutments, the finished product should be similar to what the record drawing indicates. The right bank riprap should extent approximately 100m upstream. |

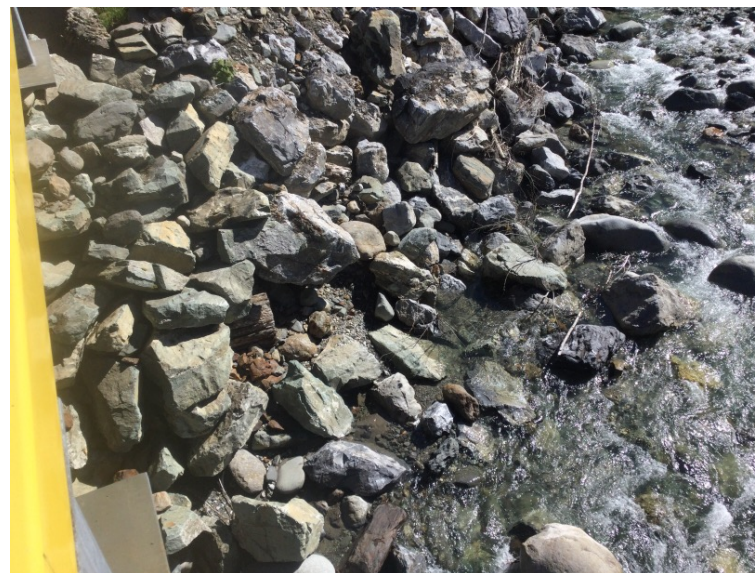
Upstream right bank riprap erosion

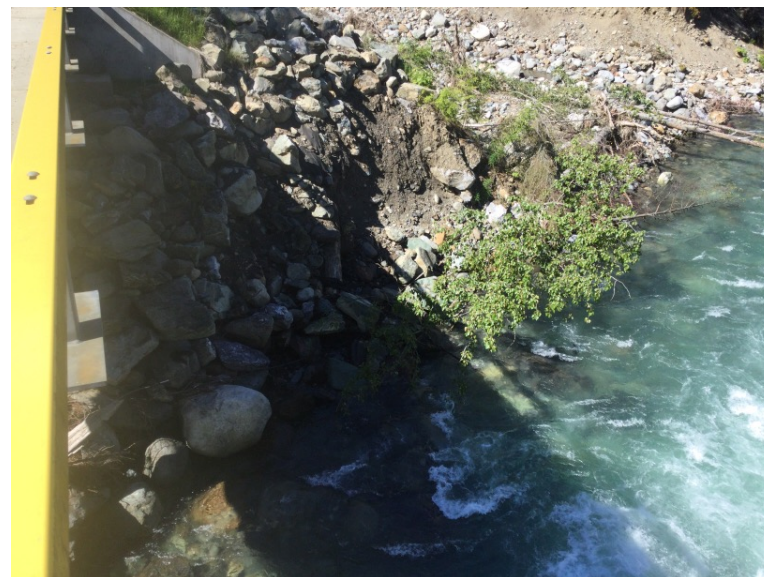
Downstream left bank riprap erosion

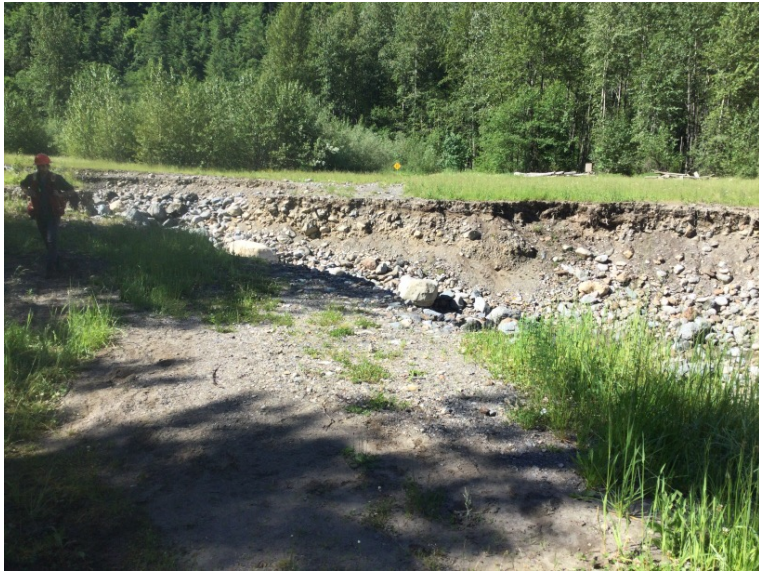
Fill Poor Left road approach has been washed away

Looking at left bank approach subgrade erosion

| Repair Item | Repair Description |
|---|---|
| 4 Approach. Reconstruct fill. Priority: High | Replace the eroded road approach material at the left bank approach. |

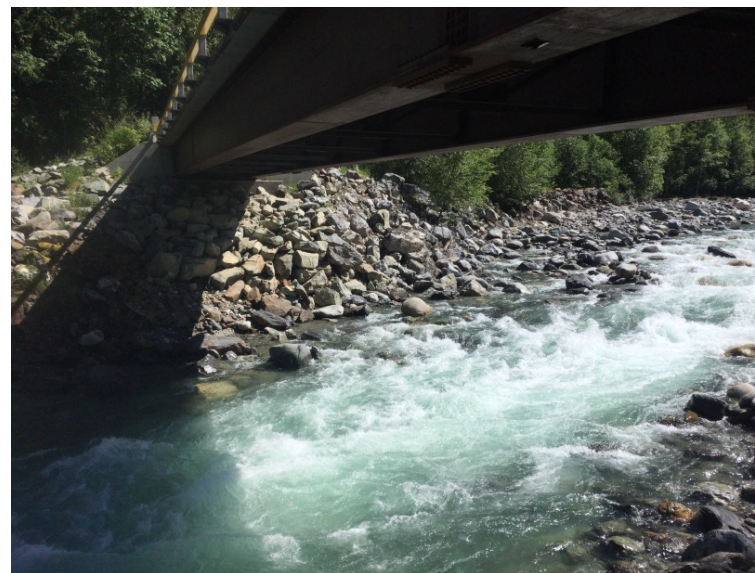
Upstream right bank riprap erosion

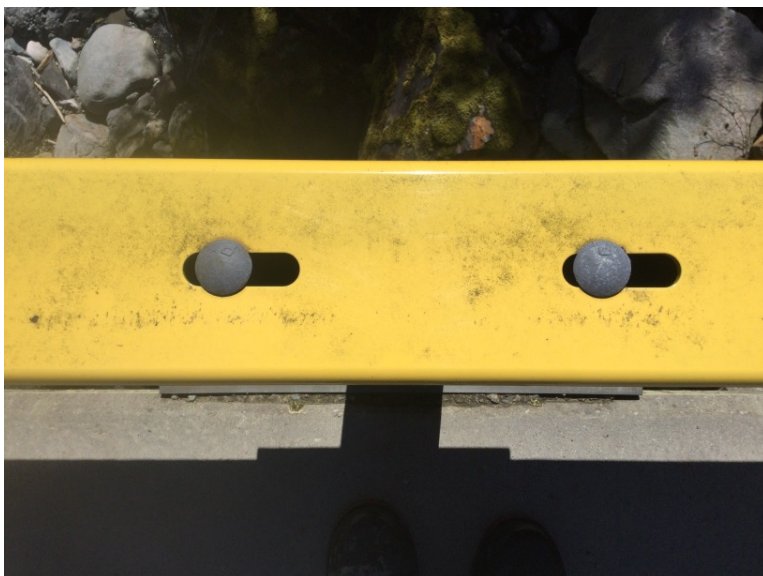
Plate washers not installed on rail

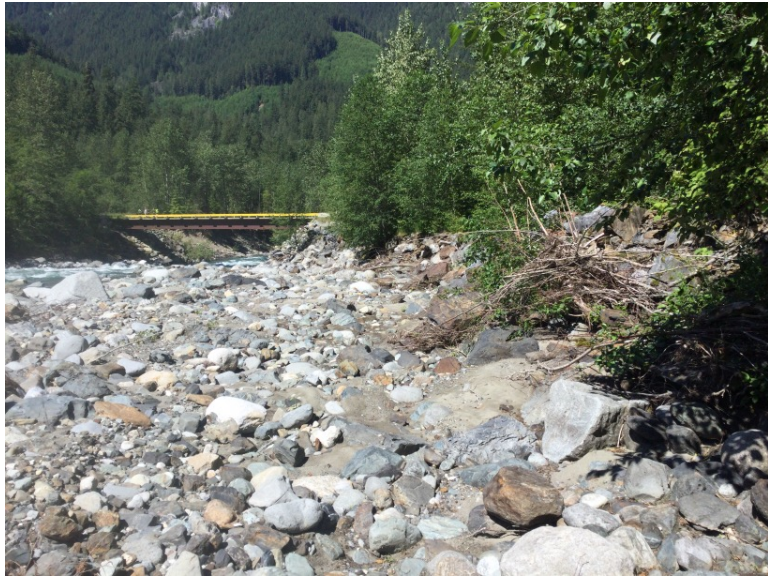
Significant bank erosion has occurred at both the right and left bank locations as a result of the November 2021 storm events. The bank erosion has extended approximately 100m upstream from the right bank abutment. At this location the flood plain widens and within the vegetated cover there is an old rock berm that was previously constructed to protect the FSR when these types of events occur. The high stream flow from the November 2021 storm event did reach this rock berm; however did not cause any damage to it. Consideration should be given to extending this rock berm downstream and tying into the existing right bank riprap to fully protect the FSR in future high flow events. The storm event also resulted in the left bank road approach being washed away, which now requires replacement.

Upstream right bank Riprap erosion extent -100m extent

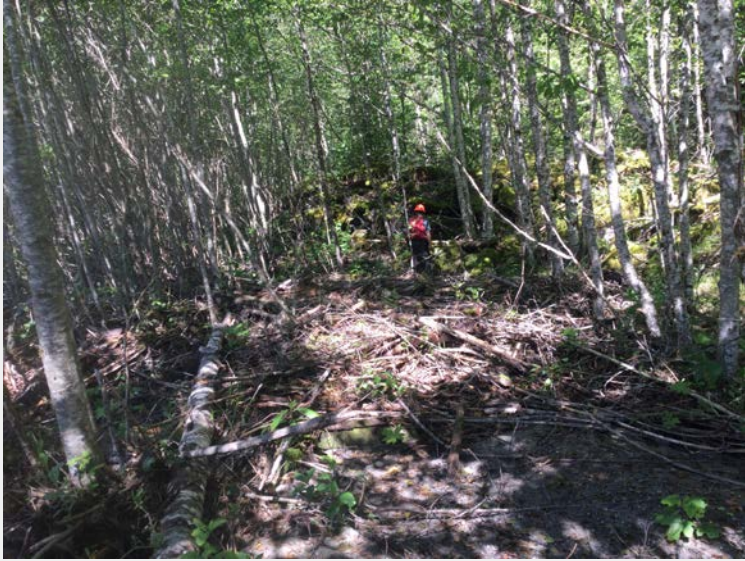
Old rock berm constructed within floodplain under vegetated cover
