CK-2073  
CK-2073

BENCH 1.5km

2022 Inspection

Crossing Name Chipmunk Creek

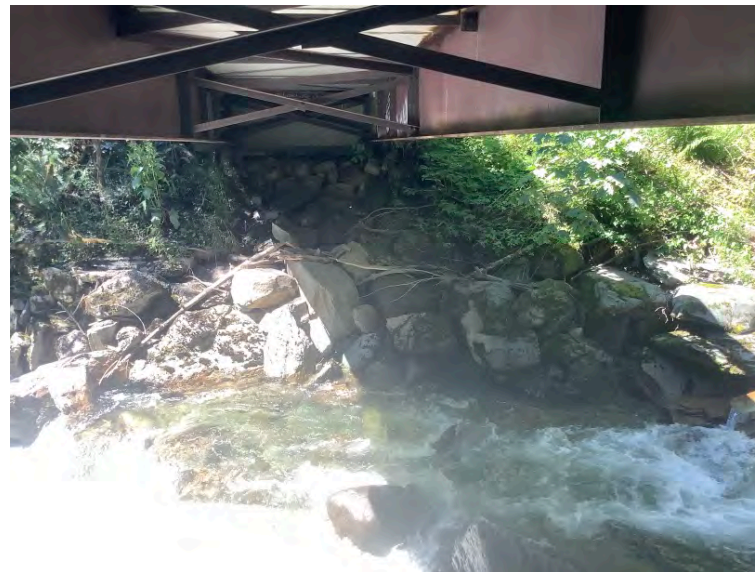
Right Bank Abutment when facing downstream

Corrosion Protection Fair

Starting to flake off.

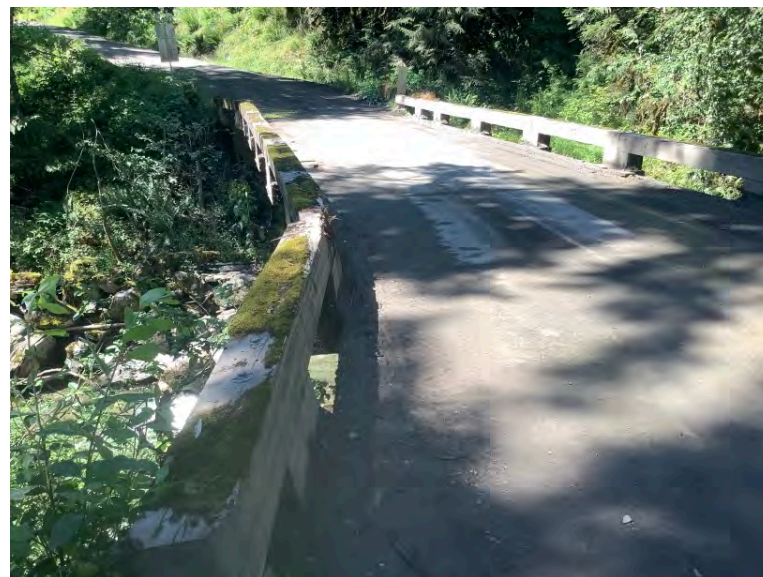
Guard Rail

Curb Rail/Blocks/Posts      Fair      Showing signs of age. Downstream left bank first section has been impacted. It is leaning but still functional.

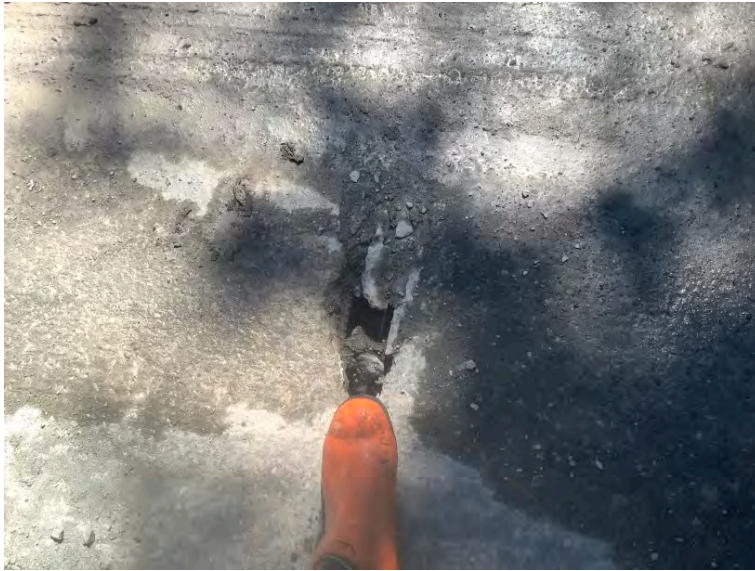
Concrete Deck      Fair      Damaged first joint right approach. Has punched a hole through and spalled beneath. See photo

Deck Joints      Fair      Appears to be rubber gasket in joint. Joint one right bank has failed. Others appear to be holding up.

| Repair Item | Repair Description |
|---|---|
| 1 Structure. Joint maintenance. m². Priority:Medium | Joint 1 right bank punched and spalled out bottom of slab.Requires repair to stop from worsening. |

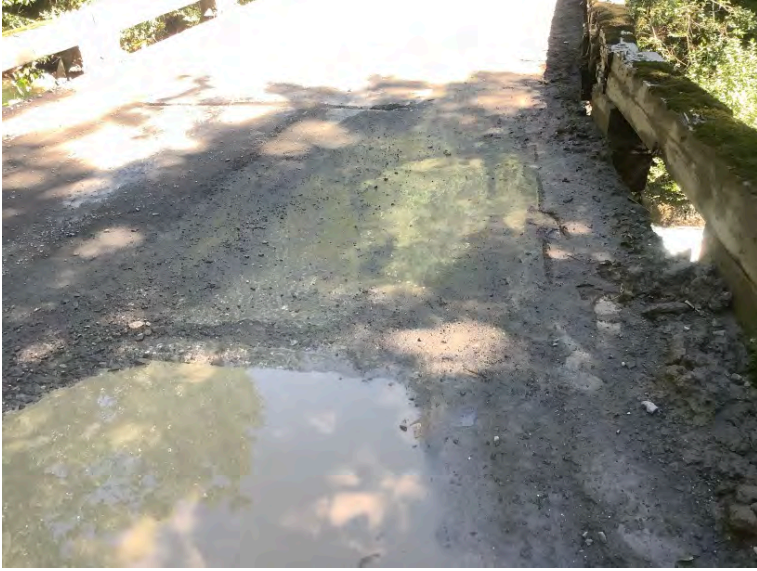
Pothole with ballast wall impact downstream right corner of bridge.

Minor damage noted at road surface.

Approach pothole with ballast wall wear

| Repair Item | Repair Description |
|---|---|
| 3 Approach. Approach surfacing grading. m. Priority:Low | Grade and ballast to limit damage to ballast wall tops. Complete prior to industrial activity. |
