CK-2074  
CK-2074B

CHIPMUNK 8.3km

2022 Inspection

Crossing Name Chipmunk Creek

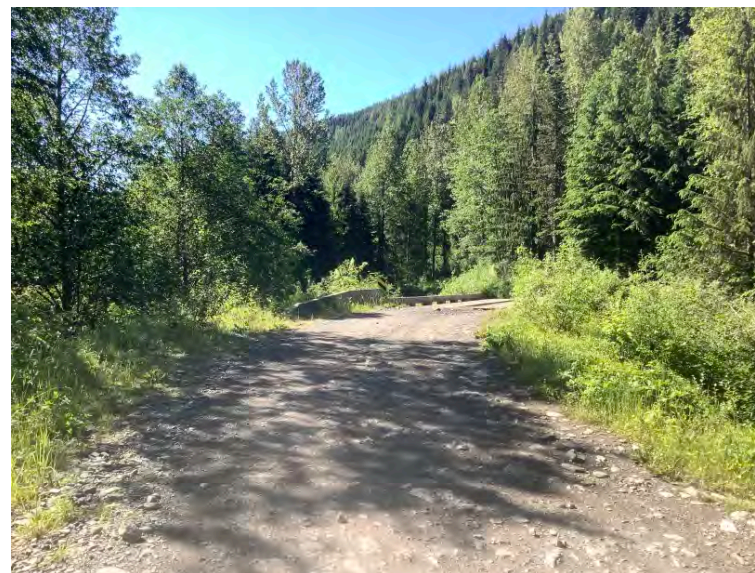
Approach from Left Bank when facing downstream

1.5km before bridge only passable with 4x4 vehicle. Approach requires ballast as ballast logs are exposed.

| Repair Item | Repair Description |
|---|---|
| 1 Approach. Approach surfacing grading. m. Priority:Low | Ballast required prior to industrial activity. Access only 4x4, rec traffic for Mt. Cheam access main users. |

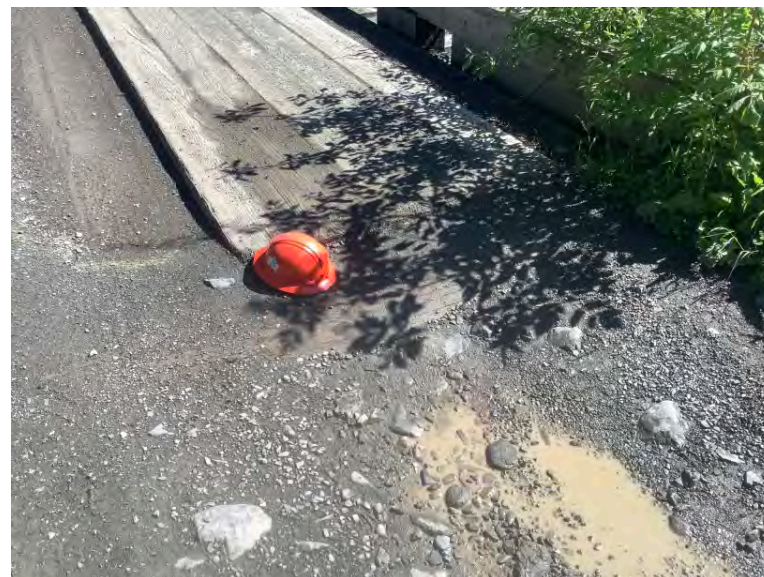
Logs, tops exposed require ballast on road

Exposed ballast log

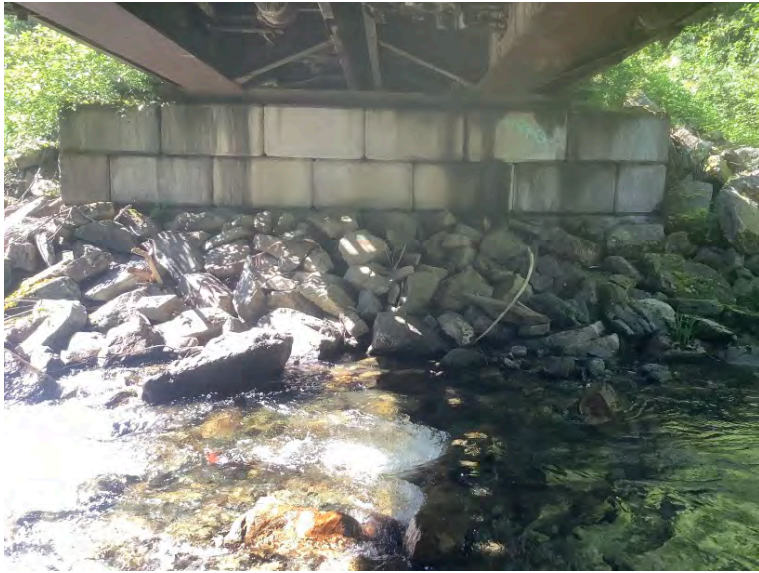
Right Bank Abutment when facing downstream

Concrete blocks in good condition

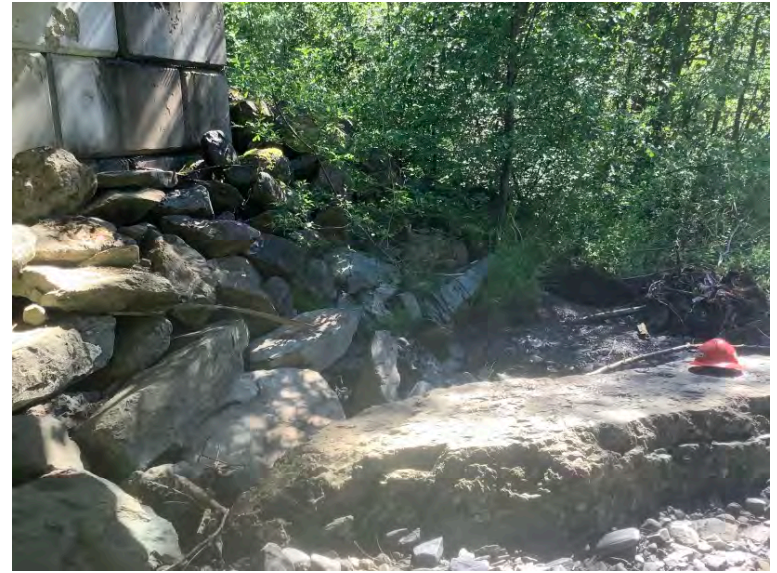
| Item | Monitor Description | Frequency |
|---|---|---|
| 1 | Left bank appears to have slight scour pool behind large angular rock on channel. Riprap appears stable behind and well keyed in. Monitor for worsening condition. Appears to be issue at peak flows only. | Routine Inspection |

Left bank scour

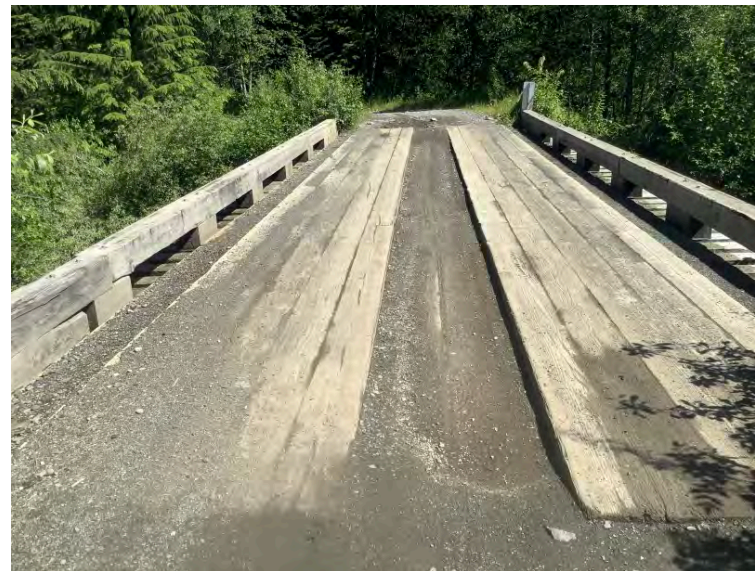
Deck to Girder Bolts Poor Non observed on outside rail of rail car. Can not confirm, if they are present.

Overall Deck Condition Fair
