CK-2075  
CK-2075

BENCH 2.1km

2022 Inspection

Crossing Name Foley Creek

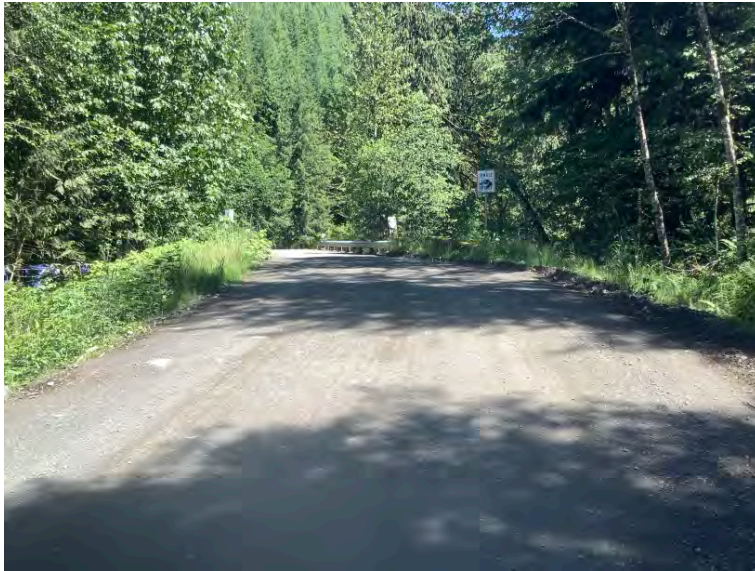
Approach from Left Bank when facing downstream

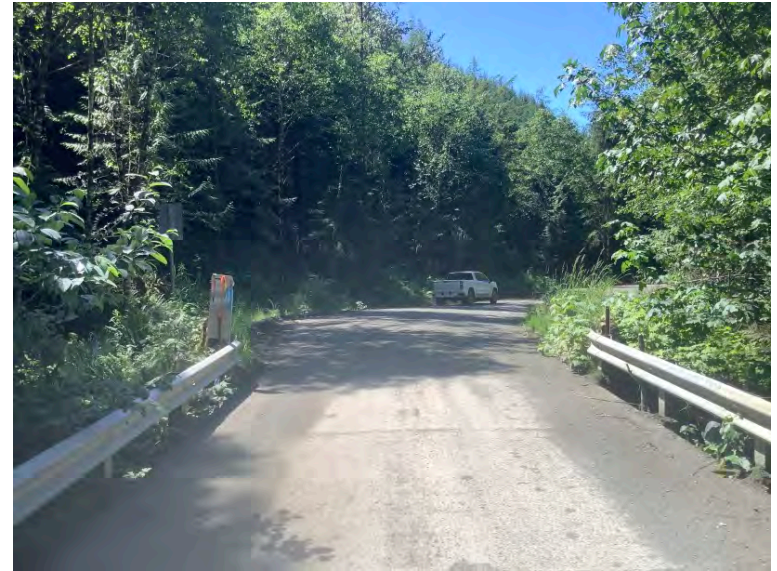
Approach from bridge deck of Left bank approach when facing downstream

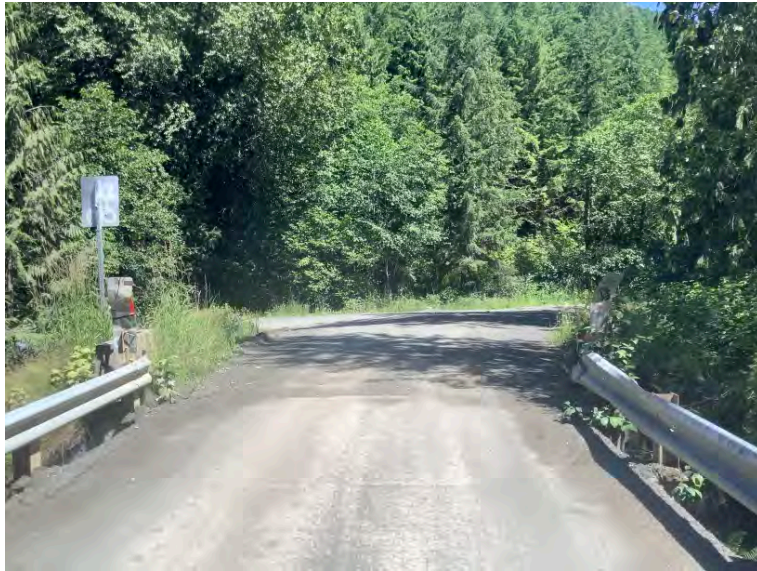
Approach from bridge deck of Right bank approach when facing downstream

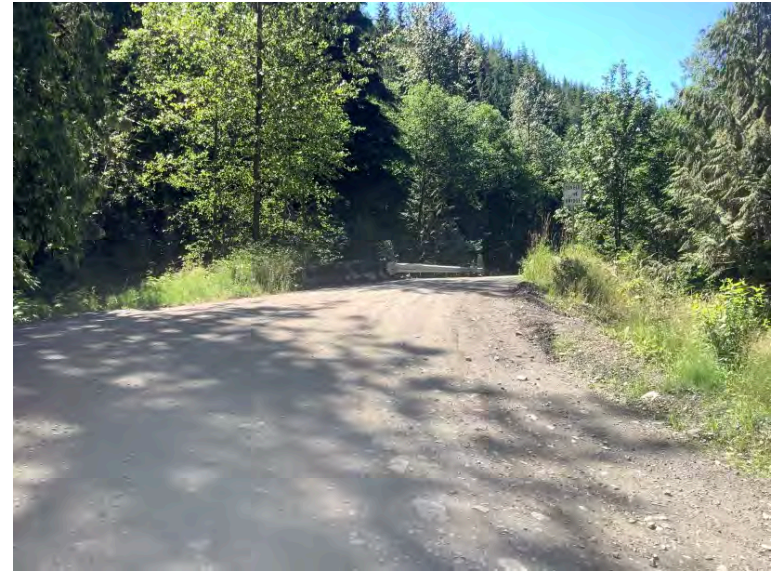
Approach from Right Bank when facing downstream

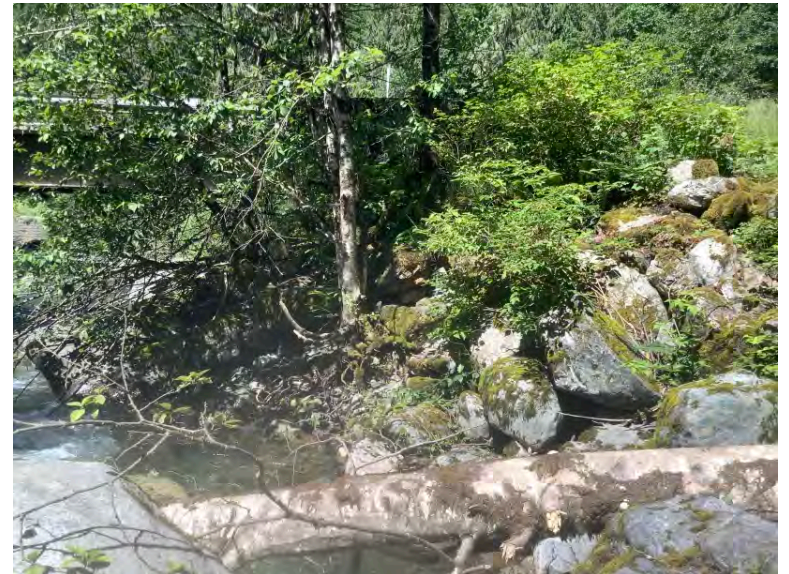
Riprap Monitor upstream right bank and downstream left bank

Scour right bank upstream

| Item | Monitor Description | Frequency |
|---|---|---|
| 1 | Upstream right and downstream left riprap | Routine Inspection |

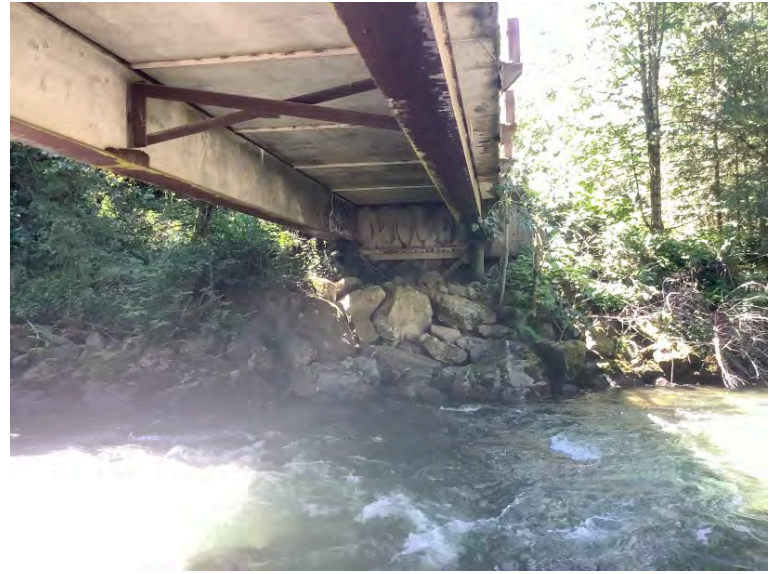
Left Bank Abutment when facing downstream

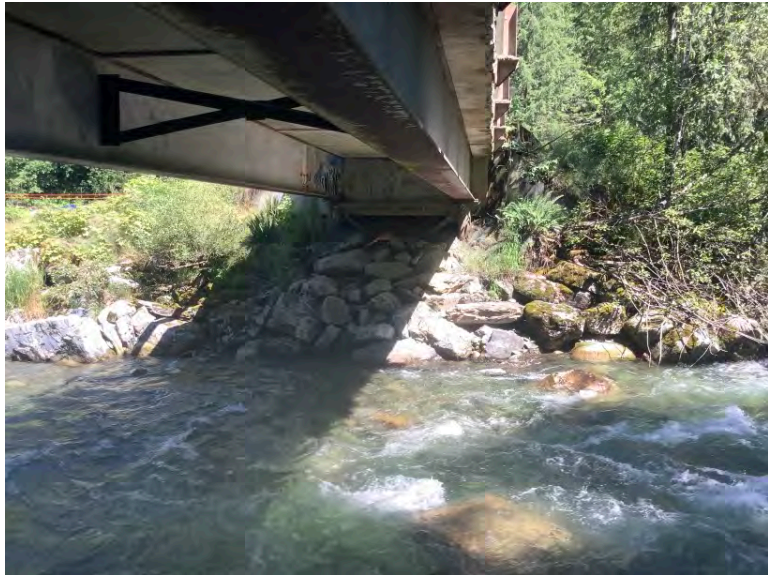
Right Bank Abutment when facing downstream

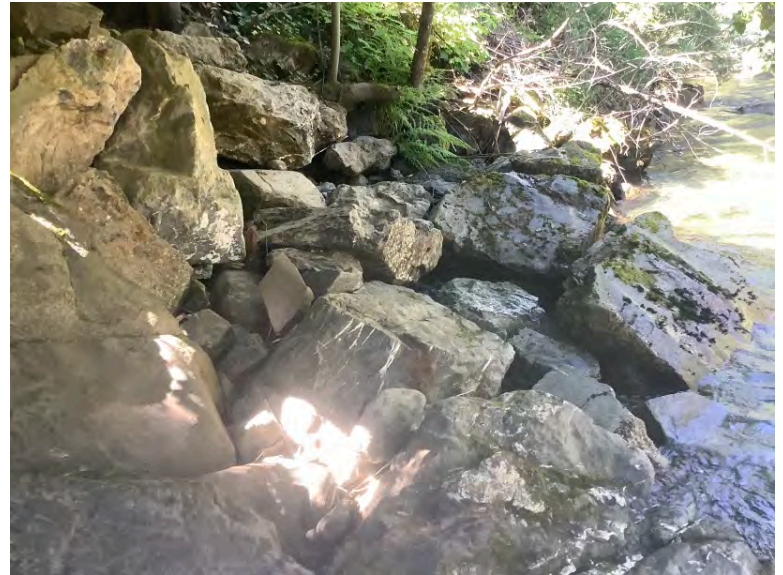
Mobilized riprap downstream left bank
