CK-2085  
CK-2085

CENTRE 0.1km

2022 Inspection

Crossing Name Chilliwack River

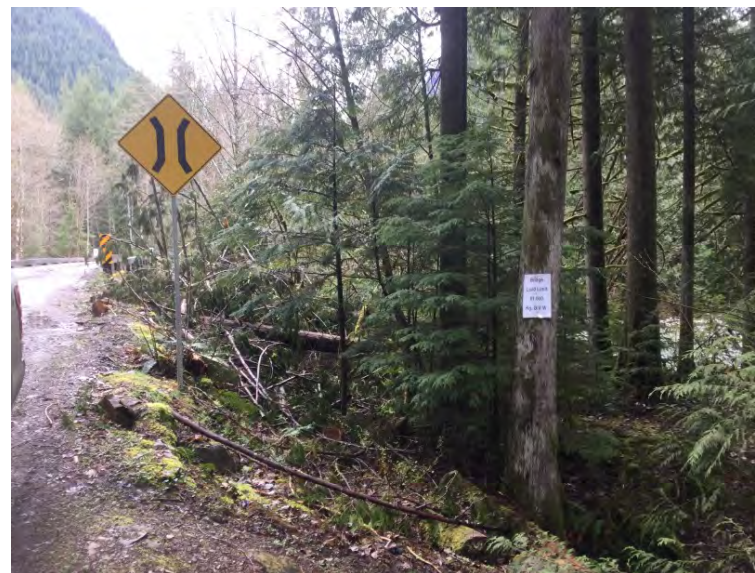
Load Rating Sign

Posted Load Rating **81000**

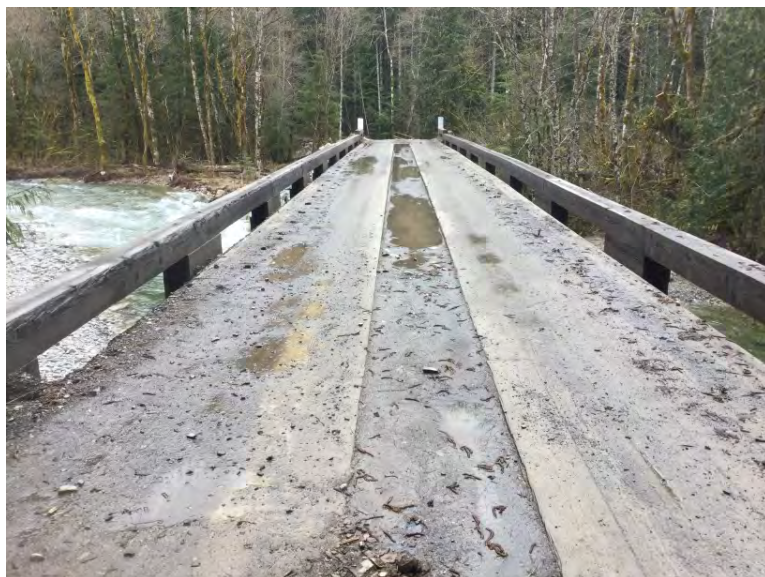
Overall Deck Condition      **Good**

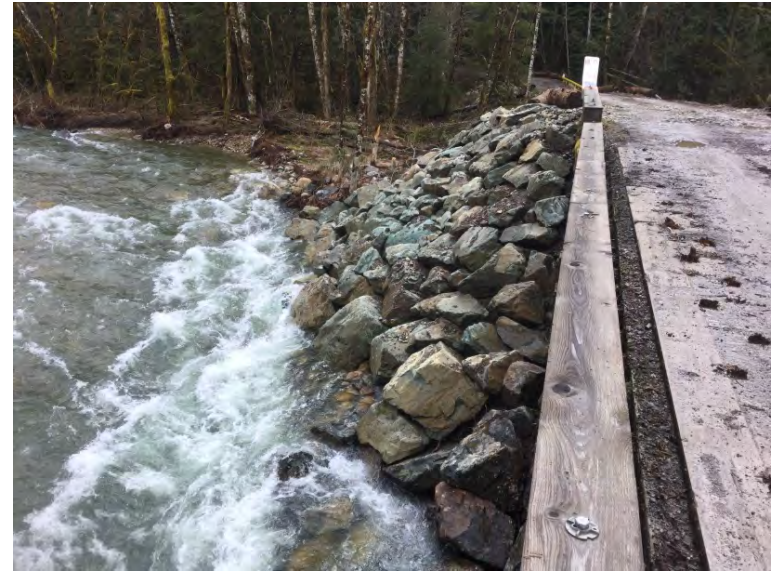
Upstream left bank riprap

Riprap **Good**

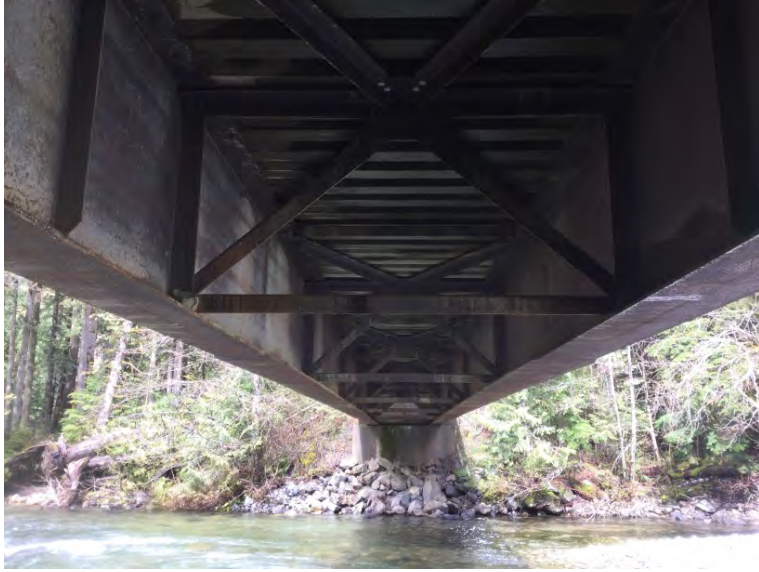
Superstructure

Girders Fair

Diaphragms Fair 7 bolted bays

Bracing Fair

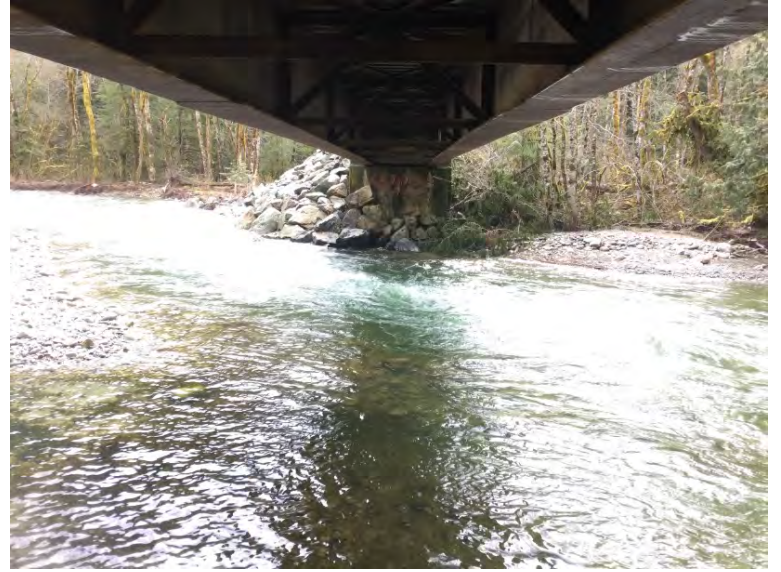
Left Bank Abutment when facing downstream

Bearings **Fair** Bearing bolts bent towards fill approach on left abutment - no apparent difference from last inspection
