CK-2099  
CK-2099

## FLORENCE LAKE 13.8km

2022 Inspection

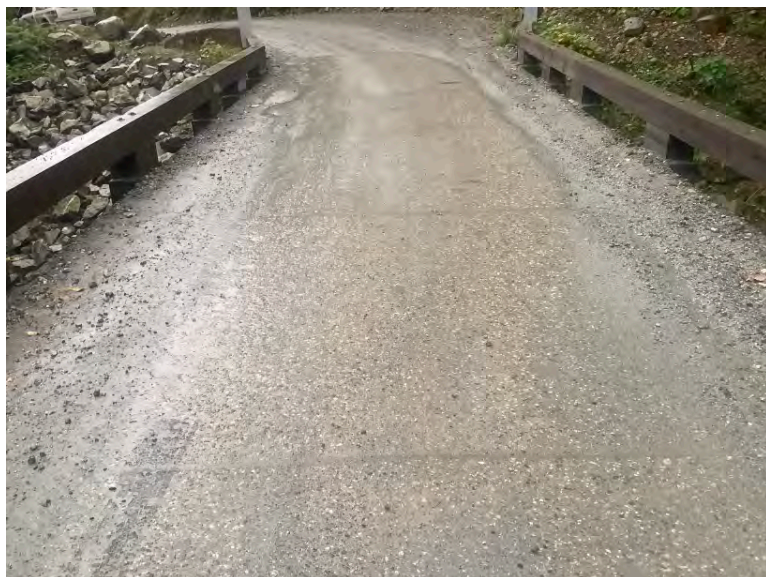
Deck

Sediment on deck

Water drips onto girder, more corrosion at these locations

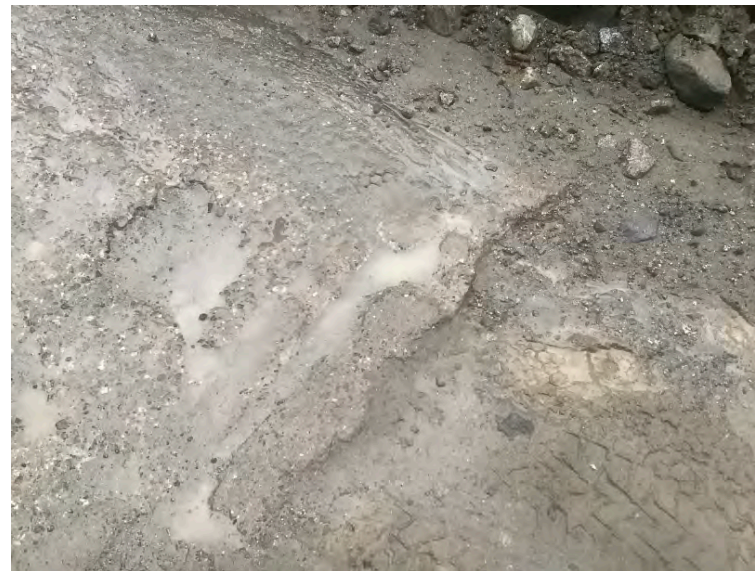
Ballast Wall Poor Downstream right still requires repairs.

Downstream right top ballast wall damage

Load rated by: MoF Sasha Ward RPF, P.Eng Feb 15 2023  
Load rating: 68 tonne or L75 to continue  
Comments: requires repair to right bank ballast wall and deck panel #1- as per Concrete Repair Guide for Concrete Bridge Components (MoFLNRO 2017)  
Next inspection: 2024

| Repair Item | Repair Description |
|---|---|
| 1 Structure. Concrete structural maintenance. m².<br>Priority:High | Repair right ballast wall |

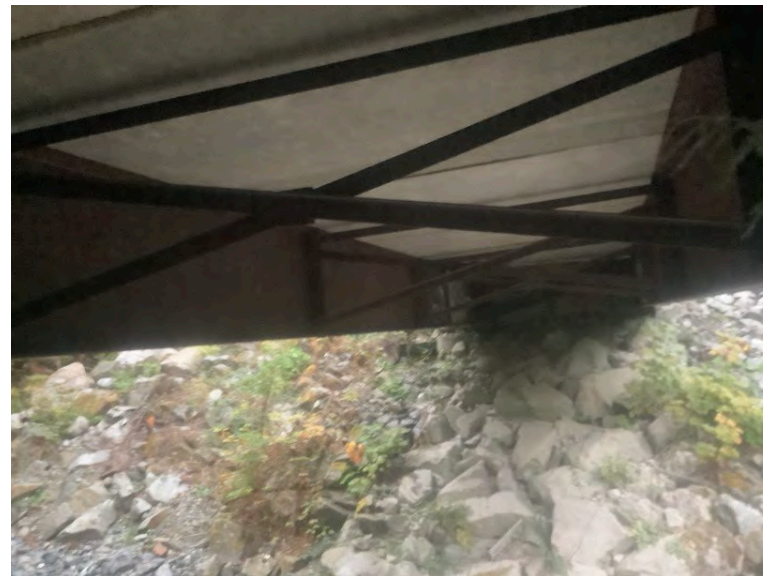
Superstructure

Minor corrosion

5 bolted bays, minor corrosion
