CK-2109  
CK-2109A

HARRISON EAST 35.3km

2022 Inspection

Crossing Name Hornet Creek

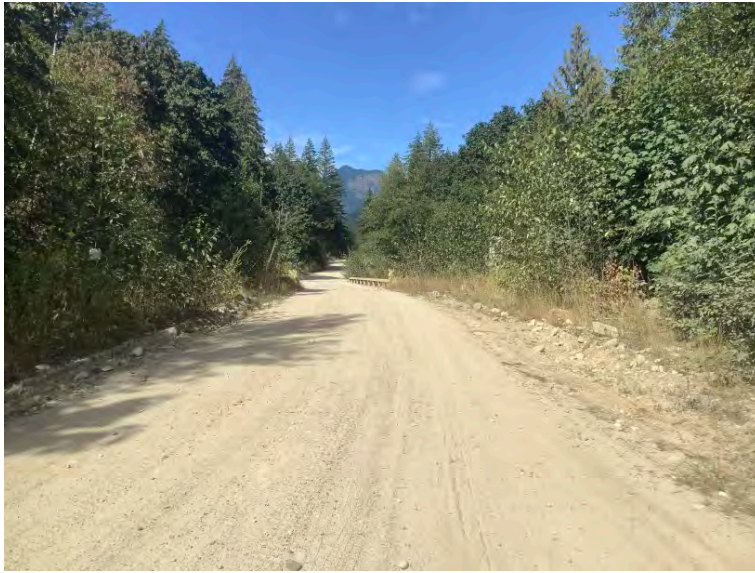
Approach from Left Bank when facing downstream

brushing required around structure

Road Surface **Fair**

Small potholes each end

| Repair Item | Repair Description |
|---|---|
| 1 Approach. Area/sight line brushing. m². Priority:Low | Brush around structure |
| 2 Approach. Approach fill repair. m³. Priority:Low | Small potholes |

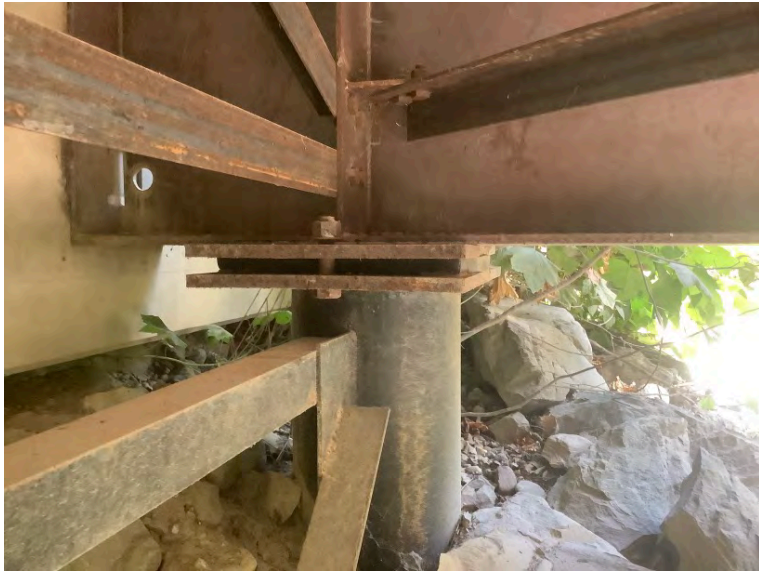
Bearing

Load rated by: MoF Sasha Ward RPF, P.Eng Feb 17 2023  
Load rating: 136 tonnes or L150  
Comments: monitor bearing pads, some bulging observed  
Next inspection: 2024

Bearings **Fair**

Bulging
