CK-2110  
CK-2110B

HARRISON EAST 38.5km

2022 Inspection

Crossing Name Clear Creek (structure # 29)

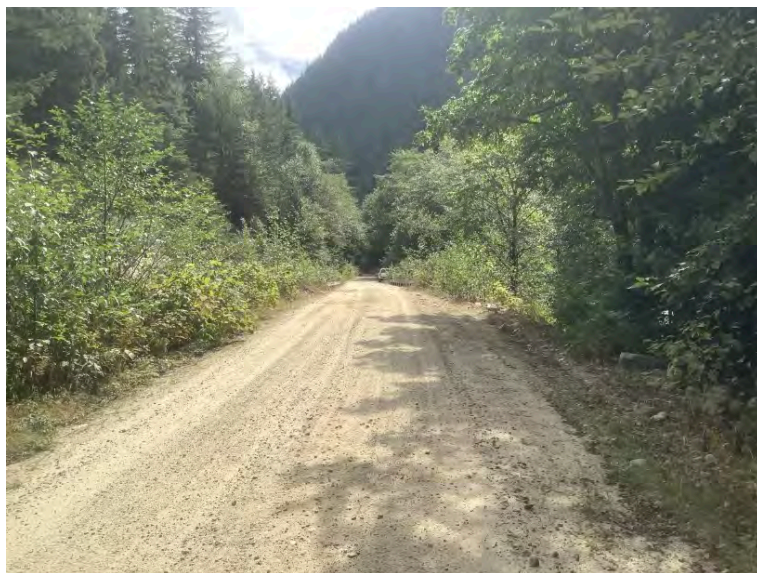
Approach from Right Bank when facing downstream

Fender Condition **Fair** Woods downstream bullnose needs to be repositioned back onto shoulder

Road Surface **Fair** Minor potholes each end of structure

| Repair Item | Repair Description |
|---|---|
| 1 Approach. Approach fenders (re-Install). # of units.<br>Priority:Low | Bull nose to be reinstalled |

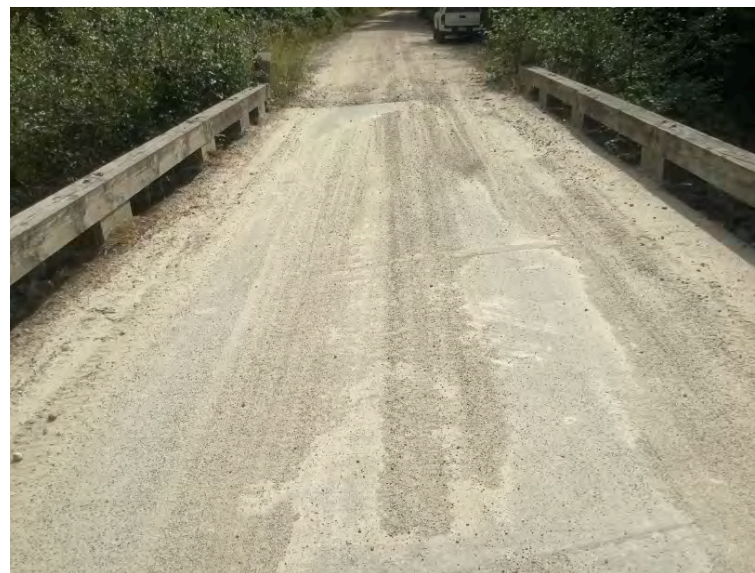
Running Surface      **Good**      Minor potholes each end of structure

Deck Joints      **Fair**      Some stick proud of deck

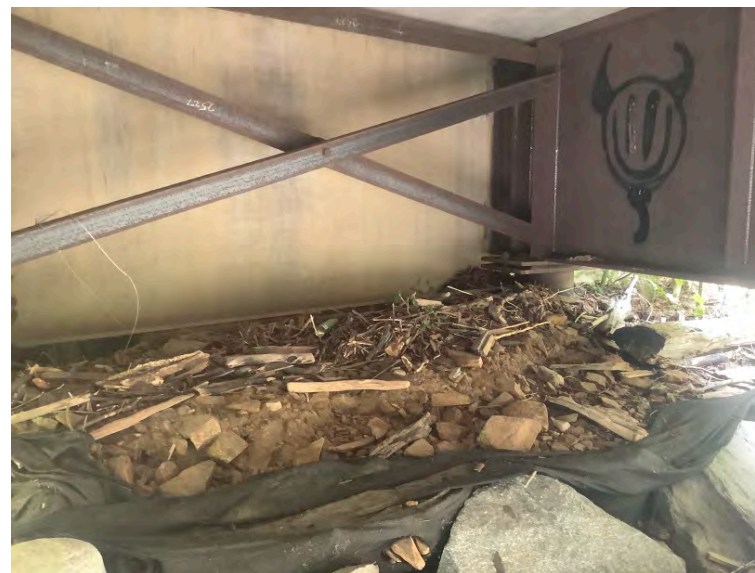
Comments Woody debris and small gravels on top of downstream bottom flange.

Deposited woody debris
