# BC Ministry of Forests, Lands, and Natural Resource Operations

## Permanent Bridge Inspection Report

| Site #: | CK-2111 | Structure Name: | CK-2111 | Road Name: | HARRISON EAST | Inspection Date: | 2022/08/31 |
| KM: | 48.90 | User km: | 47.20 | Crossing Name: | Big Silver River | Next Inspection Date: | 2023/05/15 |

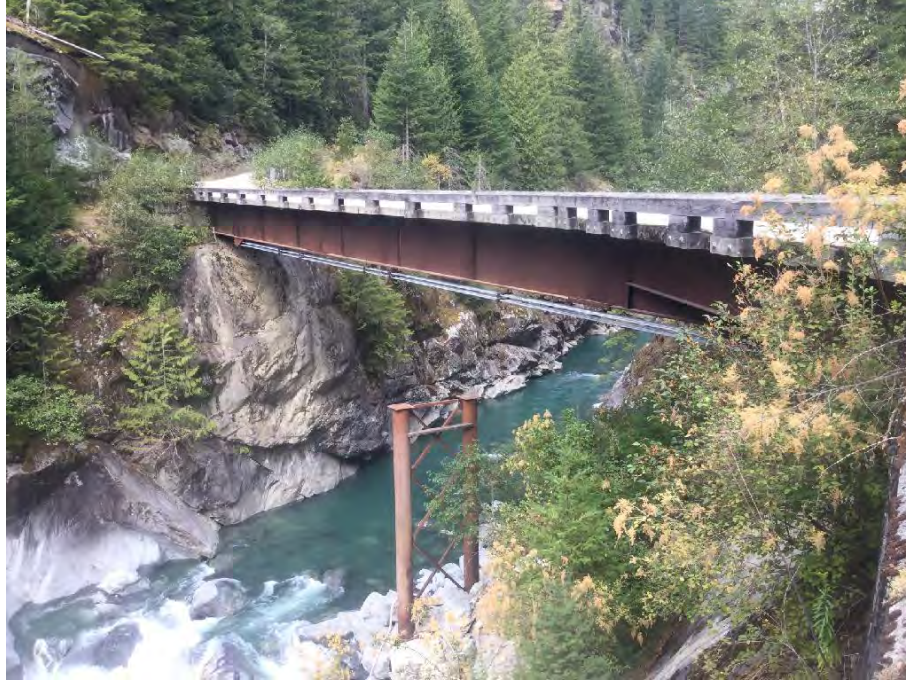
**Photo 1**  
Bridge elevation from downstream

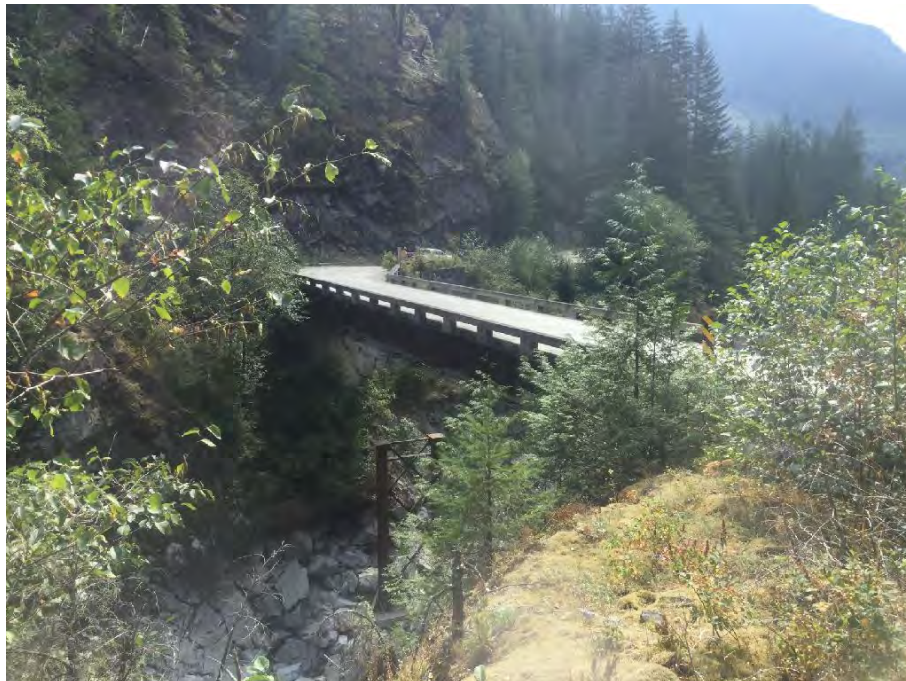
**Photo 2**  
Bridge elevation from upstream

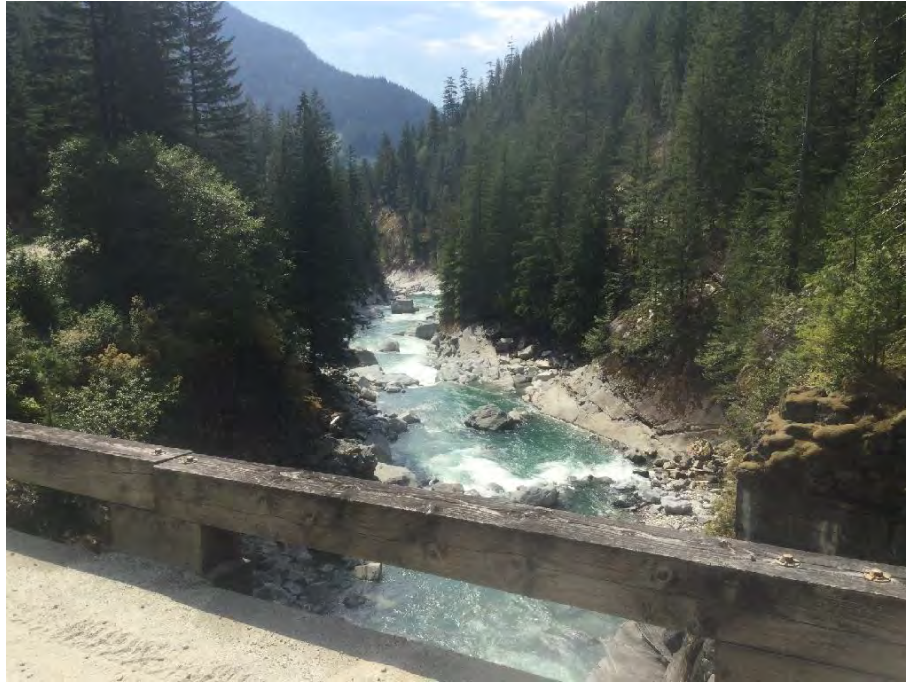
**Photo 3**  
Looking downstream

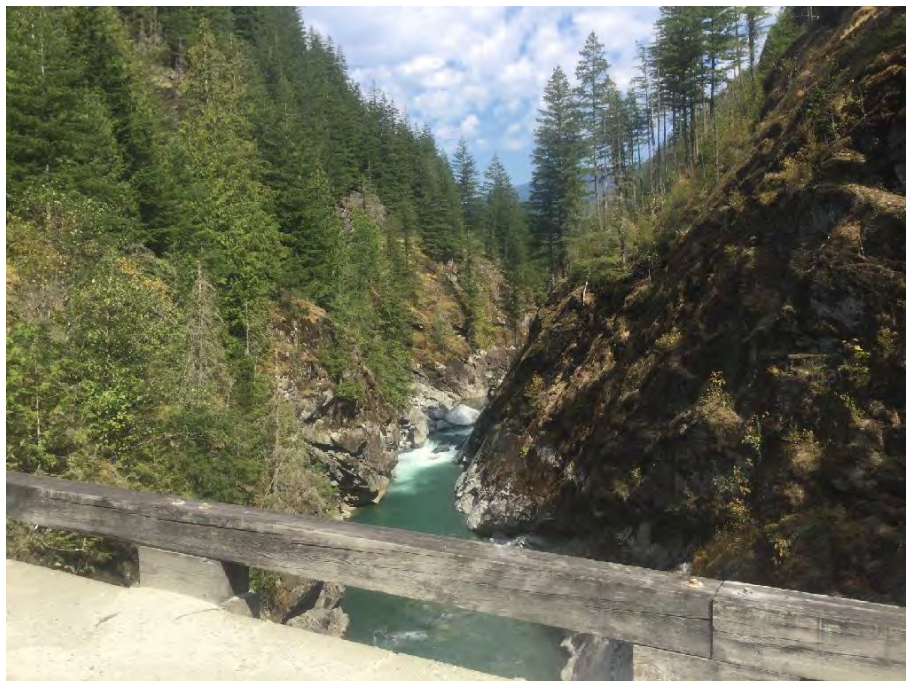
**Photo 4**  
Looking upstream

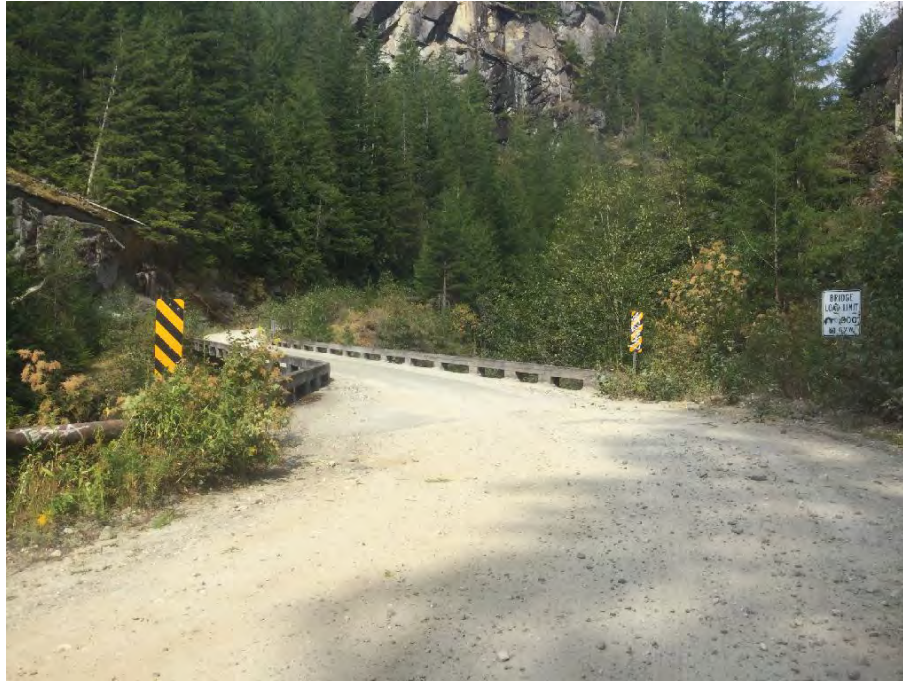
**Photo 5**  
Left approach looking towards bridge

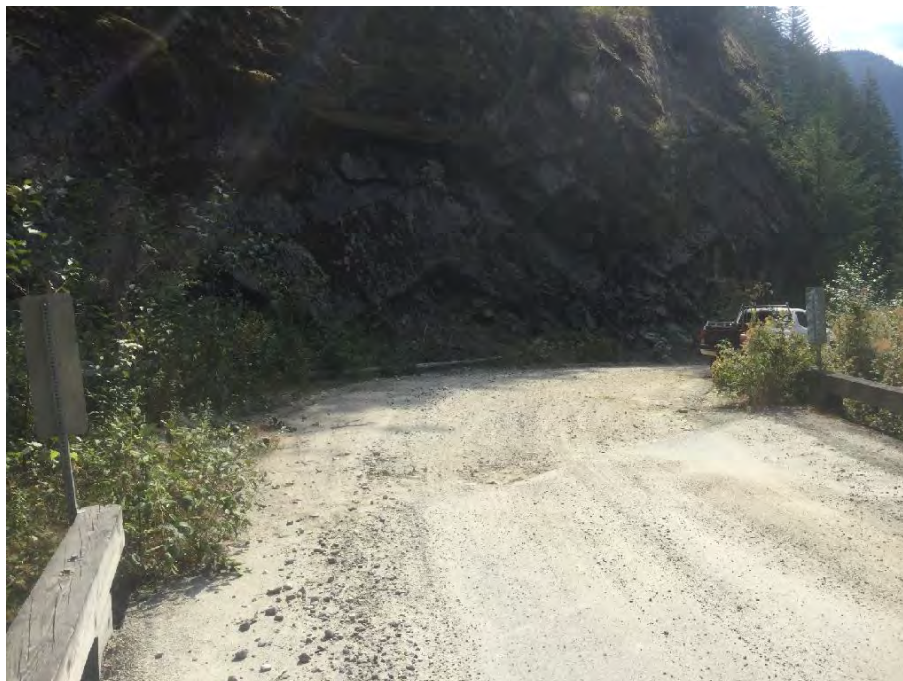
**Photo 6**  
Left approach looking away from bridge

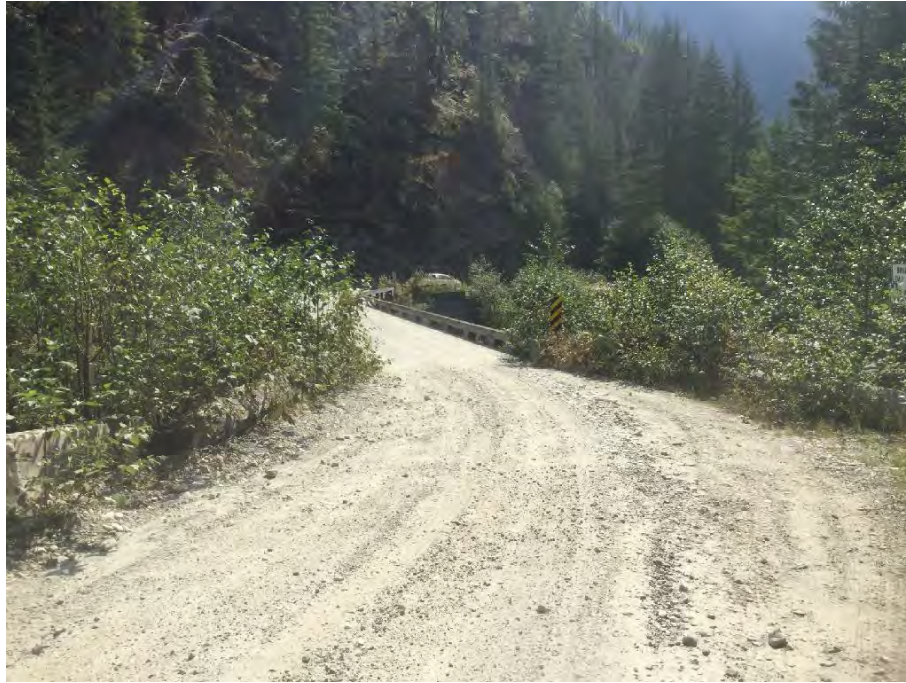
**Photo 7**  
Right approach looking towards bridge

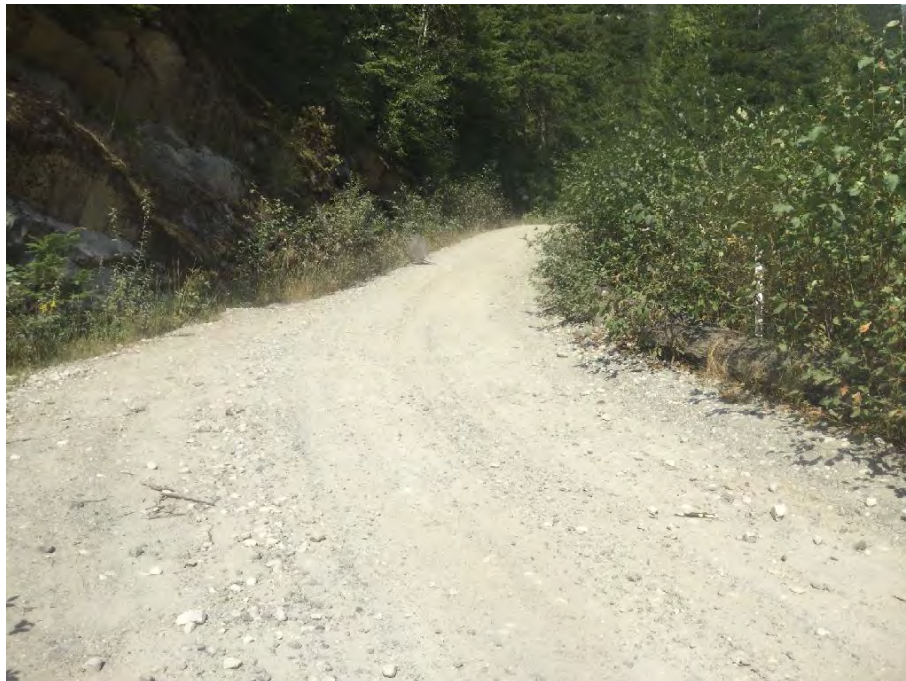
**Photo 8**  
Right approach looking away from bridge

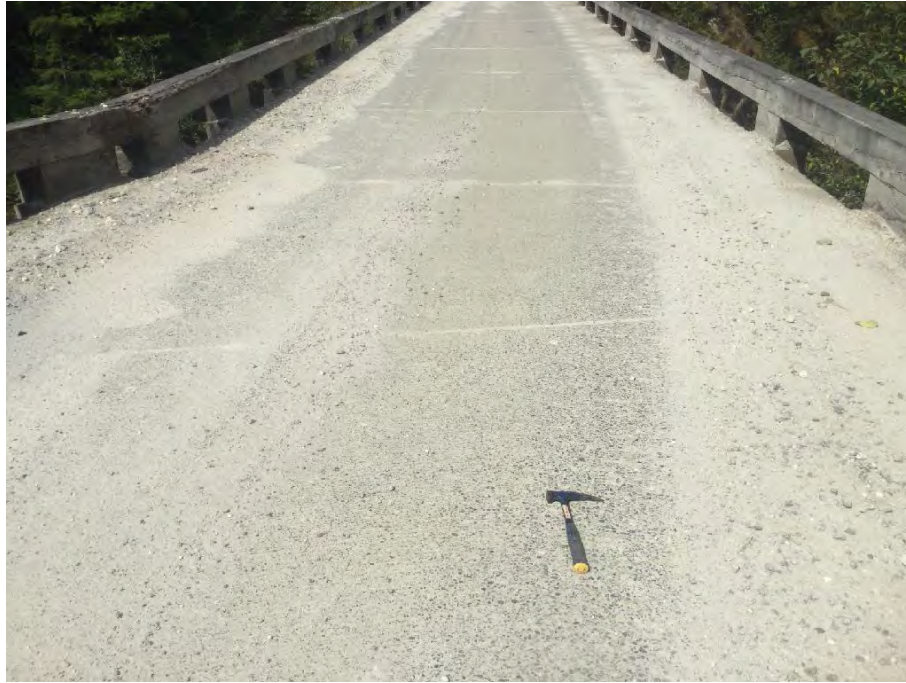
**Photo 9**  
General deck condition

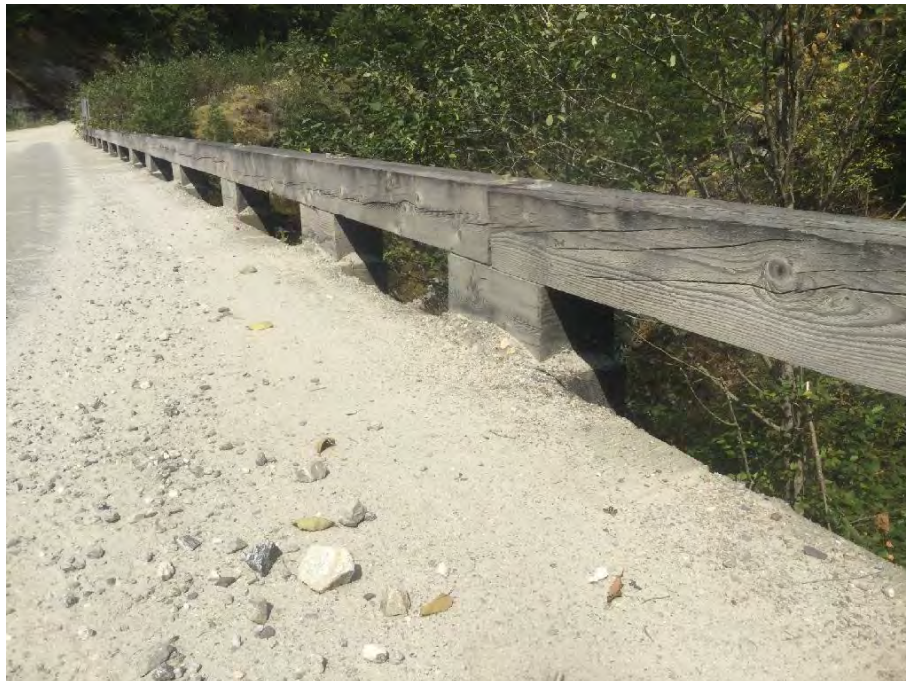
**Photo 10**  
General railing condition

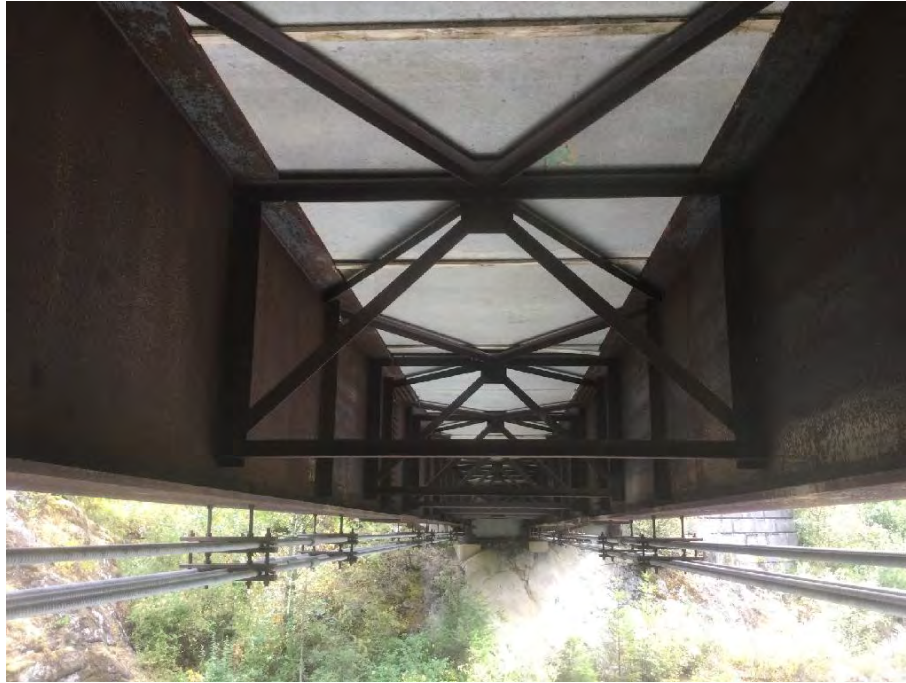
**Photo 11**  
Underside of deck condition

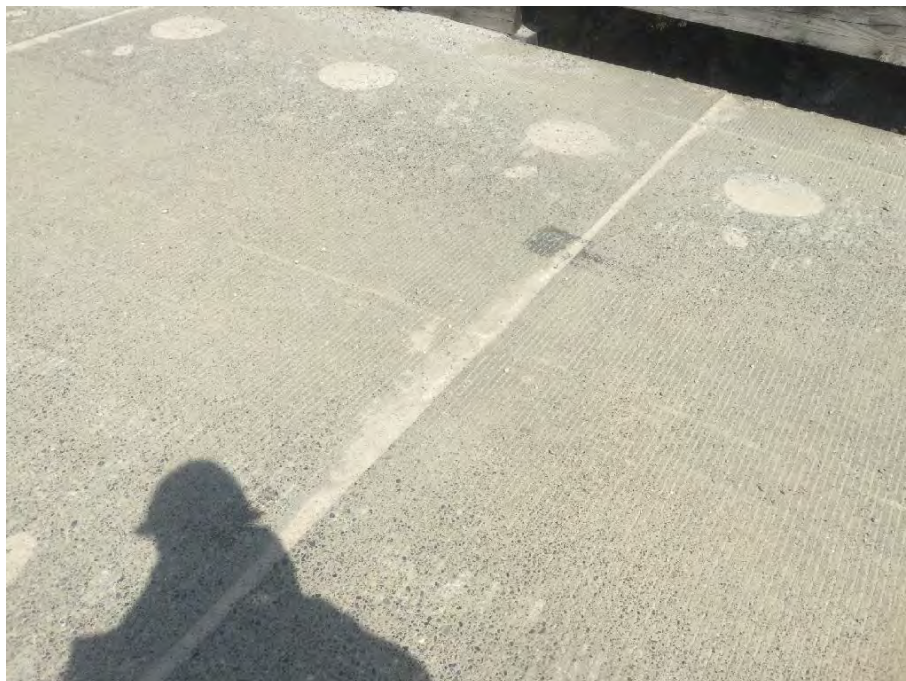
**Photo 12**  
Typical joint and grout condition

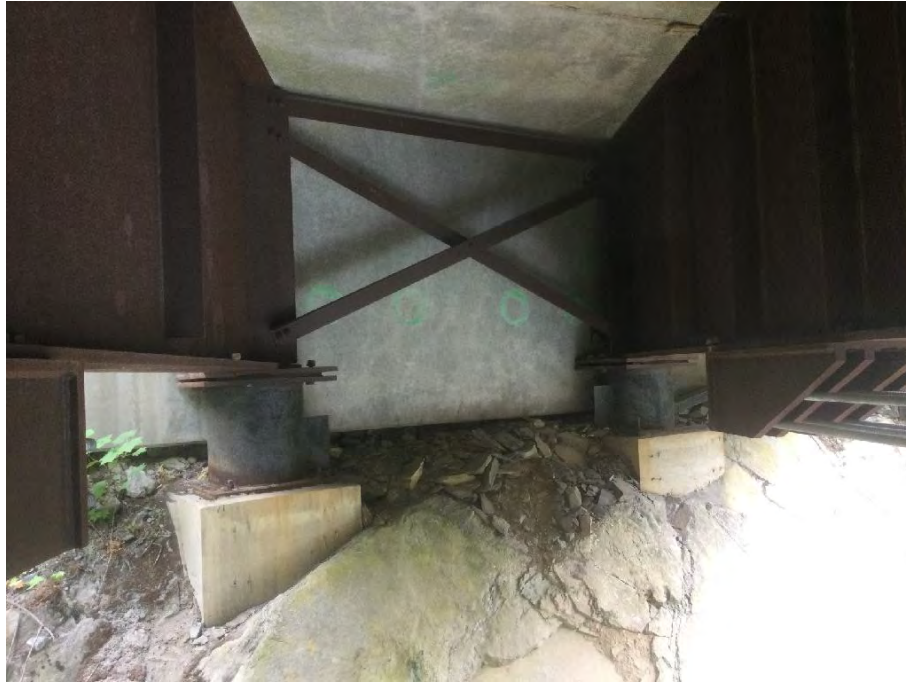
**Photo 13**  
Left abutment

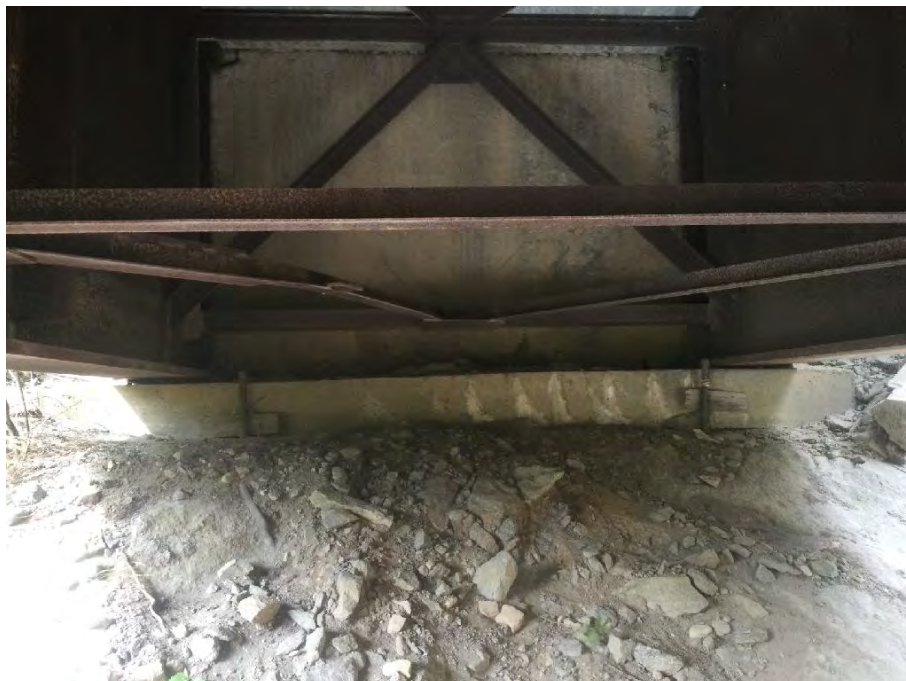
- The abutments are in fair condition.
- No issues noted in the cast-in-place concrete footings.
- Right ballast wall has moderate spalling at the sill, no rebar exposed.
- Bearing pads are bulging.
- Broken anchor bolts at left abutment indicating inadequate allowance for expansion.
- Right downstream wing wall is leaning towards stream but appears stable.

**Photo 14**  
Right abutment

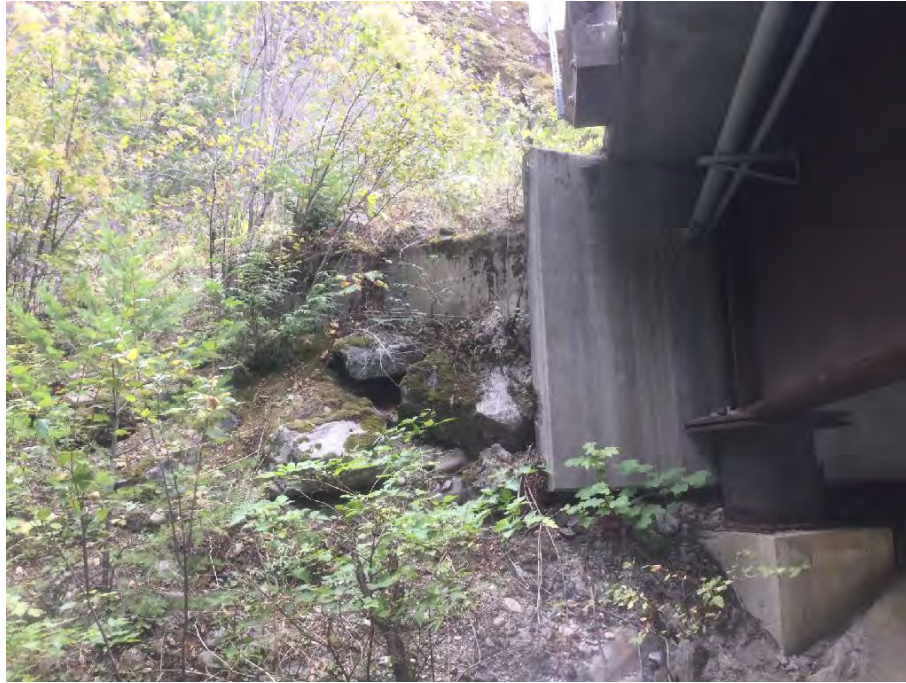
**Photo 15**  
Left upstream wing wall

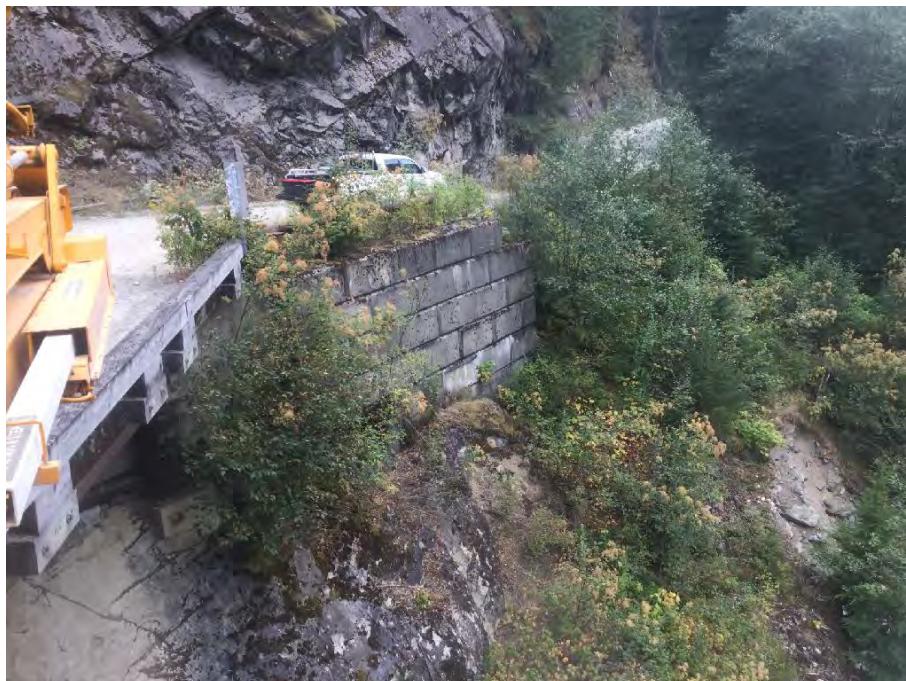
**Photo 16**  
Left downstream wing wall

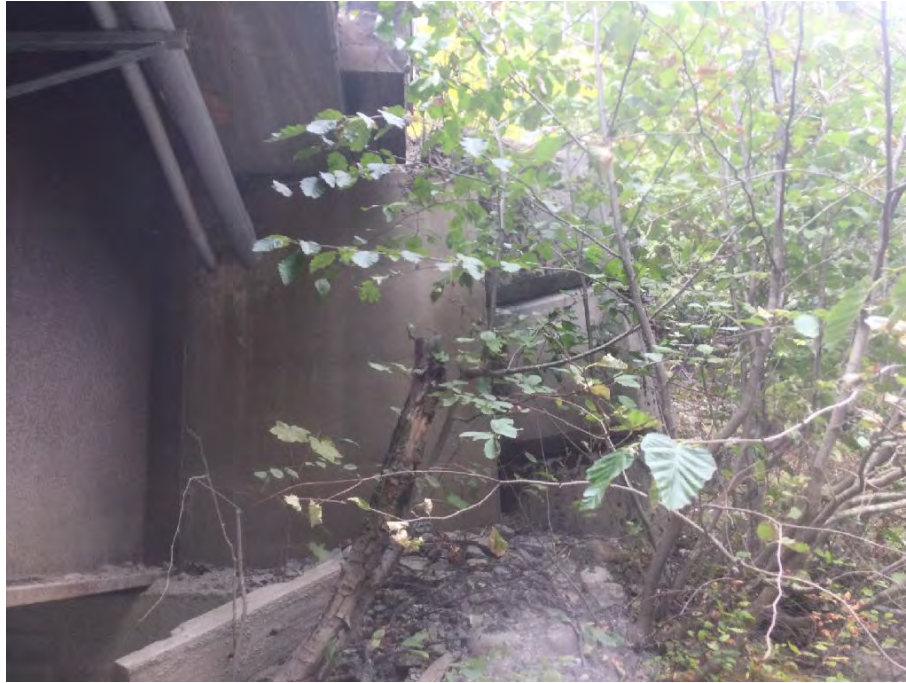
**Photo 17**  
Right upstream wing wall

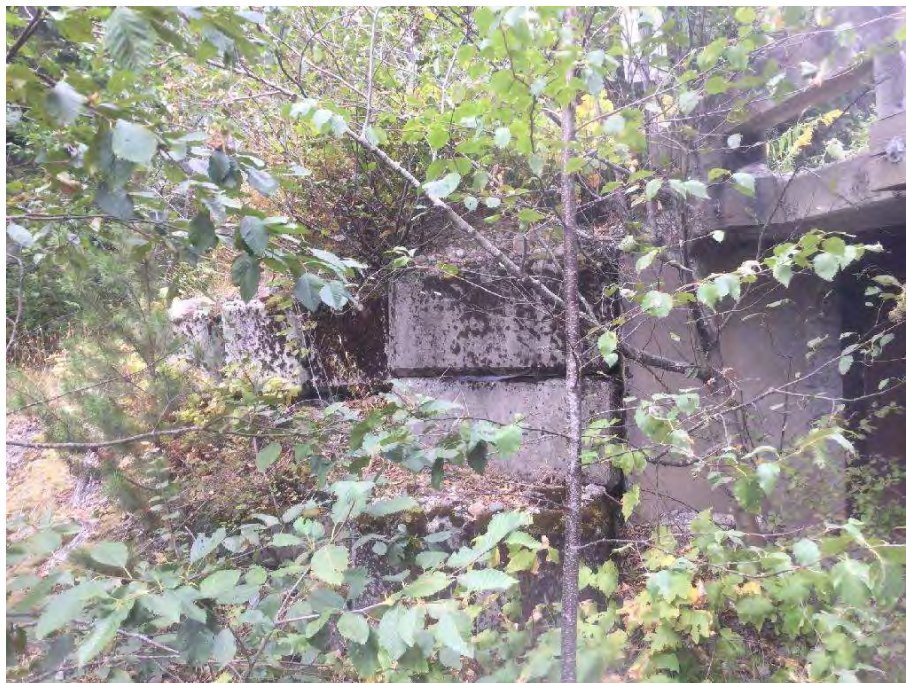
| Wing Wall | Fair | downstream right is leaning towards stream but appears stable |

**Photo 18**  
Right downstream wing wall

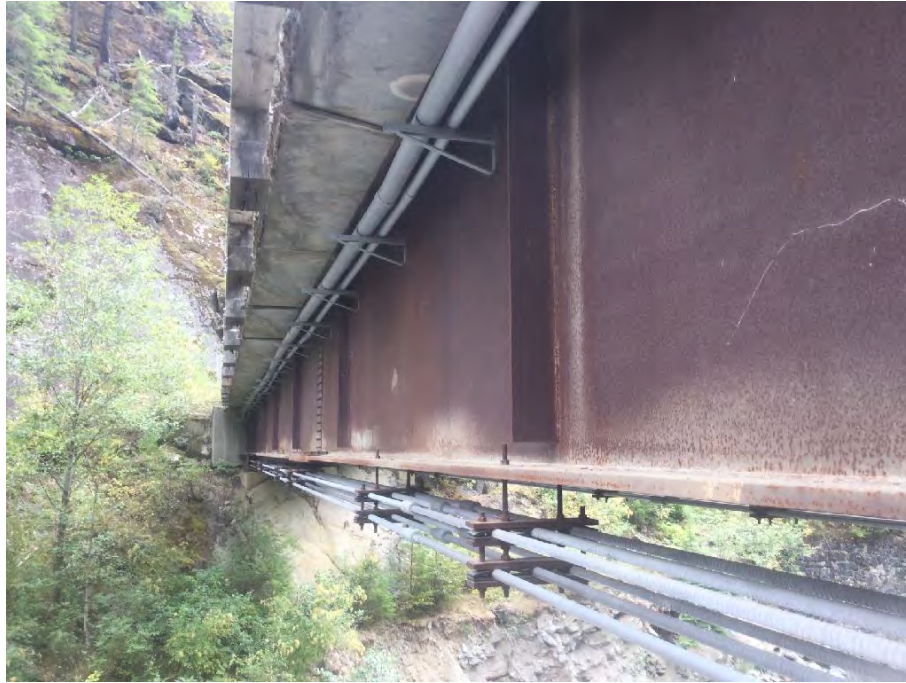
**Photo 19**  
Typical girder condition

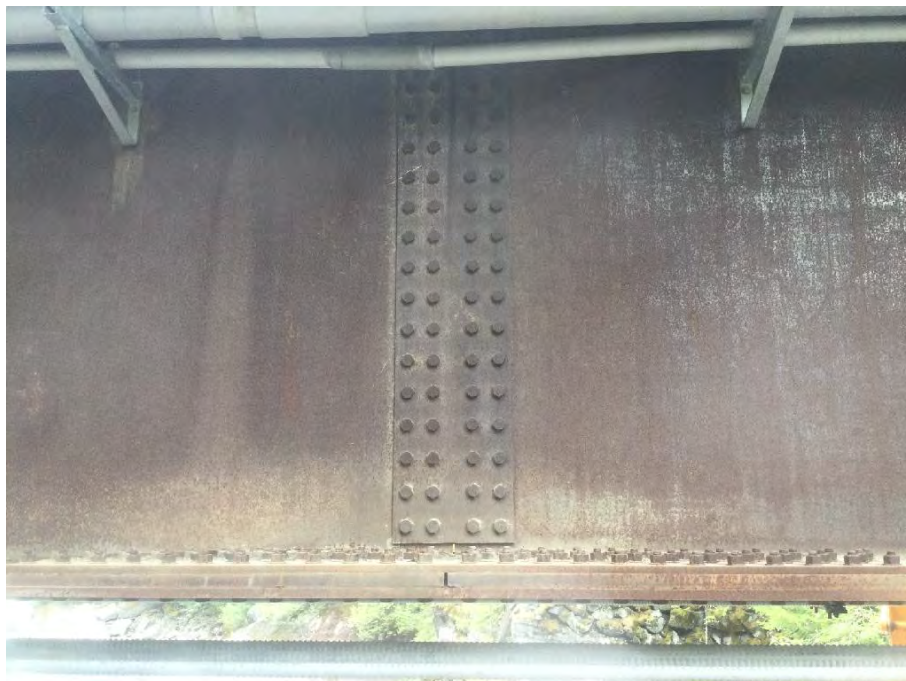
**Photo 20**  
Typical splice condition

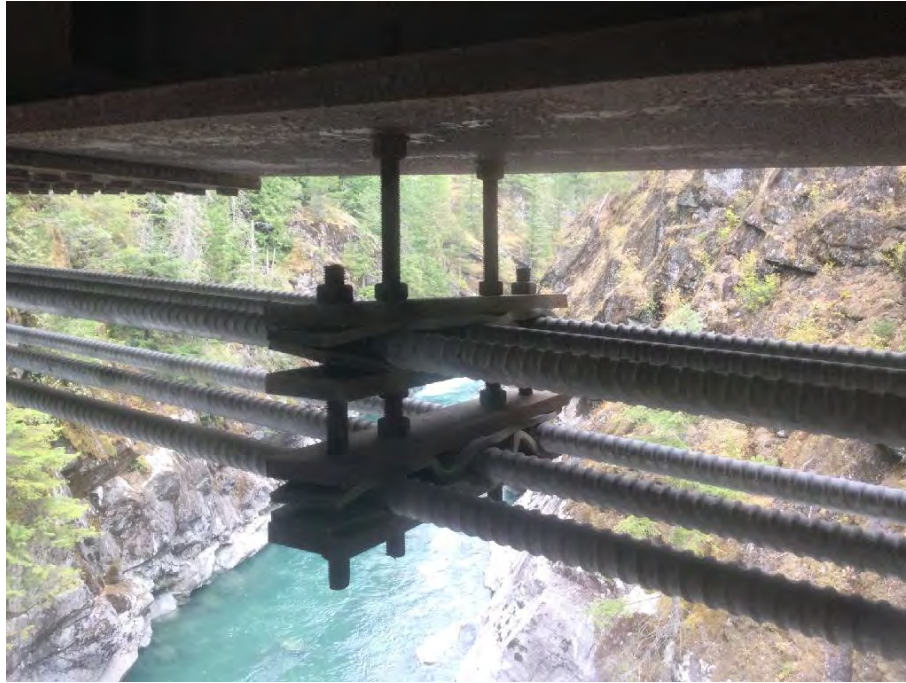
**Photo 21**  
Typical hangar and rod condition

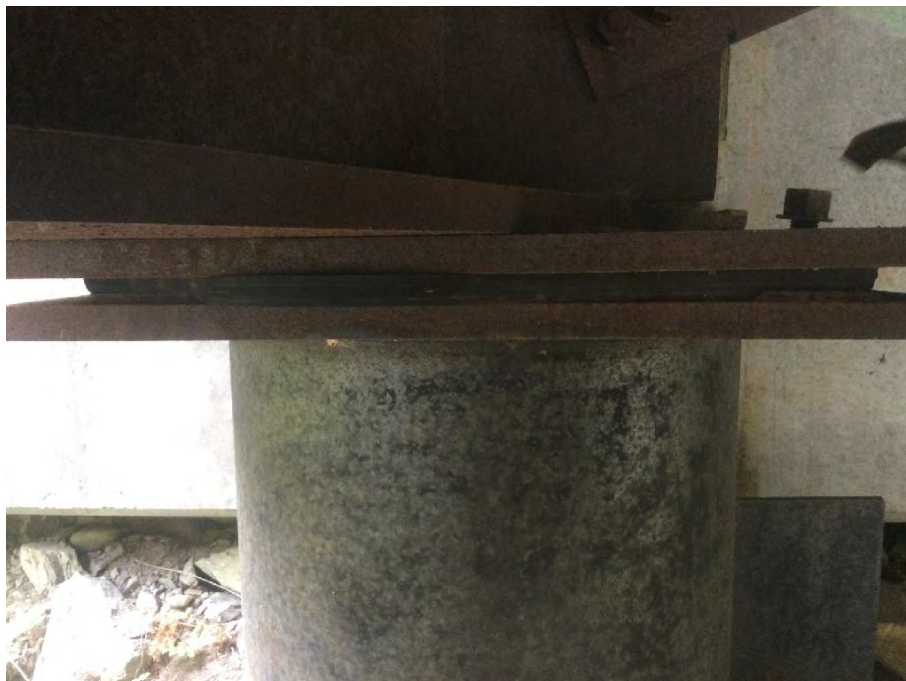
| Bearings | Fair | broken anchor bolts at left bank indicating inadequate allowance for expansion, bearing pads buldging |

**Photo 22**  
Typical bearing condition

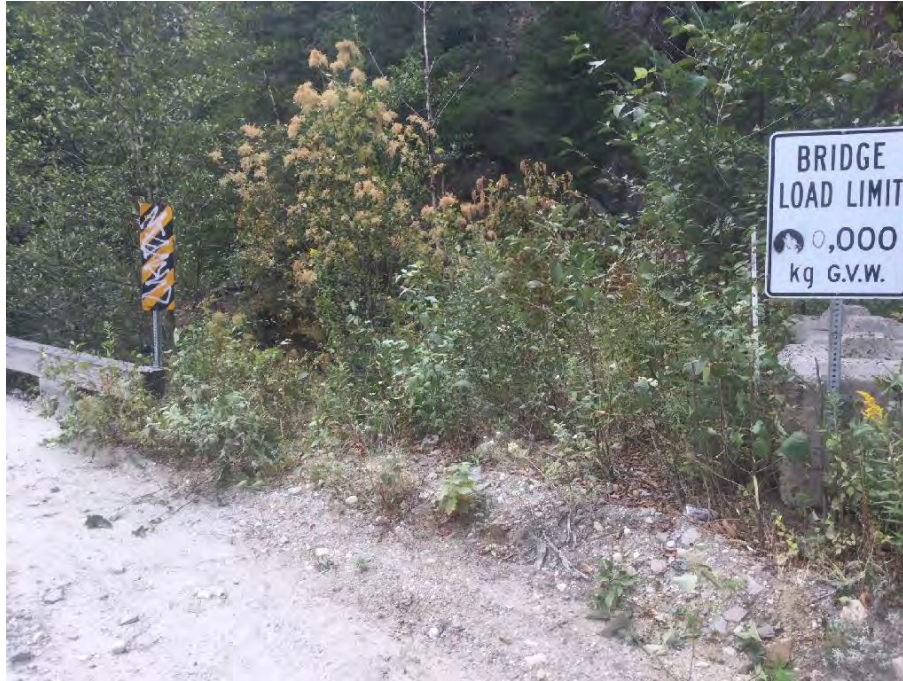
**Photo 23**

| Bridge Ahead Signs Missing | 0 | vandalized limiting functionality |
| Fender Condition | Fair | Missing upstream left approach |

Left upstream approach barrier missing and load posting vandalized

| Item No. | Description | Priority |
|---|---|---|
| 1 | Replace load rating signage | High |
| 5 | Install left upstream approach barrier | Medium |

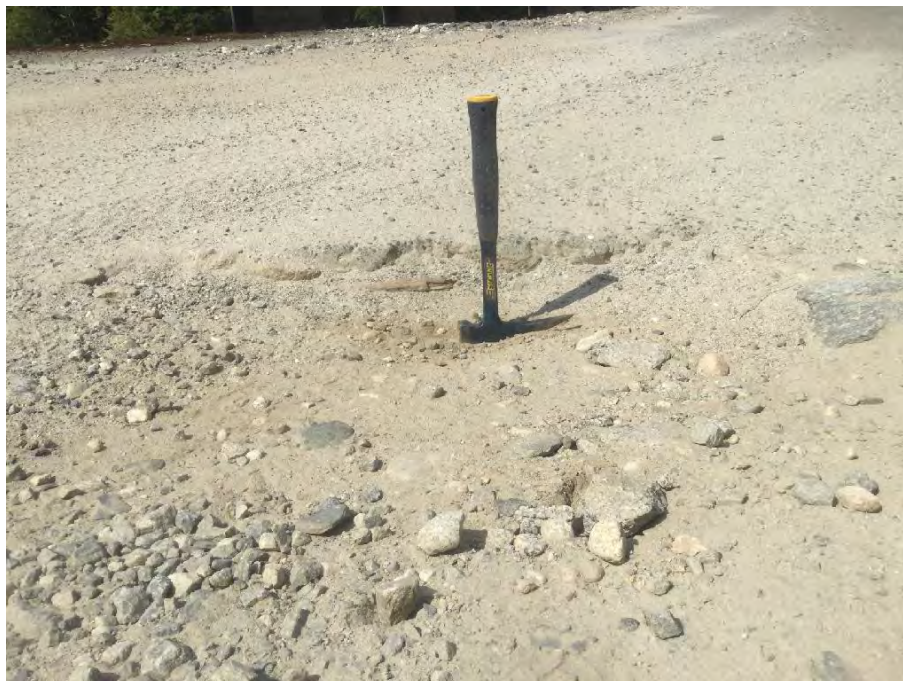
**Photo 24**

Left approach deck mechanical damage and rutting

| Item No. | Description | Priority |
|---|---|---|
| 4 | Regrade left approach to reduce further deck damage | Medium |

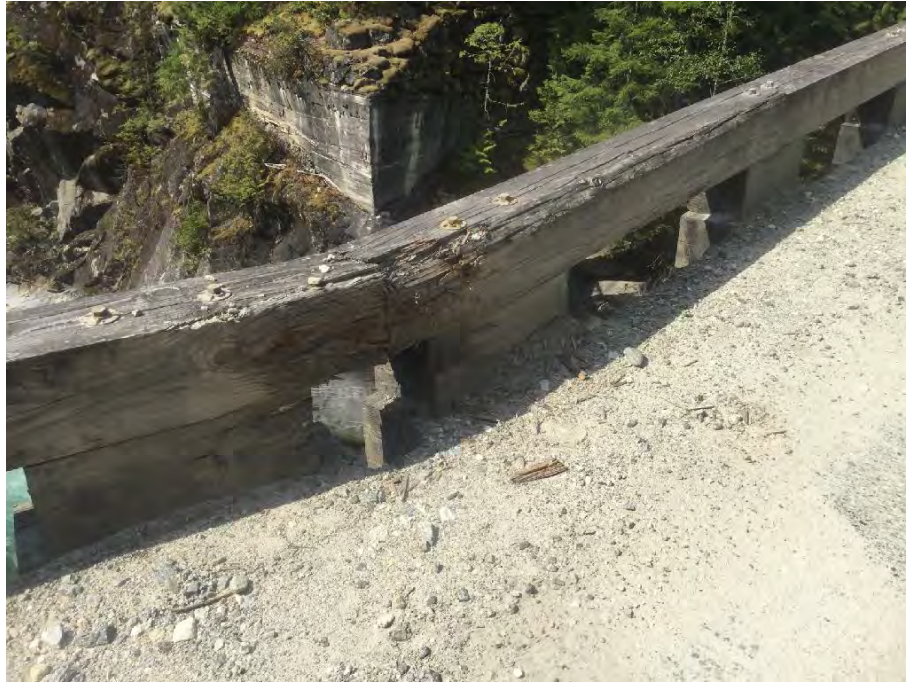
| Curb Rail/Blocks/Posts | Fair | minor impact damage at flared corner |

**Photo 25**  
Downstream railing damage at flare corner

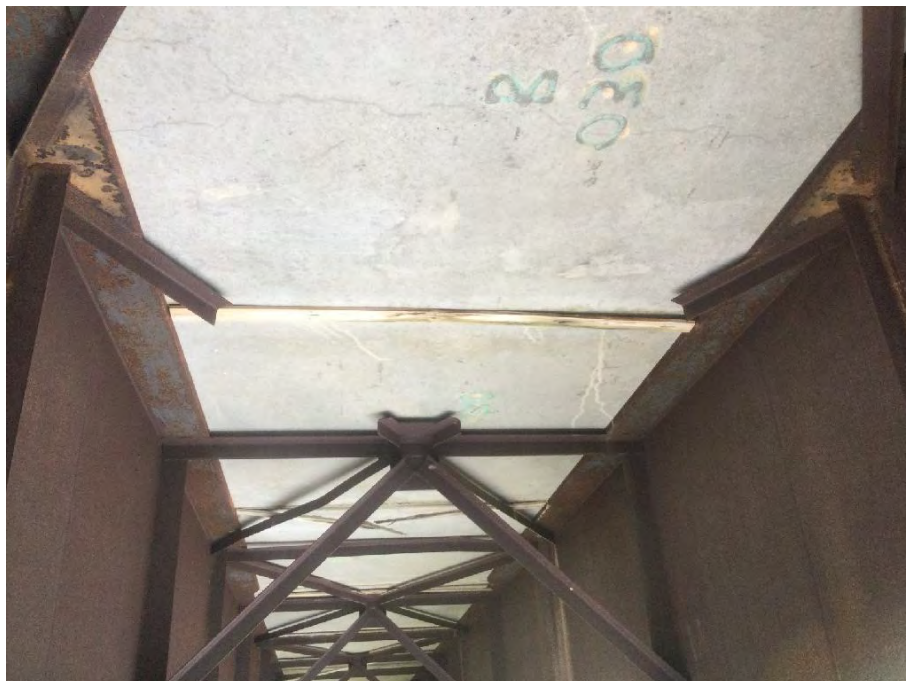
| Bracing | Fair | missing plan bracing near mid-span |

**Photo 26**  
Missing plan bracing near mid-span

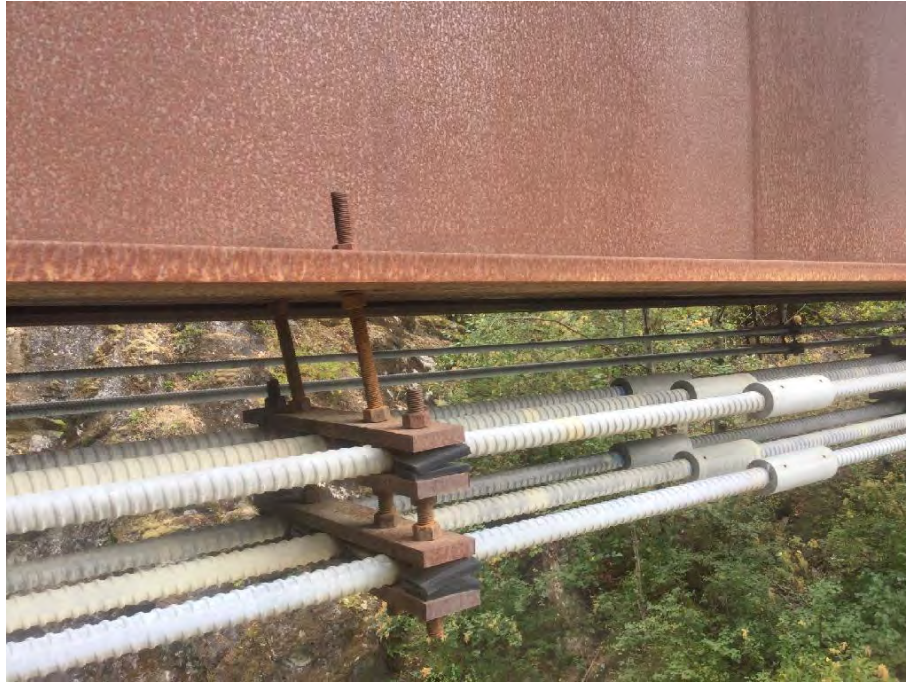
- The girders are in good condition with no issues noted.
- The bracing and dywidag post-tensioning rods are in fair condition.
- Dywidag post-tensioning rod hangers on right half of bridge are leaning towards the left approach and rubber pads are bulging, indicating there is inadequate allowance for expansion.
- Missing plan bracing near mid-span.
- Bent plan bracing at right abutment.

**Photo 27**  
Downstream hangers angled

| | 20 | Suggested | Medium | \$ 0.00 | Retorque the dywidag thread bar post-tensioning nuts to design specification |

| | 9 | Monitor dywidag post-tensioning rod hangers on right half of bridge for additional movement | | | | | | |

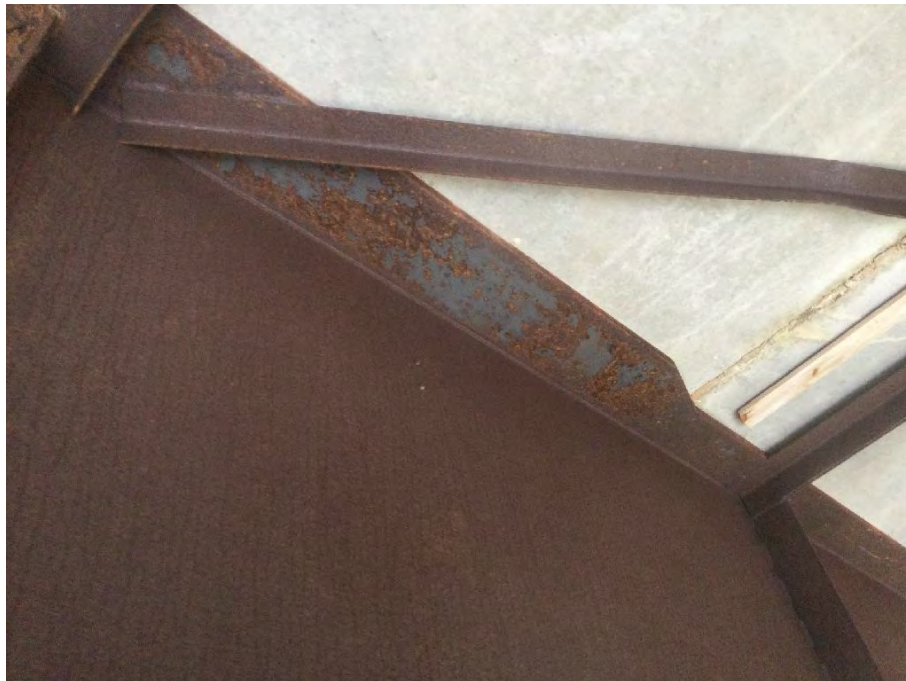
**Photo 28**  
Typical top flange corrosion

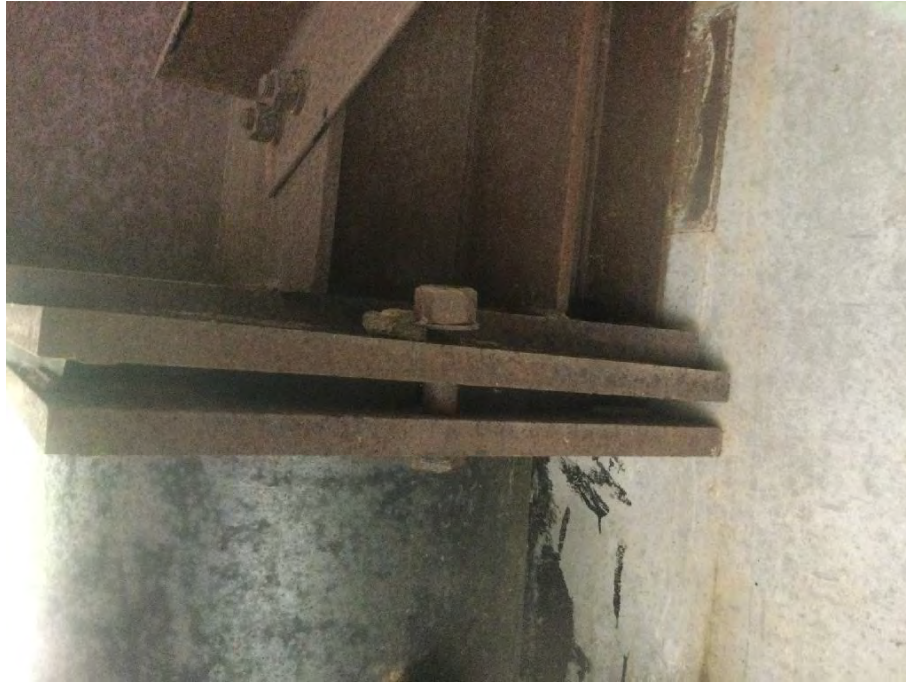
**Photo 29**  
Failed anchor bolt

| | 8 | Monitor broken anchor bolts at left abutment | | | | | | |
