CK-2118  
CK-2118A

COGBURN 8km

2022 Inspection

Crossing Name Hut Creek

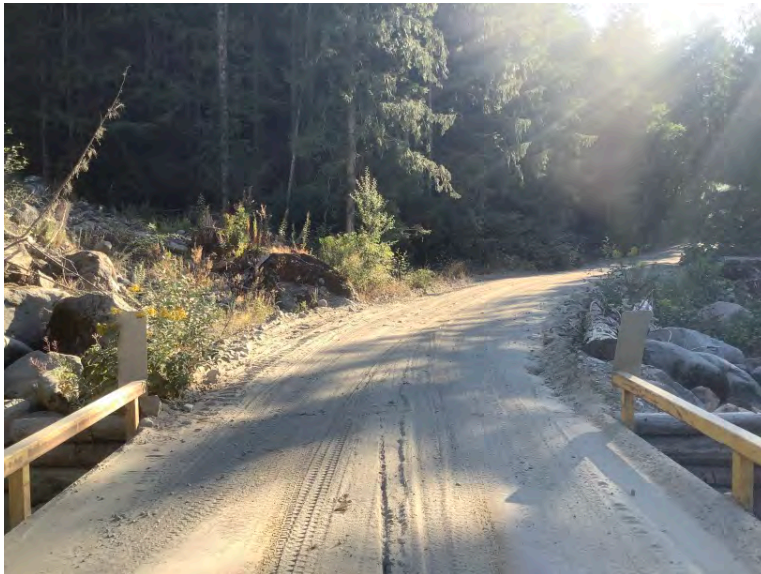
Approach from bridge deck of Left bank approach when facing downstream

Gravel berm acting as fender ds town side. No us town side fender. No us woods fender.

| 1 Approach. Approach fenders (install). # of units.<br>Priority:Low | Install fenders |

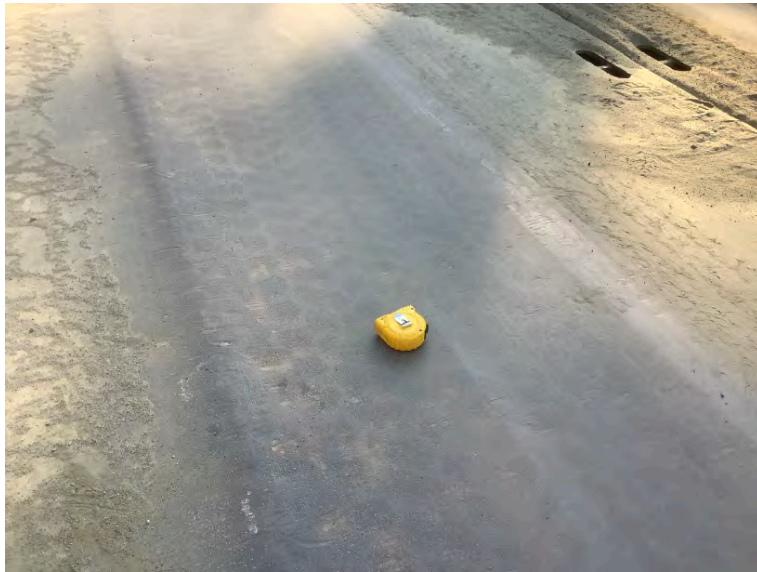
Deck

Sagging at wheel widths. No other deformation noted. Sediment accumulating on deck.

Comments: measure depth of 'sag' in steel deck plate during next inspection.

| 2 Monitor sag of steel deck plate. | | Routine Inspection |

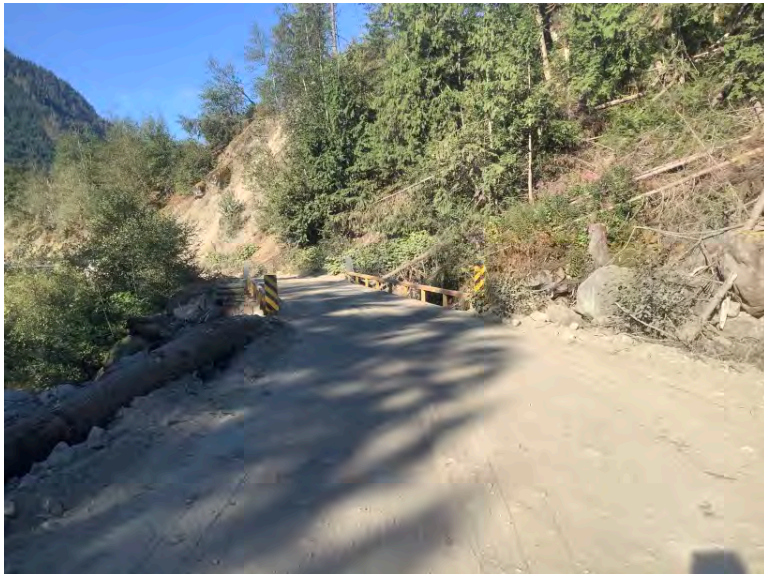
Left Bank Abutment when facing downstream

2 visible lock blocks tiers. Geogrid observed

Monitor. Scour beginning on both edges.

| Item | Monitor Description | Frequency |
|---|---|---|
| 1 Riprap scour | | Routine Inspection |
