CK-2120  
CK-2120A

BEAR 7km

2022 Inspection

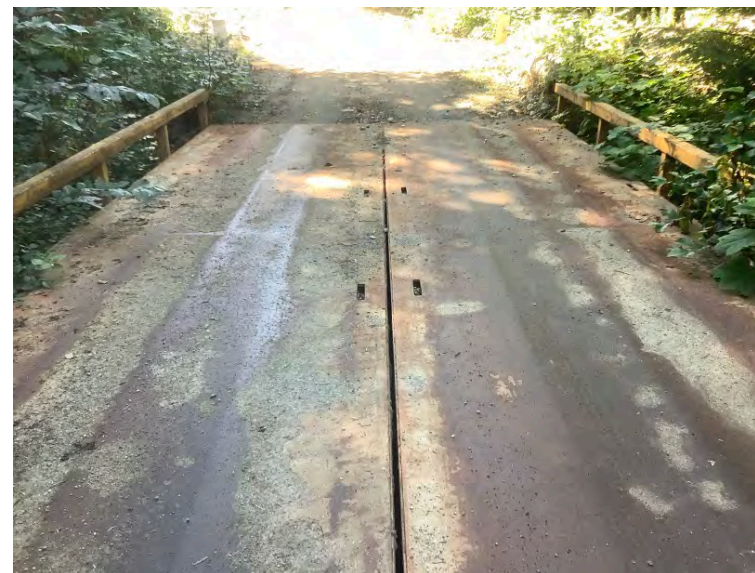
Steel Deck Plate Fair Some deformation at tracking locations. Sediment on deck

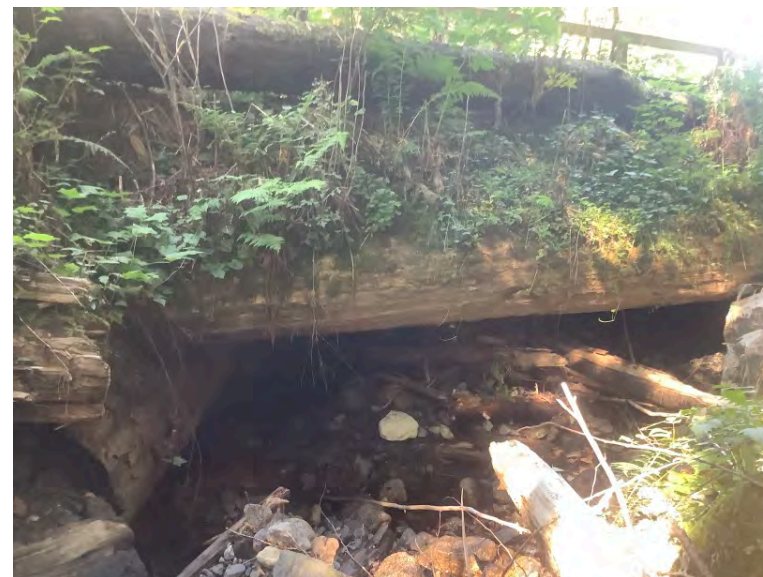
Upstream Profile

Comments Gravelly deposit beneath structure.

| Item | Monitor Description | Frequency |
|---|---|---|
| 1 | Some gravelly debris accumulating beneath. Also monitor original sill logs for scour. Non currently noted but they sit on the wetted perimeter. | Routine Inspection |
