CK-2121  
CK-2121A

BEAR 7.4km

2022 Inspection

Crossing Name Bear Creek

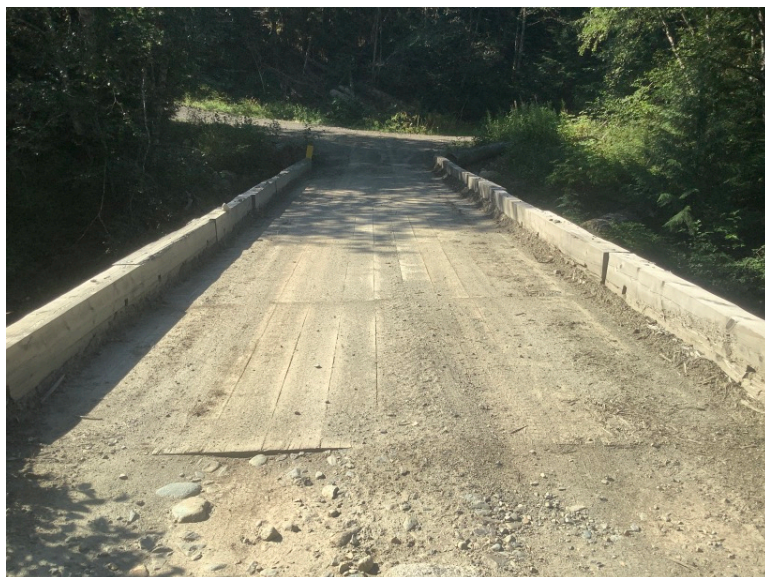
Deck to Girder Bolts      Poor      Does not appear to be fastened to girder. 6x6 fastened to underside of panel tight to outside edge of top flange to restrict laterally.

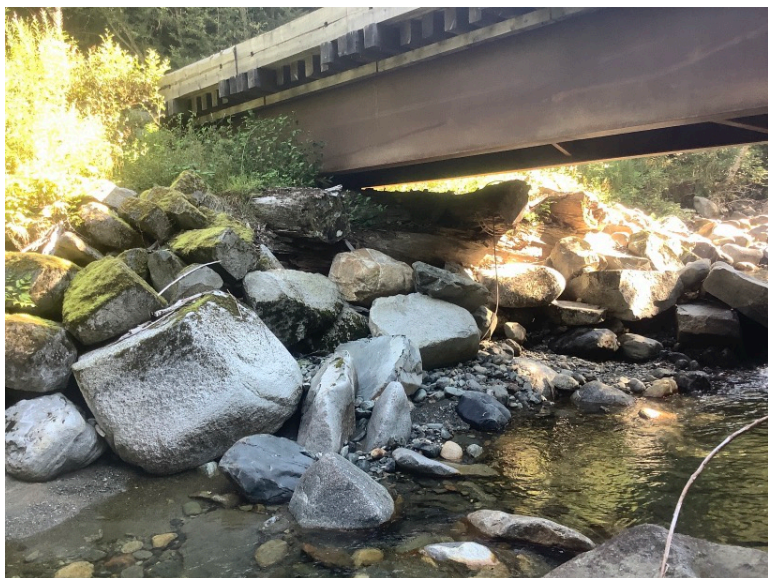
Right Bank Abutment when facing downstream

Old cribs rotting but still retaining fill

Single slabbed bearing logs set back from original log crib face

Large rock either placed or deposited in front of original cribs
