CK-2122  
CK-2122

HARRISON EAST 57.6km

2022 Inspection

Crossing Name Big Silver Creek

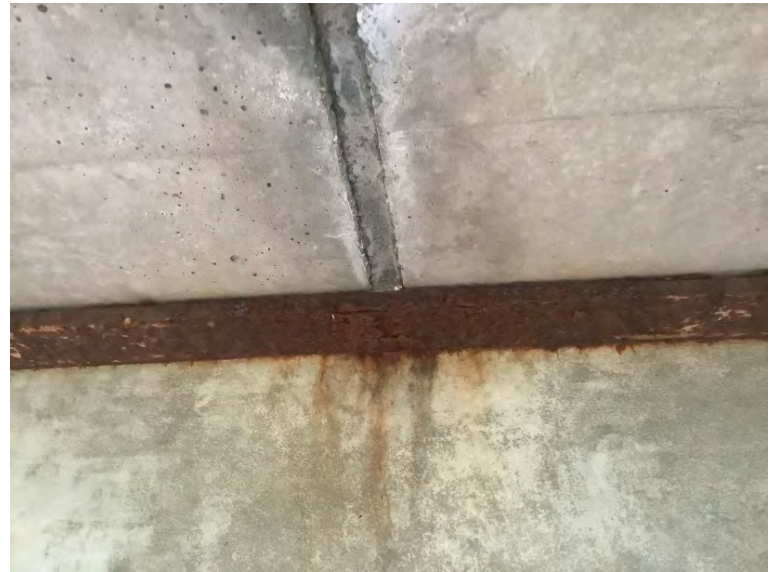
Superstructure

Girders Fair

Visible steel starting to delaminate on top flange

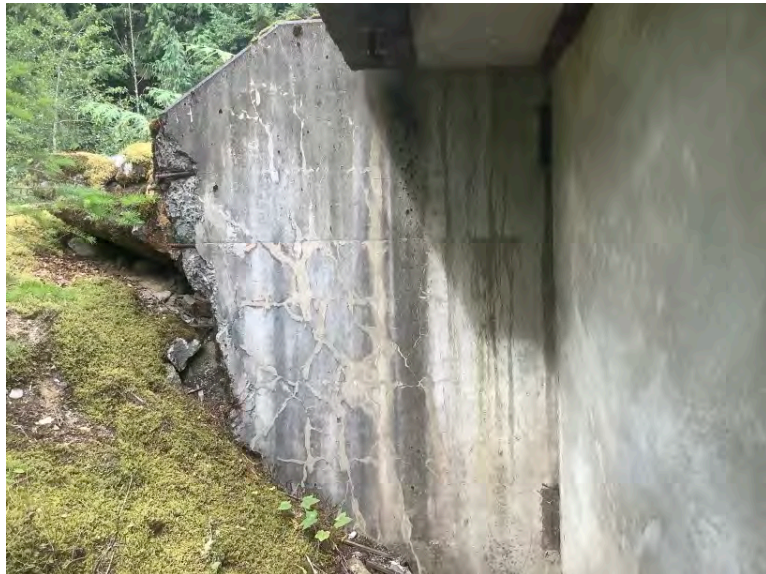
Ballast Wall **Fair**

Town downstream damaged

| Repair Item | Repair Description |
|---|---|
| 1 Structure. Concrete structural maintenance. m².<br>Priority:Low | Town ballast wall downstream, end repairs |

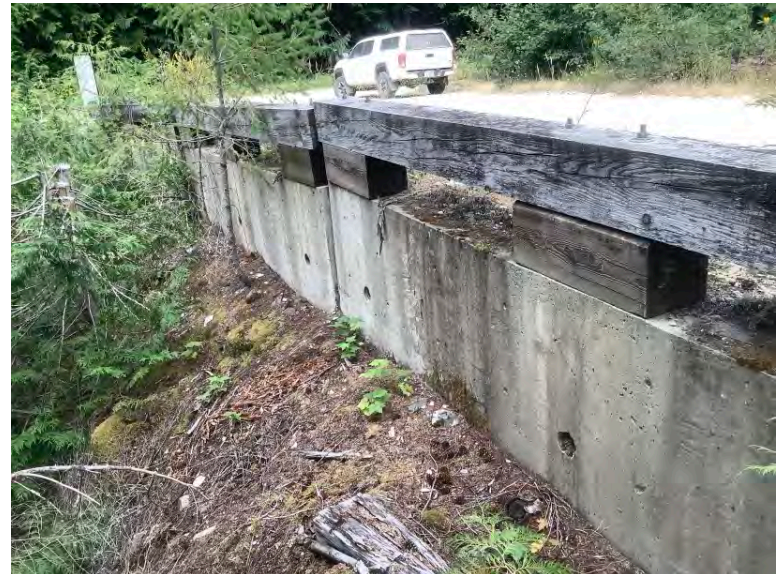
Wing wall

Wing Wall **Good**

Town end

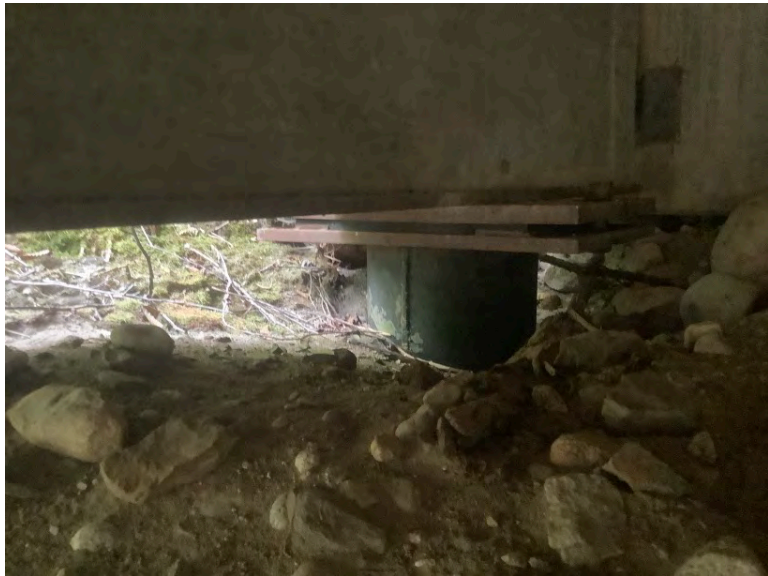
Bearing

Bearings **Good**
