CK-2123  
2123B

HARRISON EAST 7.6km

2022 Inspection

Crossing Name Pick Creek

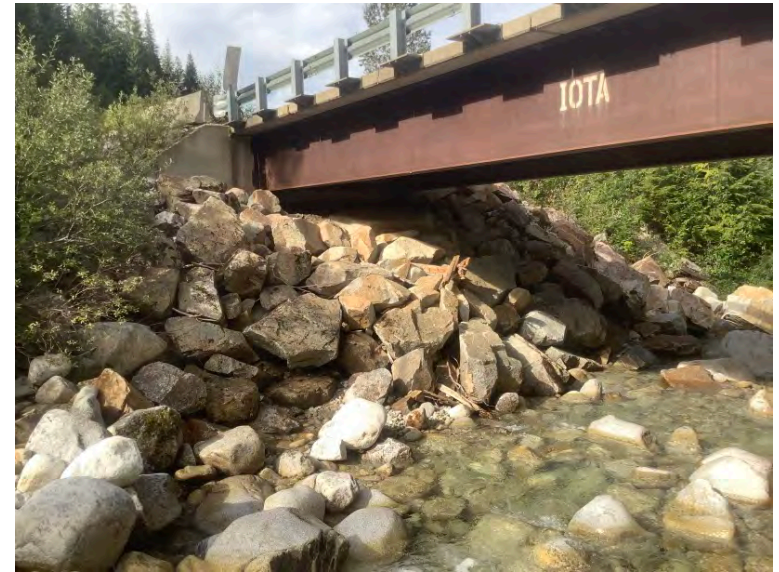
Left Bank Abutment when facing downstream

Riprap Fair

Movement upstream both sides and downstream town. Large rock still present and setback is sufficient. Monitor

Comments: monitor rip rap, especially after high flows

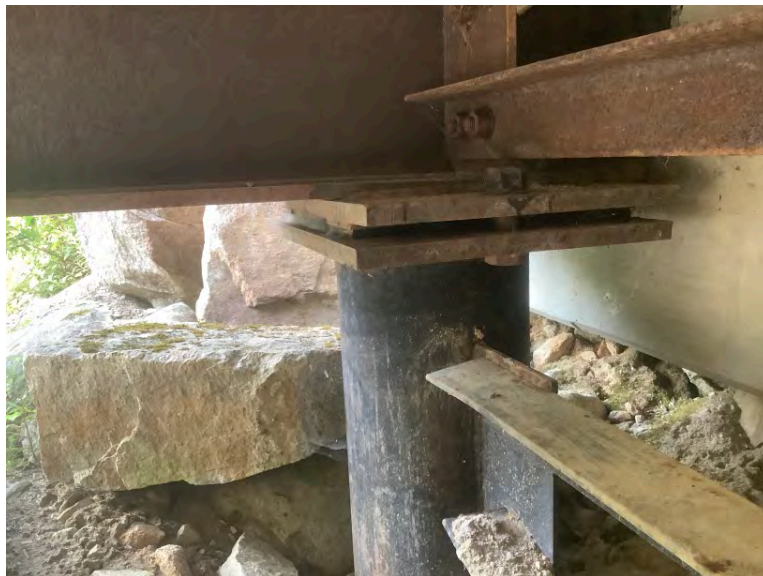
Bearing

Bearings Fair

Some bulging

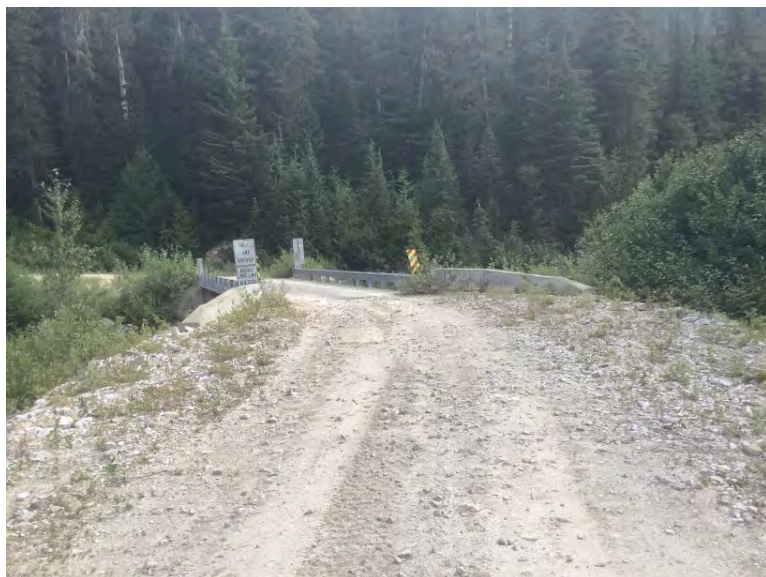
Approach from Left Bank when facing downstream

Road Surface Fair

Grading required prior to industrial use. Slight potholes at both ends of structure.

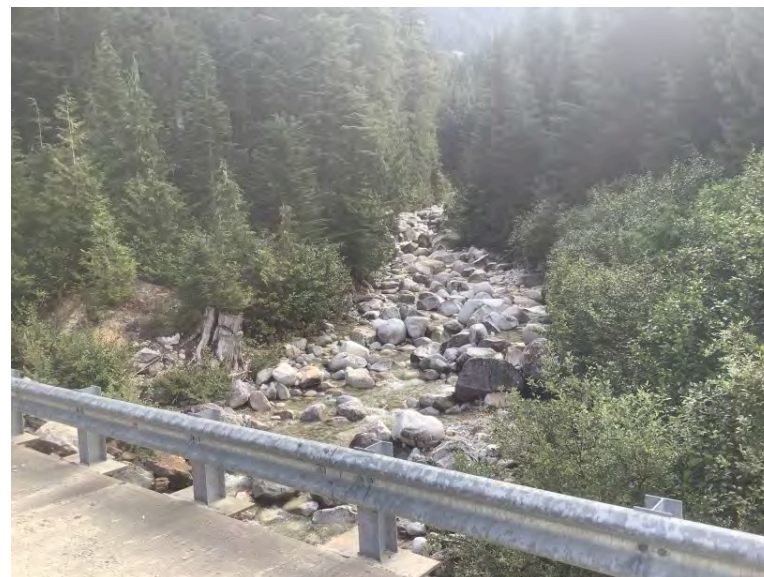
Upstream from Crossing

Comments November 2021 storm likely mobilized riprap. And placed woody debris within 1.3m of superstructure.

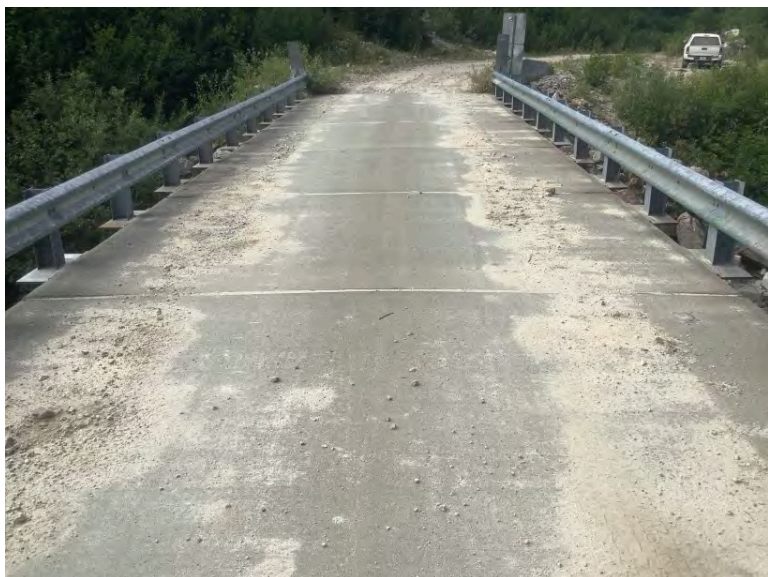
Running Surface      Good      Grading required prior to industrial use. Slight potholes at both ends of structure.

Deck Joints      Good      Rubber gaskets between removable panels
